COLORADO CULTURAL RESOURCE SURVEY

**Architectural Inventory
Form**
1 of 4

1. Resource number: 5ME.1862
2. Temporary resource number: 3178.DR
3. County: Mesa
4. City: Grand Junction
5. Historic building name: n/a
6. Current building name: n/a
7. Building address: 3178 D Road
8. Owner name and address: Kurtis Houston
3178 D Rd Grand Junction, CO 81504-6126

47. Photograph numbers: Roll # 15 Frame # 16
Negatives filed at: City of Grand Junction Planning Dept.
48. Report title: Grand Junction Phase 3 Survey 49. Date(s): October 2005
50. Recorder(s): Suzannah Reid, Patrick Duffield and Lydia Herron
51. Organization: Reid Architects, Inc.
52. Address: PO Box 1303 Aspen, Colorado 81612
53. Phone number(s): 970 920 9225

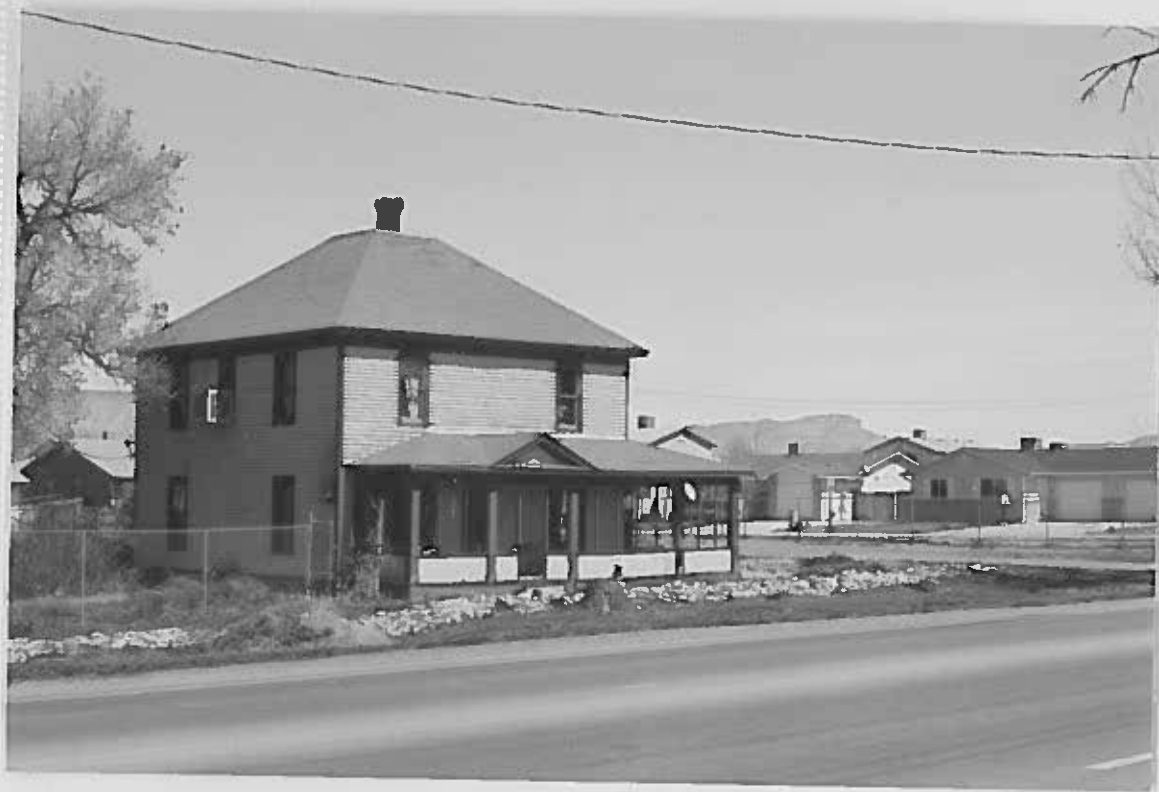
Roll # 15 Frame # 16

21. General architectural description: This is a large two story wood frame house. The house is generally rectangular in plan with a moderately pitched hipped roof. The hipped roof has a short ridge that runs east/west and the principal faces south. The roof has a small overhang with a crown molding that is continuous around the perimeter of the house. A hipped roof porch wraps the south and east sides of the house. The porch roof is supported by square wood posts with trim defining capitals and bases. The posts are located at the corners of the porch, at the building line, and bracketing the entry, which is offset to the left of center on the main façade. The porch entry has a small front gable over-framed on the main porch roof. The area between the porch posts has low infill walls and areas of screened panels. In some cases the screen frames are in place without the screen. The façade of the building has a symmetrical layout with two vertically proportioned double hung windows on the upper level, located to each side, and two large double hungs directly below on the main level, under the porch. The entry door is located on the center of the wall plane. The side walls have two vertically proportioned double hung windows on either side with a spacing similar to the front wall. The window heads engage a tall trim board that runs around the top of the wall just under the eave. A smaller vertically proportioned double hung window is centered on the wall. On the main level of the east side under the porch roof, is another large double hung window on the left. The porch ends short of the right side returning to the main wall. The west side has two vertically proportioned double hung windows in line with the windows above. A brick chimney sits on the rear roof plane, near the short ridge.

43. Assessment of historic physical integrity related to significance: The enclosed porch is the most significant alteration. The enclosure is constructed to reveal the original character of the porch and the original exterior wall is intact. The porch has a minor impact on the integrity of the house. Earlier photos show numerous large trees surrounding the house; these have since been removed.

Looking northeast
