COLORADO CULTURAL RESOURCE SURVEY

**Architectural Inventory
Form**
1 of 4

1. Resource number: 5ME.2776
2. Temporary resource number: 3168.DHR
3. County: Mesa
4. City: Grand Junction
5. Historic building name: n/a
6. Current building name: n/a
7. Building address: 3168 D.5 Road
8. Owner name and address: William Kenneth McCord
3168 D 1/2 Rd Grand Junction, CO 81504-6101

48. Report title: Grand Junction Phase 3 Survey 49. Date(s): October 2005

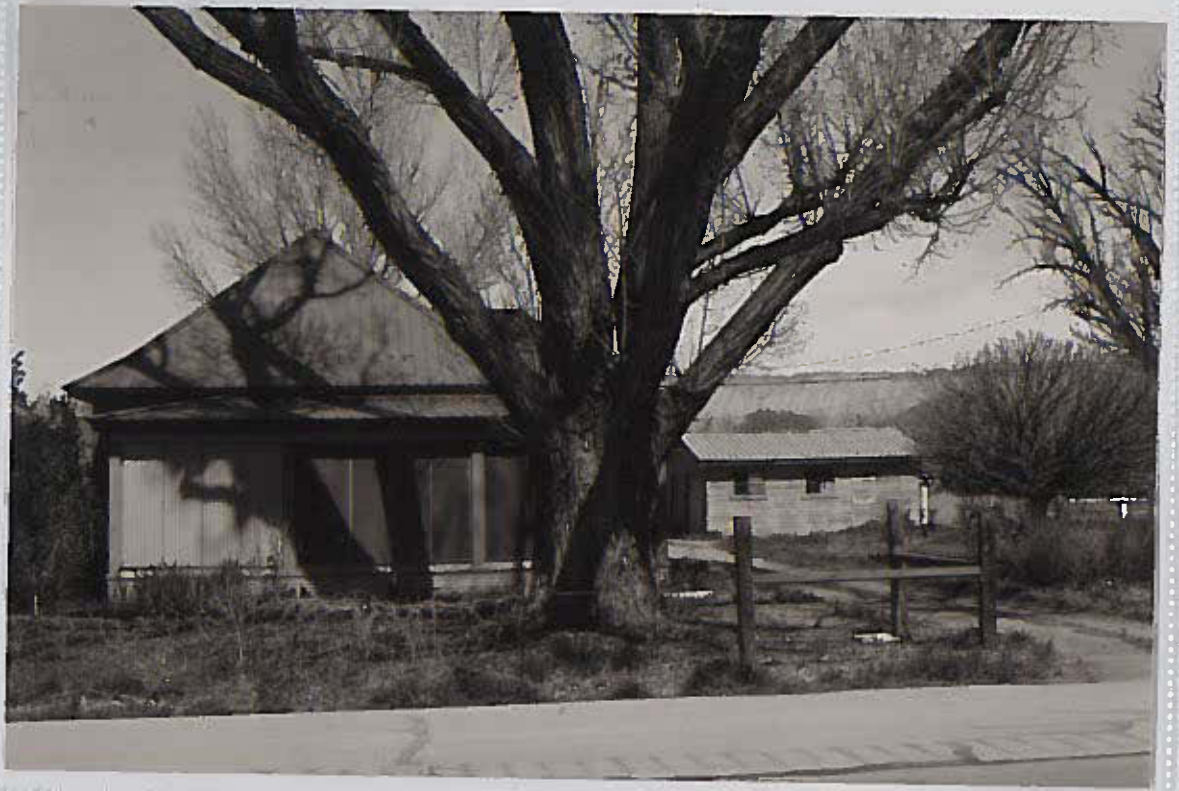
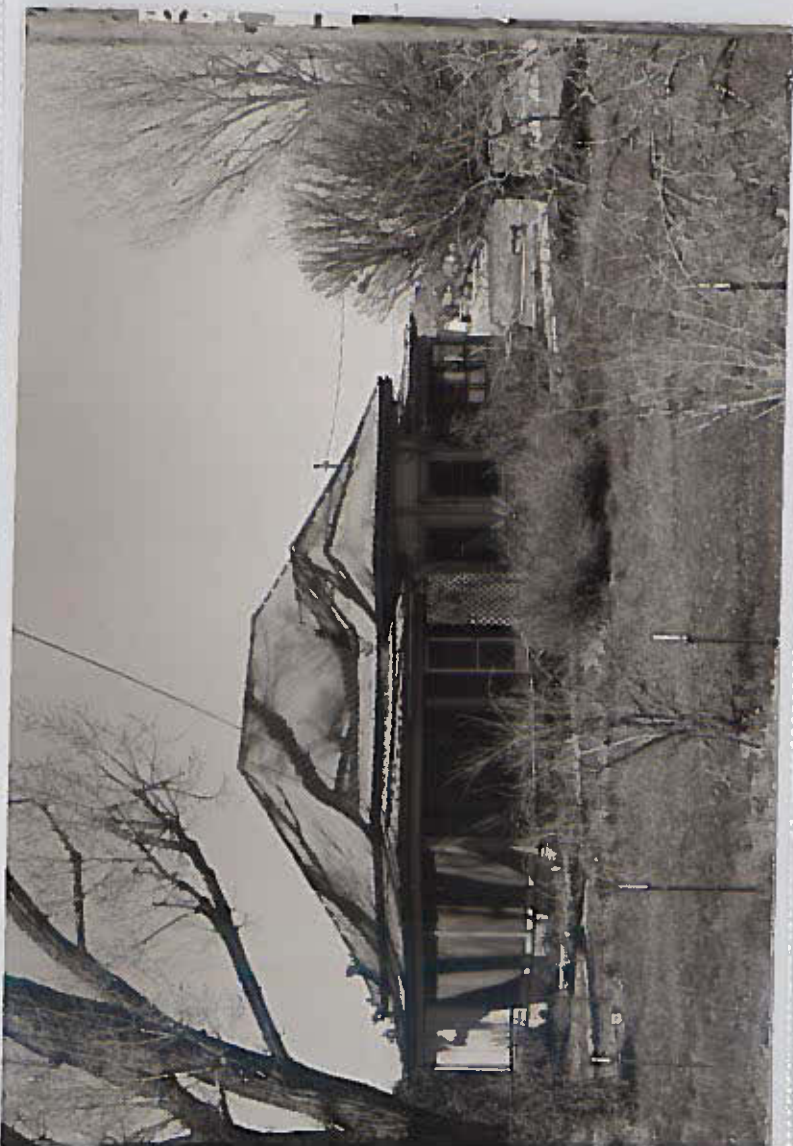
47. Photograph numbers: Roll # 15 Frame # 6 & 7

20. Special features (enter all that apply): Porch, Flared Eave
21. General architectural description: This is a one story wood frame house with a moderately pitched hipped roof. The roof has a long ridge that runs north/south and a slightly flared eave. The south side of the house faces the street. The hipped roof form has an enclosed hip roofed porch, which wraps the building on the south and east sides. The porch is interrupted by a bay which projects from the main form to the right of center. The bay has a hipped roof with a flared eave similar to the main roof. The entry door through the porch is located to the left of the bay. The porch roof is supported by square wood posts, which sit on a low wall. They are equally spaced around the porch perimeter. Large areas of screen infill the areas between the posts, with the exception of the left most section on the street facing façade. This section is infilled with solid panels. The area of the porch which appears on the far side of the bay has a series of vertically proportioned double hung windows along the east wall and wrapping to the north side. The bay has two 45° sides and a front face which are of similar size. The angled sides begin at the outside face of the porch. Each face of the bay has a single vertically proportioned double hung window filling most of the width. An entablature runs across the top of the front panel and cantilevers out along the roof eave. The screened porch conceals the main wall of the house. Pairs of double hungs appear to be located on the street facing wall and the exterior siding and trim appears to be intact.
