COLORADO CULTURAL RESOURCE SURVEY OAH P1400  
**Management Data Form**  
 Rev. 9/98  
 (page 1 of 4)

5. Resource Name: Grand Junction Regional Center (current)  
State Home and Training School for Mental Defectives, name circa 1939  
State Home and Training School, name circa 1957 to 1964  
Grand Junction Indian School commonly known as the Teller Institute,  
name circa 1885 to 1908 also called the Indian School

6. Project Name/Number: Grand Junction Phase Three Survey • Project # 04-01-069
7. Government Involvement: Local  State  Federal   
 Agency: State of Colorado Department of Human Services, Office for Adult, Disability and Rehabilitation Services

1. Resource Number 5ME.761 2. Temporary Resource Number: TELL
3. Map ID Number / Feature Number or Code: Campus Map 'K'
4. Building or Structure Name: Sudan Center  
Originally called the "Dormitory for Crippled children and Idiots at the State Home and Training School for Mental Defectives"
5. Complex/Site Name: Grand Junction Regional Center
6. Photograph Number(s): Roll #16 Frame #0

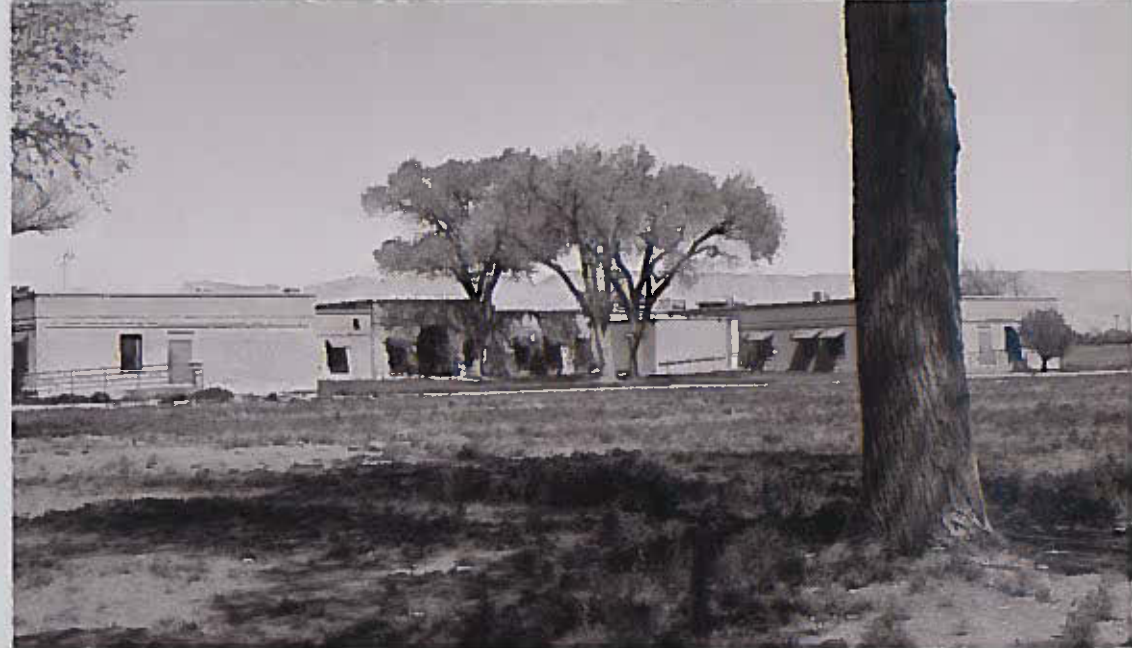
Roll # 16 Frame # 0

20. Doors: The main entry door is located in a deep arched opening and has glass panels with a round arched transom panel.
21. Porches: none
22. General Architectural Description: This is a sprawling one story masonry building with two long wings and a central connecting section. The building is biaxially symmetrical and has a flat roof. The central section is slightly taller and has a single round arched opening the center. The main entry door is deeply set into the opening. A small rectangular window is located to either side of the arch. Wings extend to the east and west connecting this central section to the main north/south wings. These connecting wings have a series of vertically proportioned window openings running in regular intervals across the length of the wall. Small masonry boxes infill the corners created by the intersection of the wings. These boxes are lower in height than the main roof line and have no openings. The long side wings have a three part layout. A tall section at the intersection with the central wings, and long sections with a regular window pattern extending both north and south. The wing ends have a single door opening with concrete ramps running the short distance to grade. The brick walls of the building sit on a concrete base and have a series of single course bands that run around the building just above the window heads. The bands step out from the face of the wall and a soldier course of brick runs infills a section between two of the bands. The corners have low relief brick quoins and the top of the parapet wall is capped with a thicker masonry unit.

Sudan Center

Looking northeast
