COLORADO CULTURAL RESOURCE SURVEY OAH P1400
Management Data Form
Rev. 9/98
(page 1 of 4)

5. Resource Name: Grand Junction Regional Center (current)
State Home and Training School for Mental Defectives, name circa 1939
State Home and Training School, name circa 1957 to 1964
Grand Junction Indian School commonly known as the Teller Institute,
name circa 1885 to 1908 also called the Indian School

6. Project Name/Number: Grand Junction Phase Three Survey • Project # 04-01-069
7. Government Involvement: Local State Federal
Agency: State of Colorado Department of Human Services, Office for Adult, Disability and Rehabilitation Services

COLORADO CULTURAL RESOURCE INVENTORY
Historic Architectural Component Form
(page 1 of 3)

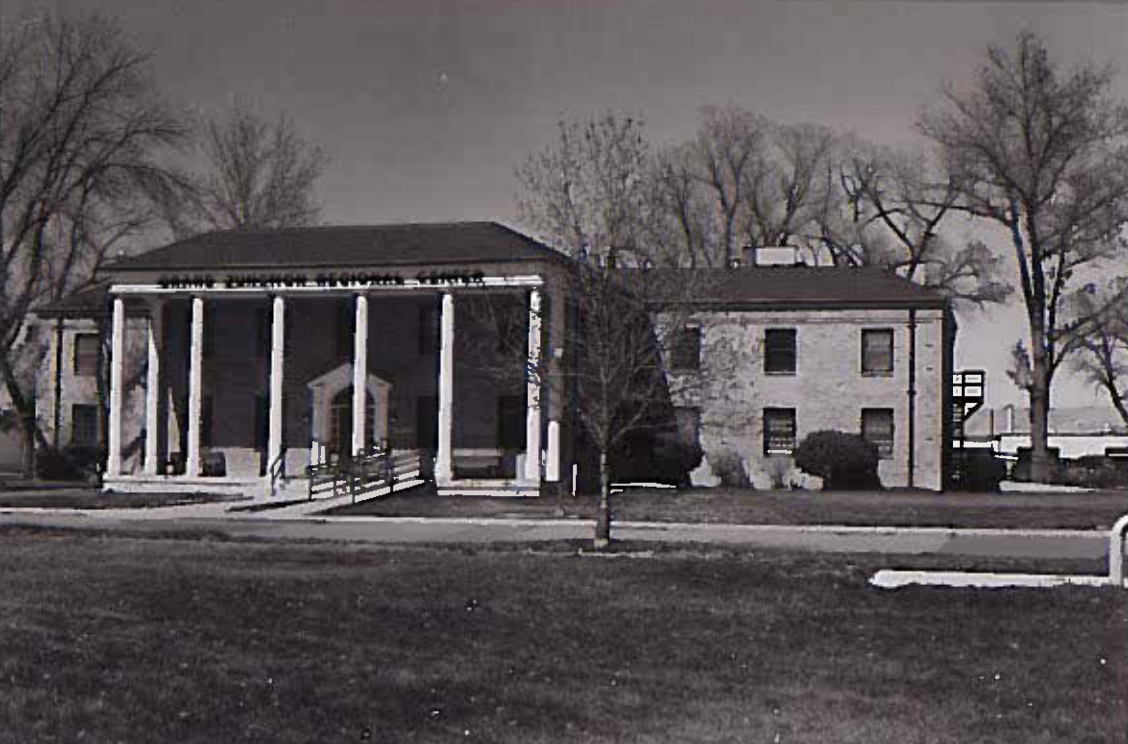
Roll # 16 Frame # 7

22. General Architectural Description: This is a large two story masonry building with a shallow pitched hipped roof over the main volume. A large portico extends to the south from the main volume in front of a wide projecting portion of the building. The projection and the portico are not centered on the overall length of the building. The portico has six two story wood columns across the front that support the hipped roof and one column on either side which sits against the main brick wall. The columns have Tuscan capitals and simplified bases with plinths. The columns sit on a raised porch and they support an entablature the runs around the portico just under the hipped roof. The entablature ends at the brick wall of the building. The main entry is centered on the portico and is framed by a pilaster on either side that supports a simple pediment. The entry opening has a round arched transom above a rectangular door with side lights. A metal ramp runs from the grade to the porch level on the right side of the doorway. The remainder of the building has a regular and repetitive pattern of window openings that are the same on both levels of the building. The windows are mostly double hung with four over two muntins. The top of the brick wall has a stepped course of brick which flows into the brick quoins on the corners.

Administration

Looking north
