COLORADO CULTURAL RESOURCE SURVEY OAH P1400
Management Data Form
Rev. 9/98
(page 1 of 4)

5. Resource Name: Grand Junction Regional Center (current)
State Home and Training School for Mental Defectives, name circa 1939
State Home and Training School, name circa 1957 to 1964
Grand Junction Indian School commonly known as the Teller Institute,
name circa 1885 to 1908 also called the Indian School

6. Project Name/Number: Grand Junction Phase Three Survey • Project # 04-01-069
7. Government Involvement: Local State Federal
Agency: State of Colorado Department of Human Services, Office for Adult, Disability and Rehabilitation Services

COLORADO CULTURAL RESOURCE INVENTORY
Historic Architectural Component Form
(page 1 of 3)

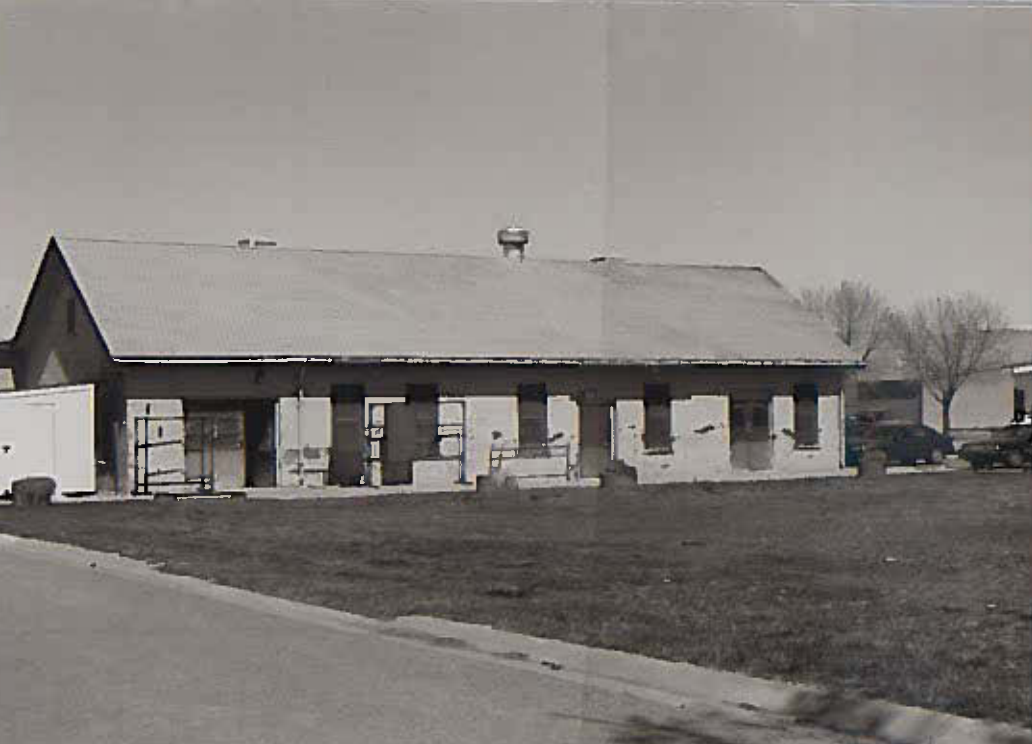
#15 Frame #23

15. Roof: The roof is a steep side gable. The structural type is unknown. The roof finish is asphalt shingles.
16. Walls: The walls are masonry
17. Foundation/Basement: The foundation appears to be concrete in some areas.

18. Chimney(s): A simple metal flue sits on the backside of the side gable roof.
19. Windows: The windows are predominantly vertically proportioned double hungs in segmentally arched openings. They appear to be original to the building.

20. Doors: The doors are both single and double door units in segmentally arched openings. The floor level seems to vary based on exterior thresholds. Some doors appear to be original, many have been replaced.

21. Porches: none
22. General Architectural Description: This is a long masonry side gable building. The ridge runs east/west and the main façade faces south. The south wall has an overhead door on the left, three vertically proportioned double hung windows in segmental arched openings occupy the wall plane to the center point. A single door and another double hung window are located further to the right and a pair of doors with a final double hung window are located on the far right end of the building. Small vent windows are located in the eave ends. A small wing extends off the left side at the rear of the building.

29. Modifications: Minor Moderate _____ Major _____ Moved _____ Date _____
Describe Modifications: Alterations to original doors; dates unknown
Additions and Date: Small addition to northwest corner; dates unknown

43. Management Recommendations: The East House 'A' and West House 'B' should be targeted for appropriate reuse. Renovation to restore original features and removal of inappropriate alterations should be undertaken. The Boiler House 'G' and Adaptive 'H' are relatively unchanged and seem to have current uses which are compatible to the buildings. Any anticipated alterations should be performed in an appropriate manner for the preservation of the historic integrity of the buildings. A local landmark designation should be considered for this complex, in order to provide tools for the preservation of the remaining original buildings.
