COLORADO CULTURAL RESOURCE SURVEY OAH P1400
Management Data Form
 Rev. 9/98
 (page 1 of 4)

5. Resource Name: Grand Junction Regional Center (current)
State Home and Training School for Mental Defectives, name circa 1939
State Home and Training School, name circa 1957 to 1964
Grand Junction Indian School commonly known as the Teller Institute,
name circa 1885 to 1908 also called the Indian School

6. Project Name/Number: Grand Junction Phase Three Survey • Project # 04-01-069
7. Government Involvement: Local State Federal
 Agency: State of Colorado Department of Human Services, Office for Adult, Disability and Rehabilitation Services

1. Resource Number 5ME.761 2. Temporary Resource Number: TELL
3. Map ID Number / Feature Number or Code: Campus Map 'J'
4. Building or Structure Name: Bower's Cafeteria
A Dining Hall Building for the State Home and Training School, per architectural drawings
5. Complex/Site Name: Grand Junction Regional Center
6. Photograph Number(s): Roll #15 Frame #24

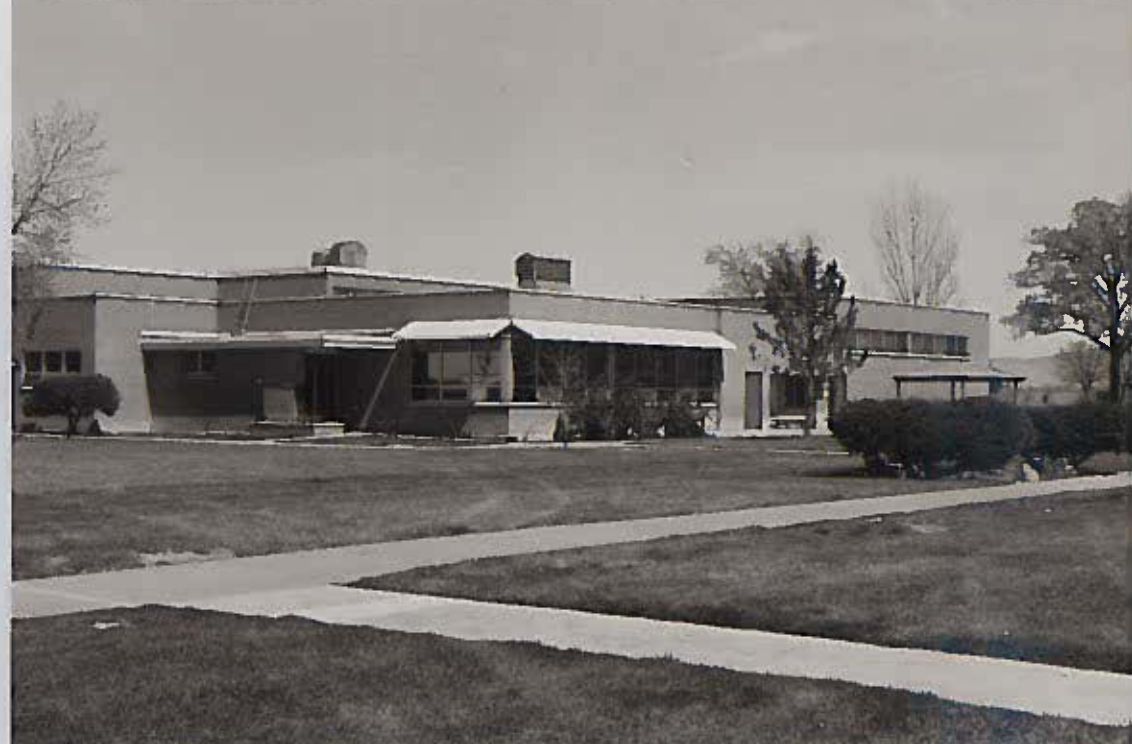
Roll # 15 Frame # 24

- 22. General Architectural Description: This is a horizontally proportioned brick building with a flat roof. The building is a series of two 'Z' shaped nested volumes sections. The front volume is on the south side and is lower in height than the back volume. The front volume has a step in the south west corner where a lower flat roofed entry volume sits in the ell. The entry faces south and runs into this smaller volume. A band of fixed windows wrap the corner of the front volume beginning at a point adjacent to the entry roof and running more that half way along the south wall. The windows have aluminum frames with a low band on the bottom and top and a taller glass area in the center. The back volume comes out to the south face of the building on the east side and has a band of high windows running across just less than the full width of the wall. The west wall of the front volume has a series of rectangular openings near the south corner. Other sides of the building have minimal openings.

Bower's Cafeteria

Looking northeast
