COLORADO CULTURAL RESOURCE SURVEY OAH P1400
Management Data Form
 Rev. 9/98
 (page 1 of 4)

5. Resource Name: Grand Junction Regional Center (current)
State Home and Training School for Mental Defectives, name circa 1939
State Home and Training School, name circa 1957 to 1964
Grand Junction Indian School commonly known as the Teller Institute,
name circa 1885 to 1908 also called the Indian School

6. Project Name/Number: Grand Junction Phase Three Survey • Project # 04-01-069
7. Government Involvement: Local State Federal
 Agency: State of Colorado Department of Human Services, Office for Adult, Disability and Rehabilitation Services

COLORADO CULTURAL RESOURCE INVENTORY
Historic Architectural Component Form
(page 1 of 3)

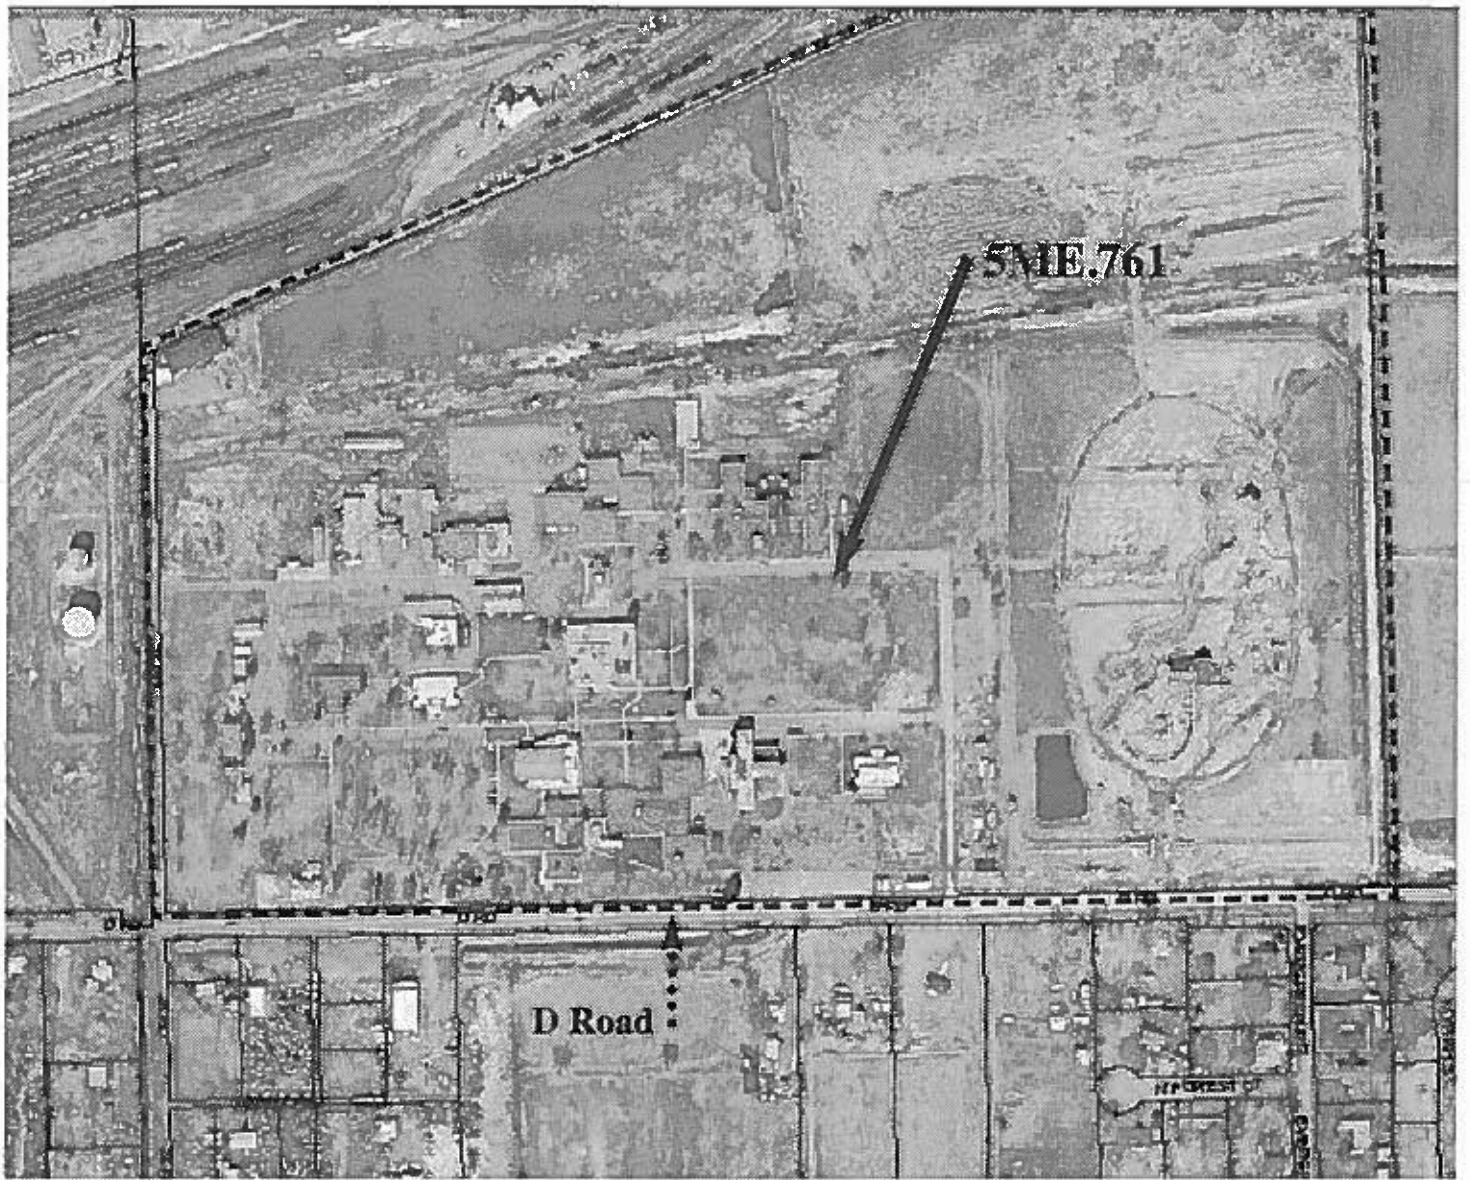
Key to Surveyed Sites • Campus Map

14. Associated Buildings, Features, or Objects - Describe material and function (map number / name): Buildings with component forms attached are indicated on the sketch map with letters and are as follows: 'A'- East House; 'B'- West House; 'C'- Pace; 'D'- Amos Training; 'E' - Zuni; 'F'- Administration; 'G'- Boiler House; 'H'- Adaptive; 'K'- Sudan Center; and 'L'- MJC. Numerous buildings on the site were constructed outside of the period of interest for this survey. They are indicated with their common names and construction date noted on the sketch map and briefly described below. These buildings are not described on individual component forms: Wood Stakes (1950) a flat roofed and stucco storage building; Brodine Storage (1973) a front gable storage building; Maintenance (1957) a one story office and shop building designed by Robert A. Van Duesen; Laundry (1963); the Porter Center (1975) a low pitched front gabled group of dormitory buildings with brick and stucco walls; The Computer Lab (1964); Carson (1964) a brick predominantly flat roofed building; Hinds Gymnasium (1960) an auditorium; Meyer Health Center (1958) a low pitched synthetic roofed buildings with groups of aluminum frame windows used as an infirmary and health services facility; Draper (1964) slated for demolition; and Butler (1958) a group of three buildings used as classrooms. The buildings are arranged around a central entry court with the majority of the later buildings concentrated to the north and east of the courtyard.

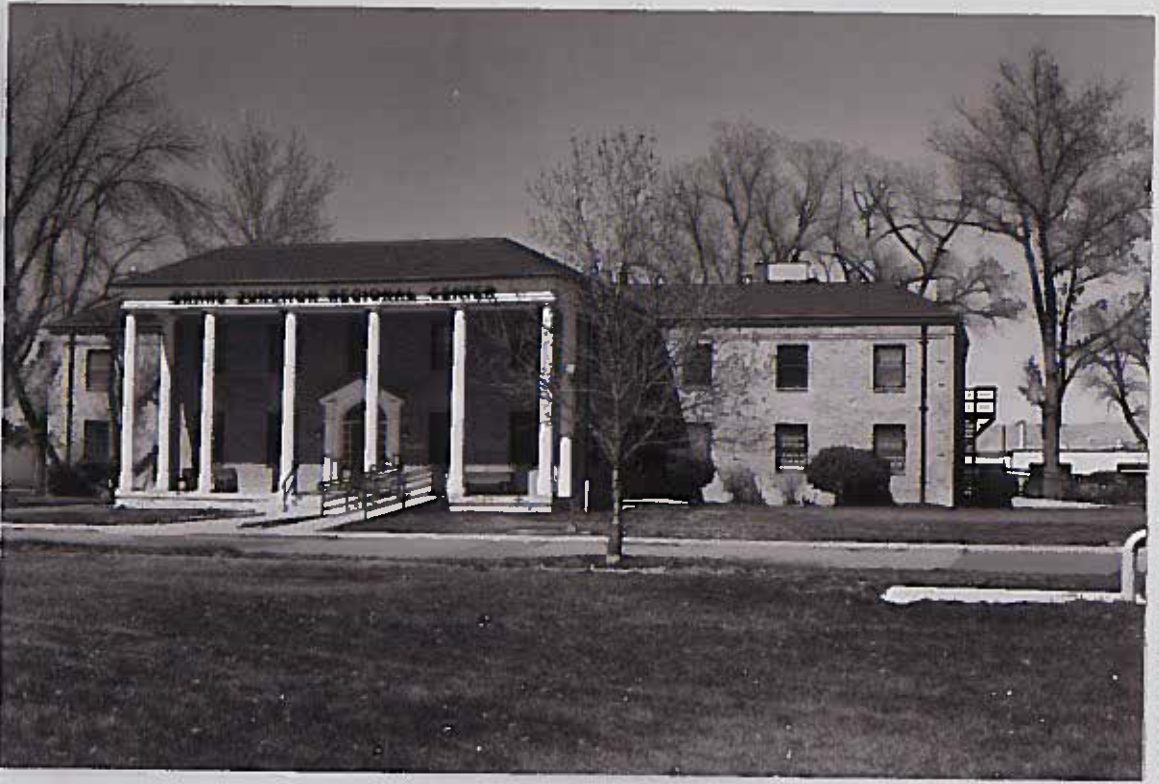
5ME.761 2800 D Road
Roll # 16 Frame # 4
East House
Looking southeast
Grand Junction, Mesa County, CO

1. Resource Number 5ME.761 2. Temporary Resource Number: TELL
3. Map ID Number / Feature Number or Code: Campus Map 'A'
4. Building or Structure Name: East House
5. Complex/Site Name: Grand Junction Regional Center
6. Photograph Number(s): Roll #16 Frame #4

15. Roof: Asphalt roofing on wood frame roof structure
16. Walls: The walls are common bond brick with segmental arched openings.
17. Foundation/Basement: Masonry

18. Chimney(s): Two brick chimneys with corbelled brick tops are located on the roof plane. One chimney is located on the north side and one on the south side. The chimneys are flush with the wall plane on their respective sides. The eave line of the roof runs through separating the chimney from the wall below.

19. Windows: The windows are vertically proportioned double hung windows in segmentally arched openings. Aluminum storm windows are applied to the outside and it is unclear if original windows are existing.

20. Doors: Doors are wood and not original to the structure.
21. Porches: The porch has been enclosed with a low wood sided wall and a series of window openings running around the top of the wall. The hip roof is supported by the wall and is not likely to be original to the building.

22. General Architectural Description: This is a one and one half story masonry building with a hipped roof. The roof has a short ridge that runs east/west and the principal façade faces west. The principal façade has a hipped roof porch applied to the main wall. The porch is enclosed with a central entry door. A small hipped roof dormer sits near the bottom of the main front roof plane with a door way in the west face. The roof of the porch is flat in the center with a railing that runs at the edge of the flat area; a metal stair runs from this level to the grade on the south side of the porch. Two tall brick chimneys sit on the main roof plane at the line of the brick wall below. The chimneys rise almost to the level of the main roof ridge and have corbelled brick caps. The front areas of brick wall and the sides of the building have two vertically proportioned double hung windows set in segmental arched openings widely spaced on the elevations. The east side has a flat roofed element that extends off the hipped roof on the upper level.

29. Modifications: Minor _____ Moderate X Major _____ Moved _____ Date _____
Describe Modifications: The original porch has been removed and an enclosed porch sits in the center of the façade. The main dormer has been modified to include a door and a steel stairway runs from the dormer to grade on the south; probably around 1979.

43. Management Recommendations: The East House 'A' and West House 'B' should be targeted for appropriate reuse. Renovation to restore original features and removal of inappropriate alterations should be undertaken. The Boiler House 'G' and Adaptive 'H' are relatively unchanged and seem to have current uses which are compatible to the buildings. Any anticipated alterations should be performed in an appropriate manner for the preservation of the historic integrity of the buildings. A local landmark designation should be considered for this complex, in order to provide tools for the preservation of the remaining original buildings.

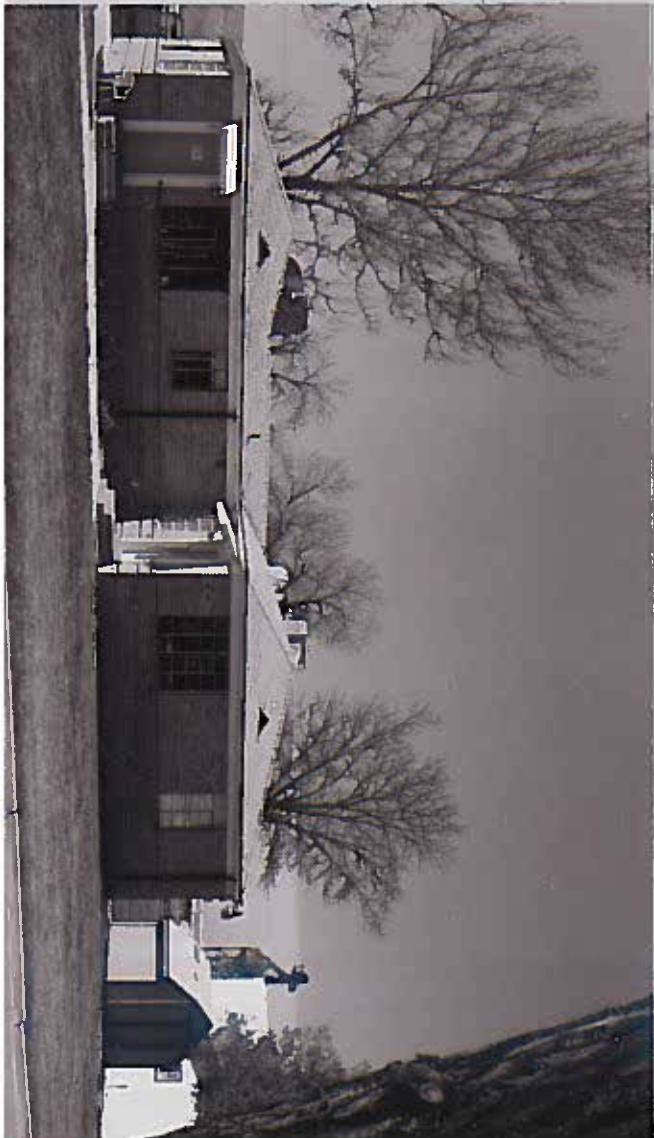
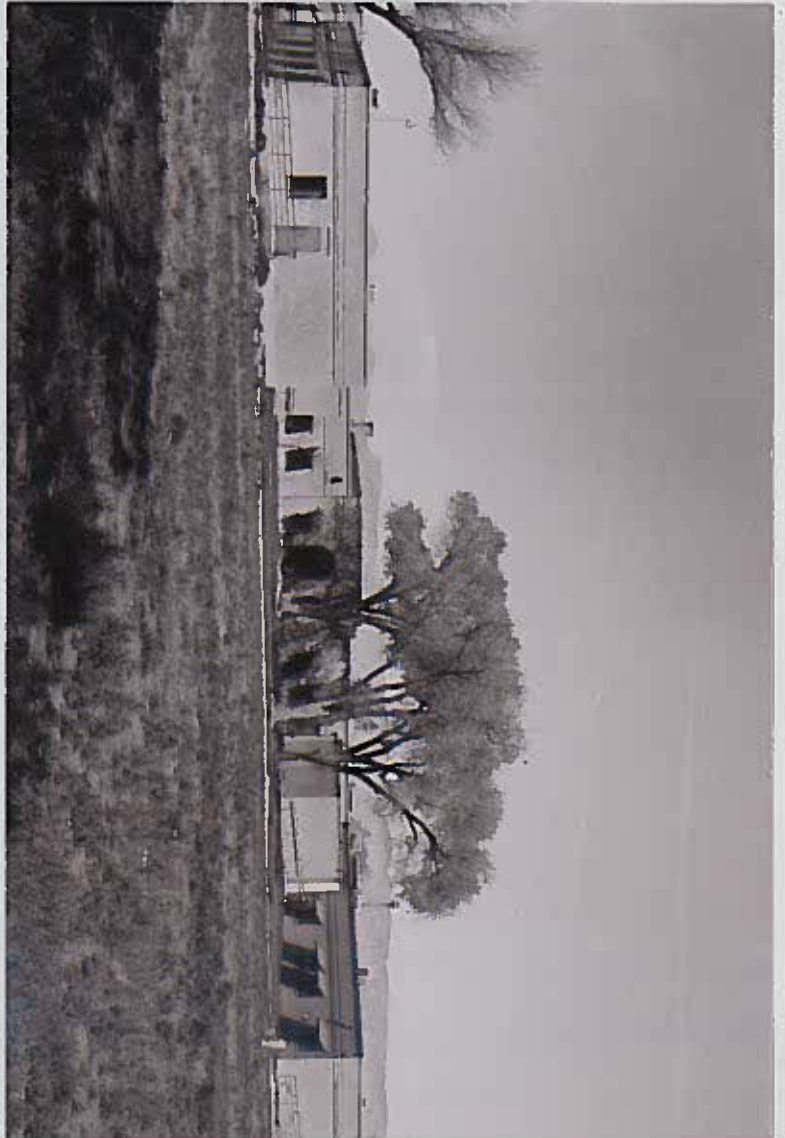
Roll # 16 Frame # 2 Sudan Center
Looking northeast
Grand Junction, Mesa County, CO

1. Resource Number 5ME.761 2. Temporary Resource Number: TELL
3. Map ID Number / Feature Number or Code: Campus Map 'K'
4. Building or Structure Name: Sudan Center
Originally called the "Dormitory for Crippled children and Idiots at the State Home and Training School for Mental Defectives"
5. Complex/Site Name: Grand Junction Regional Center
6. Photograph Number(s): Roll #16 Frame #0

17. Foundation/Basement: The foundation is assumed to be concrete.
18. Chimney(s): none
19. Windows: The windows are steel sash with a single vertical muntin and several horizontal muntins. An operable section is included within the larger unit. Windows are distributed sparingly around the building.
