# Architectural Inventory Form

1. 1	den	tification	
	1.	Resource number:	5ME.14864
	2.	Temporary resource number:_	465.HAL
	3.	County:	Mesa
			Grand Junction
	5.	Historic building name:	n/a

6.	Current building name:	n/a
	7.	Building address:	465 Hall Ave
	8.	Owner name and address:	Gerald H Shippert
			465 Hall Ave Grand Junction, CO 81501-2135
II.	Ged	ographic Information

71.			
	Negatives filed at: City of Grand Junction Planning Dept.			
	48. Report title: <u>Grand Junction Phase 3 Survey</u> 49. Date(s): <u>March 2005</u> 50. Recorder(s): <u>Suzannah Reid, Patrick Duffield and Lydia Herron</u>			
		Organization: Reid Architects, Inc.		
		Address: PO Box 1303 Aspen, Colorado 81612

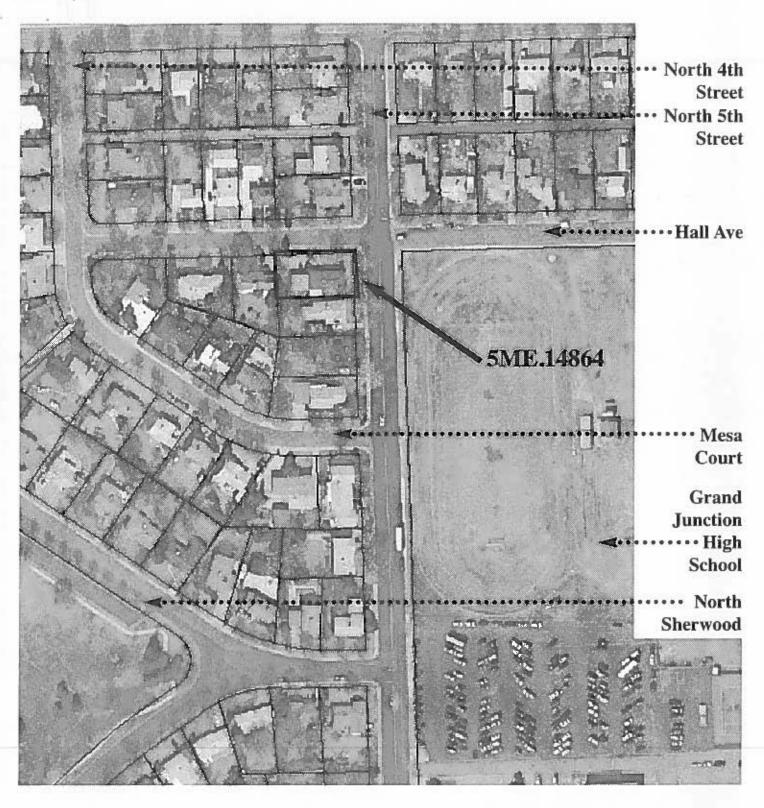
# 465 Hall Ave.

Grand Junction, Colorado image from 2002 aerial map

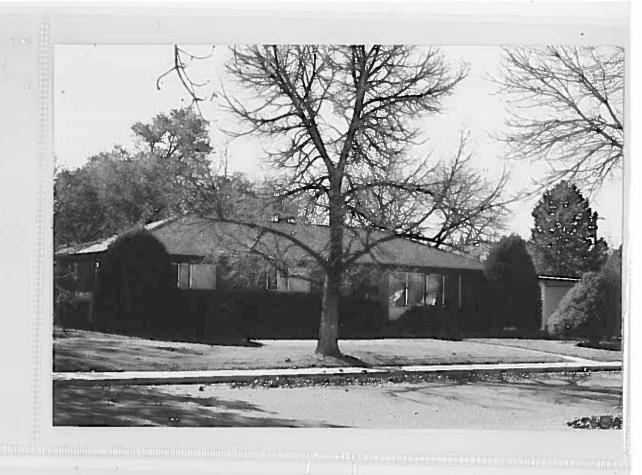
Roll #14 Frame #25

21.	. General architectural desc	ription: This is a long horizontally proportioned wood frame	
		house with a moderately p	itched hipped roof. The ridge runs east/west and the principal	
		façade faces north. The m	ain entry door is set off center to the right on the main façade.	
		A series of large vertically	proportioned picture windows fill the remainder of the wall to	
		the right. Two horizontally	proportioned window groups are located on the remainder of	
		the façade to the left. Thes	se windows are comprised of a sliding unit and a fixed unit of	
	similar sizes. The west facade has two of the same window units equally distributed on the wall. The east façade has a carport which extends off the main wall plane to the east			
		A shed is attached to the rear of the carport. A large rectangular brick chimney sits on the		
		east facade of the house adjacent to the carport space.

Looking southwest
