Architectural Inventory Form

1. Resource number: 5ME.14843
2. Temporary resource number: 1301.ETHD
3. County: Mesa
4. City: Grand Junction
5. Historic building name: Van Deusen Apartments
6. Current building name: Sherwood Park Apartments
7. Building address: 1301 E. 3rd Street
8. Owner name and address: Lisa Reed, Sherwood Park Apartments
305 Kennedy Ave Grand Junction, CO 81501

48. Report title: Grand Junction Phase 3 Survey 49. Date(s): March 2005
50. Recorder(s): Suzannah Reid, Patrick Duffield and Lydia Herron
51. Organization: Reid Architects, Inc.
52. Address: PO Box 1303 Aspen, Colorado 81612
53. Phone number(s): 970 920 9225

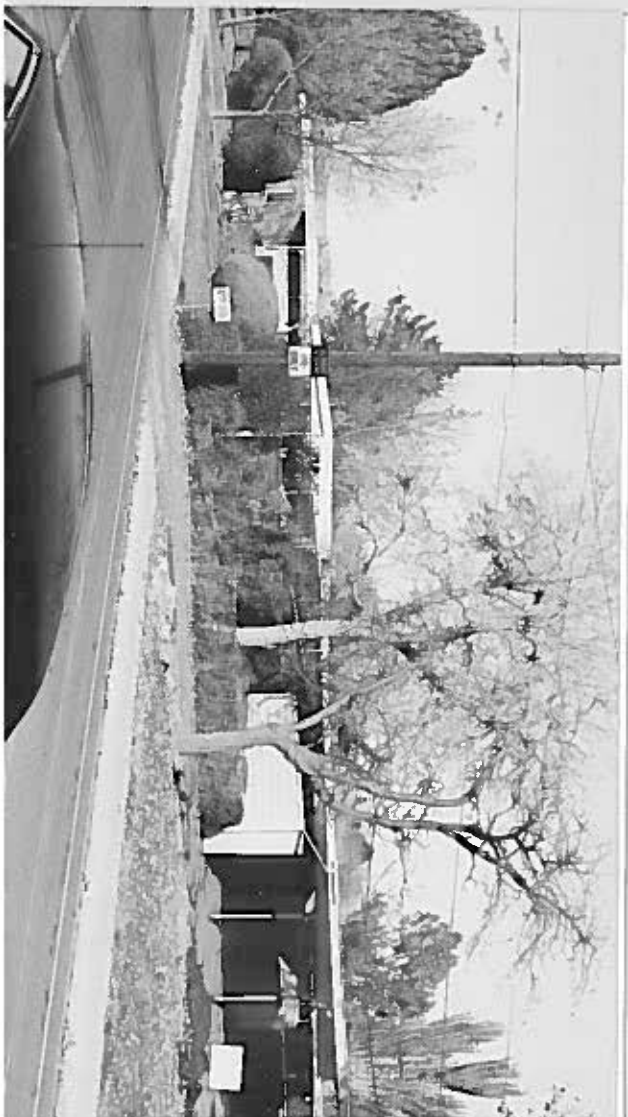
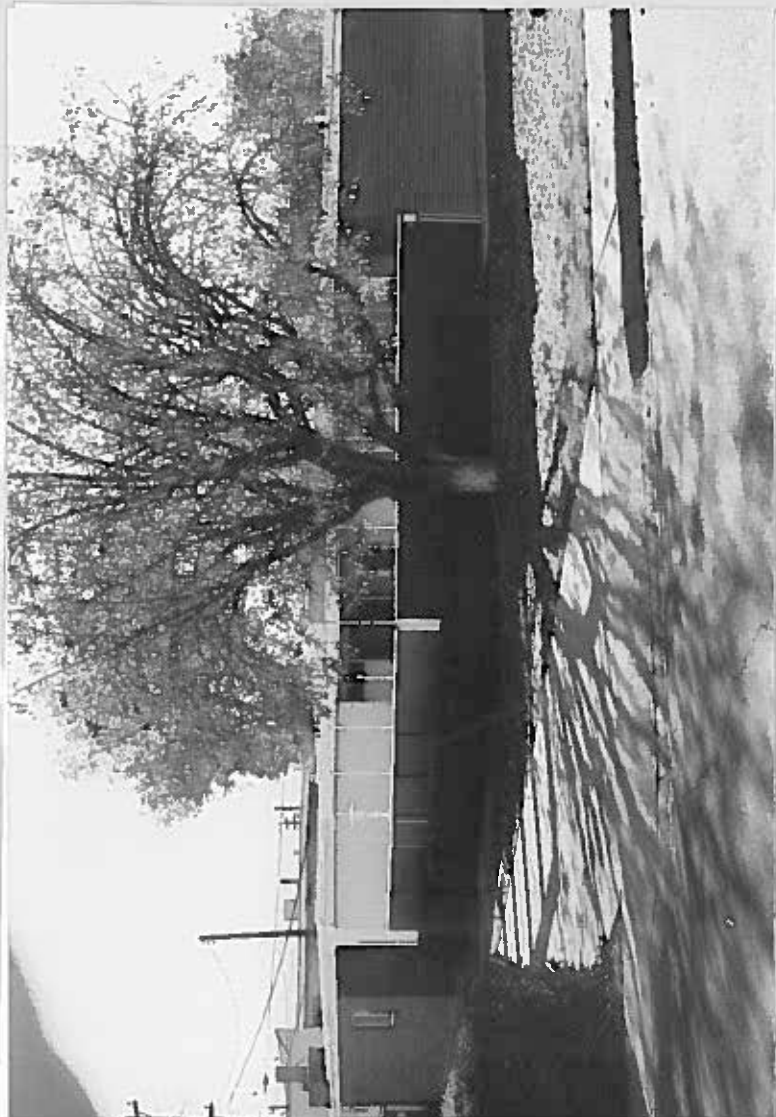
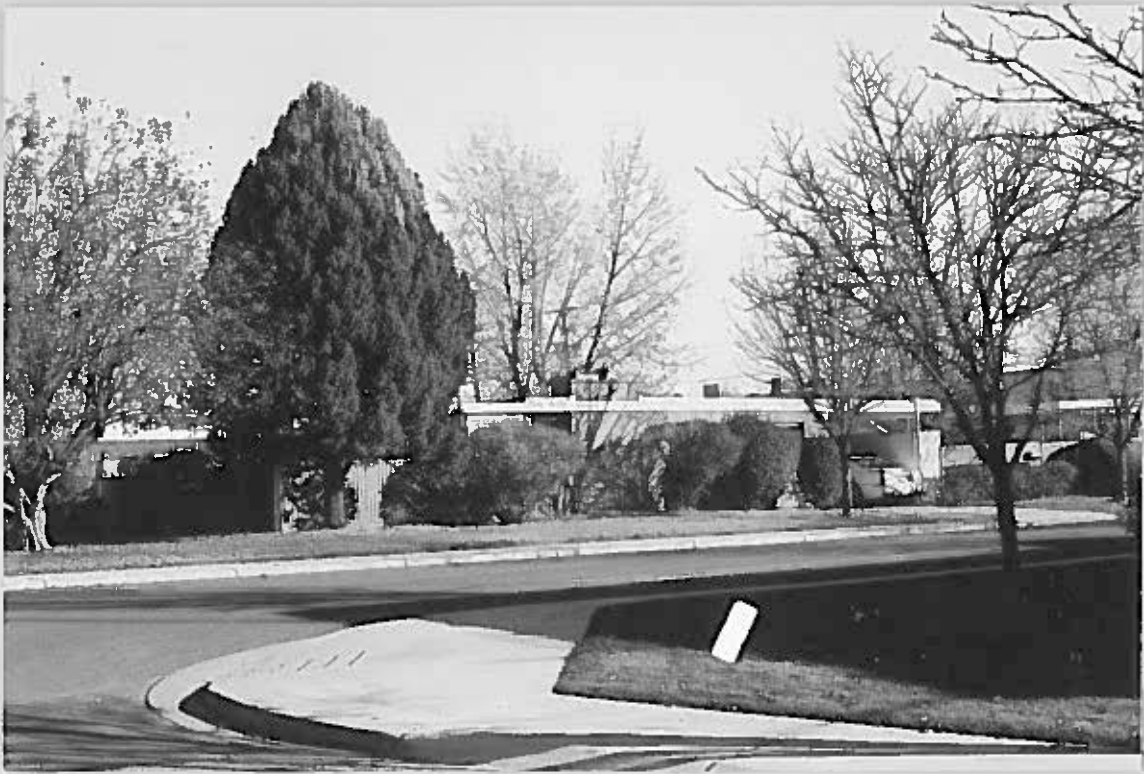
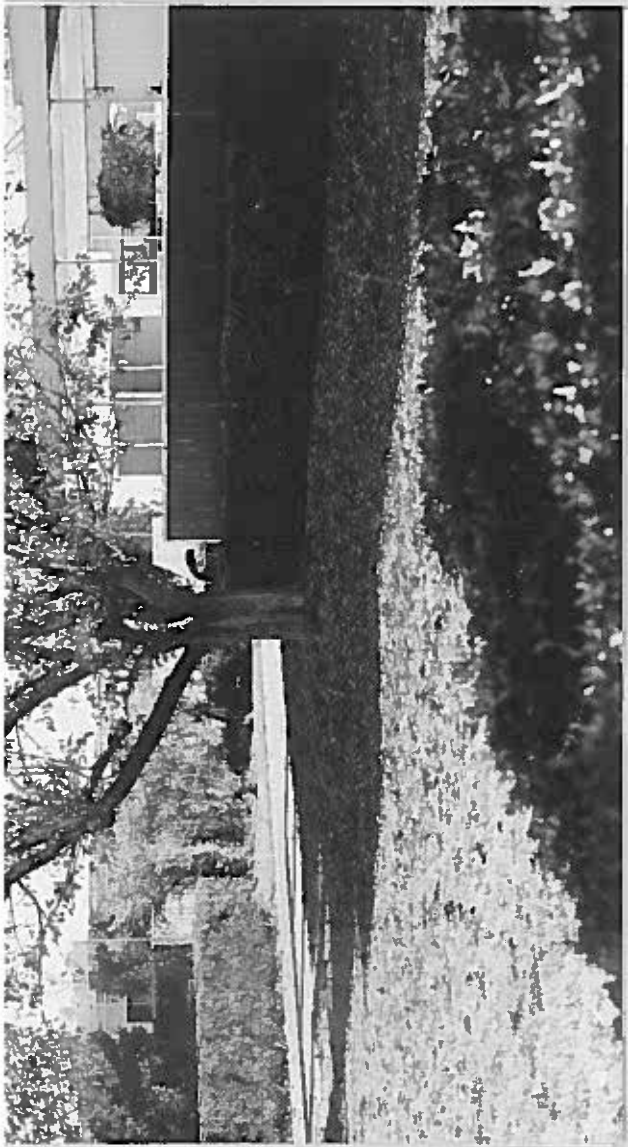
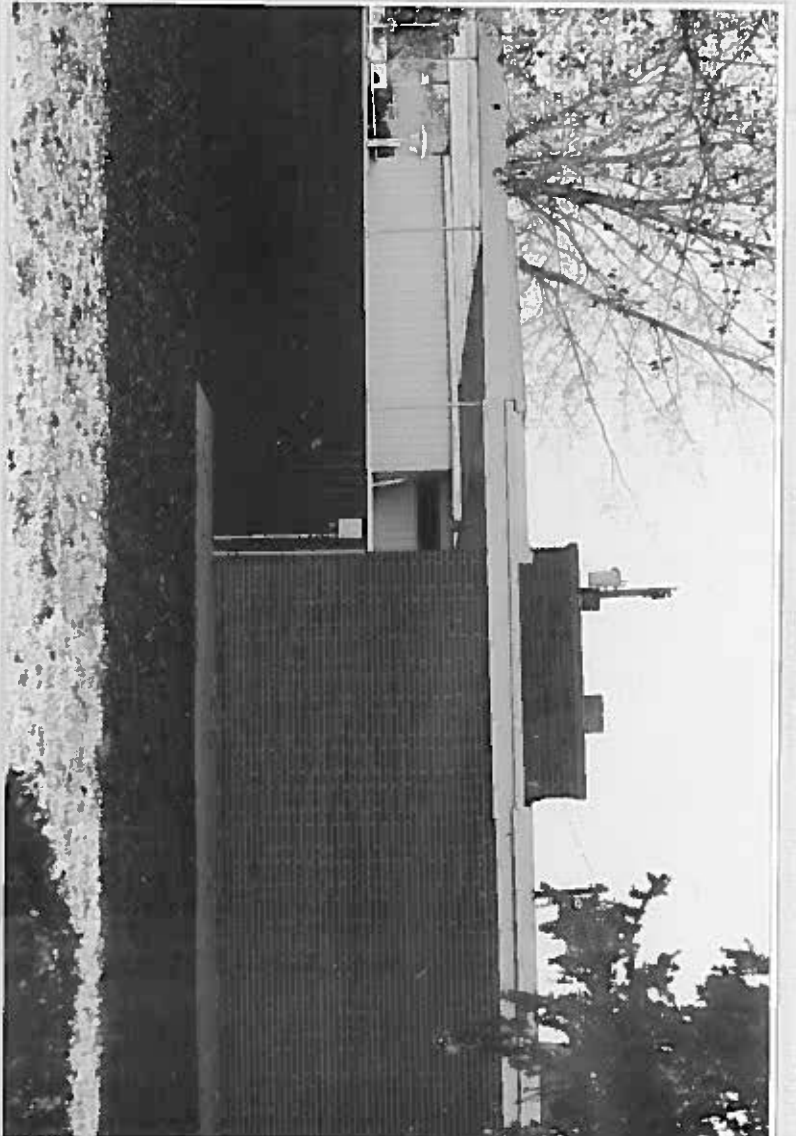
SME.14843 1301 E. 3rd Street
Roll # 13 Frame # 13
Looking east
Grand Junction, Mesa County, CO

21. General architectural description: This is a horizontally proportioned wood frame building with several living units. The building is comprised of areas of brick wall with minimal openings, walls that are primarily large areas of glazing, sections of wood wall enclosing yard areas and carports. The flat roof edge is a simple flat fascia which unifies the variety of wall planes and voids. The fascia is continuous across the carport roofs, where it is supported by thin steel columns; to the top of the roman brick wall, where it bisects the wall when it steps up to become a chimney; to the courtyard space where it becomes a trellis element over the thin garden wall plane. The pattern is repeated throughout the building, providing each interlocking unit with a carport/entry, enclosed living space and enclosed outdoor space. The west facing wall, for example, has a carport on the right, enclosed by a wood screen on the left and the main brick wall on the right. The brick wall runs to the continuous fascia board at its top. A single vertically proportioned opening sits in the wall near the carport, otherwise the wall has no openings. The north end of the wall steps up to form a low rectangular chimney, which is flush with the wall on the north and west sides. A wood screen wall continues the west wall plane, enclosing the courtyard, and the fascia continues along the same line, now supported by a series of very light steel struts, with no roof plane behind it. The building enclosure becomes a glass wall under a moderate overhang on the north side, looking into the enclosed garden. This pattern is repeated for the adjoining units with some variation.
