COLORADO CULTURAL RESOURCE SURVEY

Architectural Inventory Form

1. Resource number: 5ME.14906
2. Temporary resource number: 1549.WSER
3. County: Mesa
4. City: Grand Junction
5. Historic building name: n/a
6. Current building name: n/a
7. Building address: 1549 W. Sherwood Ave.
8. Owner name and address: Ann Kuhlman
1549 W Sherwood Dr Grand Junction, CO 81501-2142

48. Report title: Grand Junction Phase 3 Survey 49. Date(s): March 2005

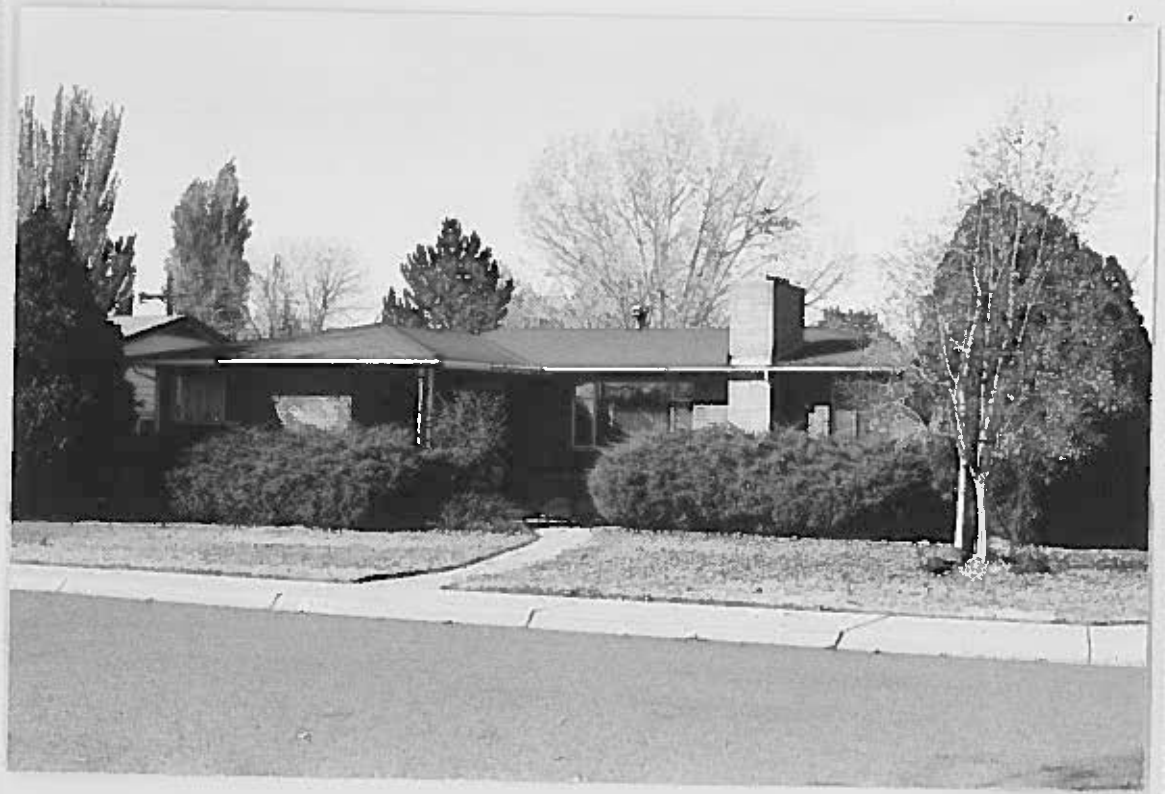
5ME.14906 1549 W. Sherwood
Roll # 14 Frame # 18
Looking west
Grand Junction, Mesa County, CO

21. General architectural description: This is a horizontally proportioned wood frame house with a low pitched hipped roof. The main ridge runs northeast/southwest and the principal façade faces southeast. The principal façade has a hipped roof projecting volume on the left side and the north part of the volume is recessed under the hipped roof form. A large sliding window sits on the southeast corner of the projecting volume and the main wall plane carries across the recess with a low brick wall. A pair of metal columns support the overhanging corner of the hipped roof. The main entry door is located on the street facing wall under the recess. A concrete landing infills the area of the recess and three steps run from the north side to the grade. A large picture window, flanked by casements sits on the main wall to the right of the entry door. A rectangular rusticated brick chimney engages the main wall plane and runs back into the plane of the roof. A fixed window with a casement to the left side sits on the corner of the remaining wall to the right of the chimney. The same unit appears on the corner of the northeast façade. A hipped roof wing continues along the northeast and has an enclosed porch and a garage under its form.
