COLORADO CULTURAL RESOURCE SURVEY

Architectural Inventory Form

1. Resource number: 5ME.14852
2. Temporary resource number: 1525.SEV
3. County: Mesa
4. City: Grand Junction
5. Historic building name: n/a
6. Current building name: n/a
7. Building address: 1525 N. 7th Street
8. Owner name and address: Rose Ann Morey
1525 N 7th St Grand Junction, CO 81501-3005

48. Report title: Grand Junction Phase 3 Survey 49. Date(s): March 2005

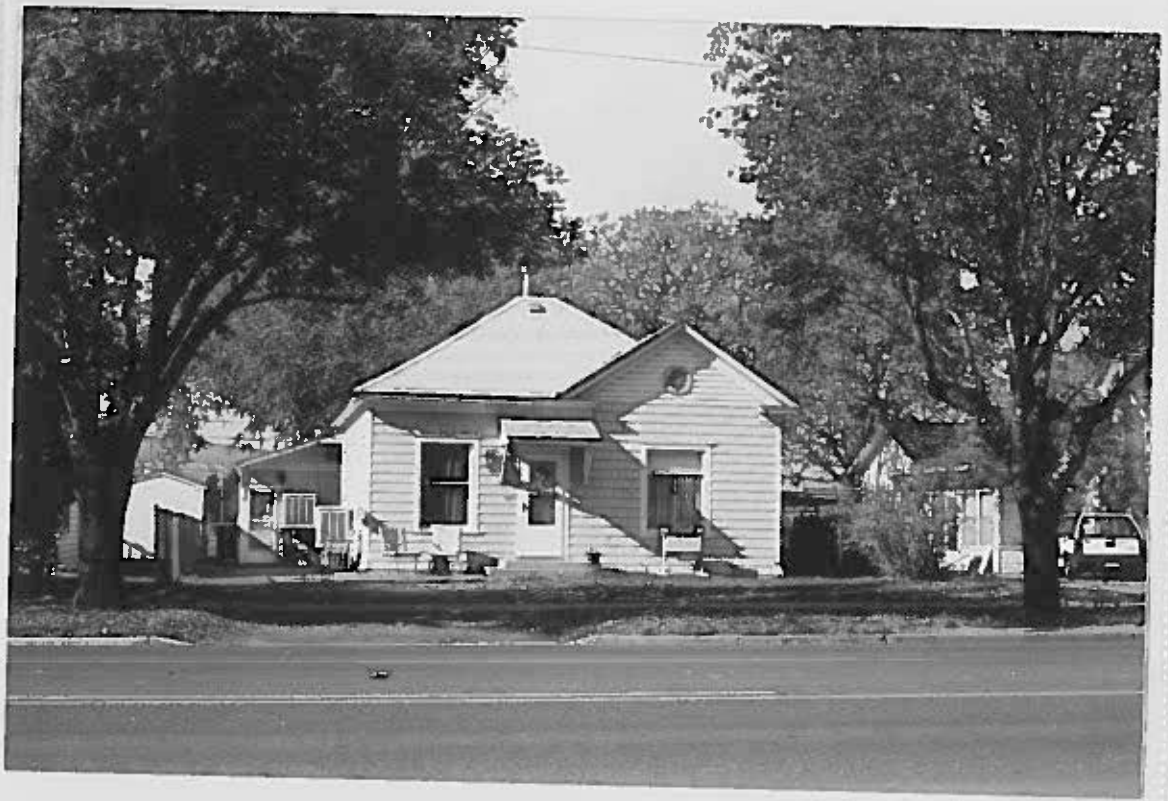
Roll # 9 Frame # 30

21. General architectural description: This is a simple wood frame house with a steeply pitched hipped roof. A very short ridge runs north/south and the principal façade faces east. A front gable roof is applied to the main roof plane on the north side of the façade; it shares the north roof plane with the main hipped roof but does not project beyond the main building face. A large double hung, with a small upper sash and a single vertical muntin in the lower sash, is centered on the front gable and a round vent is located near the peak. The main entry door sits just south of the front gable with a small shed roof over the door. The roof is supported by brackets. A double hung window is located on the remainder of the façade to the south. The house has wood shingle siding throughout with a field of clapboards in the gable end. The base of the wall has a short flare close to the ground. The gable end has small cornice returns along the eave line and an ogee detail at all the roof edges. The south side of the house has three double hung windows of varying sizes and a shed roof addition extends off the rear.

Looking west
