COLORADO CULTURAL RESOURCE SURVEY

# Architectural Inventory Form I of 4

ı.	lder	ntification		
	1.	Resource number:	5ME.8878	
	2.		1337.SEV	
	3.		Mesa	
	4.		Grand Junction	
	5.		n/a	
	6.	Current building name:	n/a	
	7.	Building address:	1337 N. 7th Street

City of Grand Junction • Phase Three Survey 2004

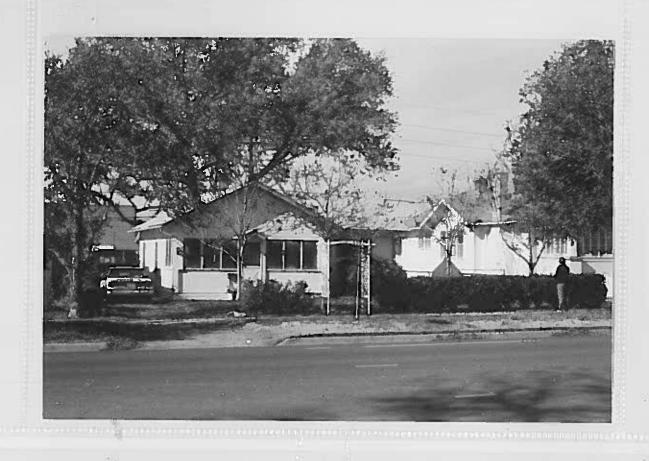
**Roll #9** Frame #33

21.	. General architectural descr	ription: This is a simple wood frame house with a moderately		
		pitched gable roof. The house consists of a main front gable form, running east/west, with			
		a side gable wing projectin	g off the north wall. The principal façade faces east and is		
		symmetrical over the gable	end. The entry door is centered on the peak, three casement		
		windows fill the width of the	e wall to either side of the door. Similar windows wrap the		
	corners on the north and south sides. A low wall runs under all the windows with vert				
		siding. A small gable sits above the door at the entry. Two vertically proportioned			
		double hung windows sit on the south wall. The side gable has a pair of double hungs o			
		the east wall. The roof has a moderate overhang and the rafters are exposed behind a			
		continuous fascia board. A brick chimney sits on the ridge about halfway back.

Looking west
