COLORADO CULTURAL RESOURCE SURVEY

Architectural Inventory Form

1 of 4	Noncontributing to eligible NR District
1. (den	tification	
	1.	Resource number:	5ME.14912
	2.	Temporary resource number:_	141.TEX
	3.	County:	Mesa

48. Report title: Grand Junction Phase 3 Survey 49. Date(s): M	larch_2005	
50. Recorder(s): Suzannah Reid, Patrick Duffield and Lydia Herron		
51. Organization: Reid Architects, Inc.	***************************************

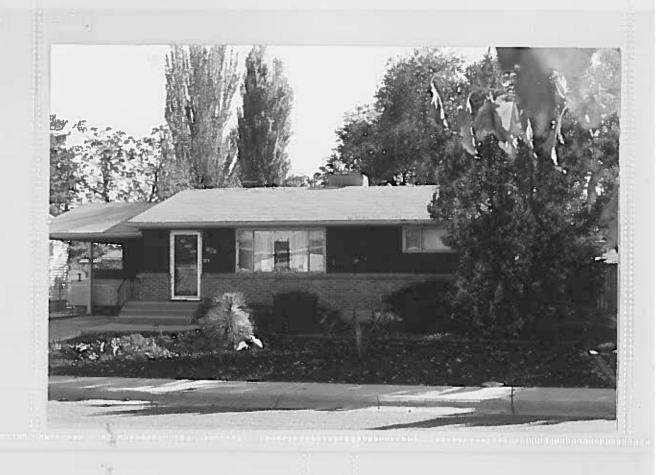
Roll #12 Frame #15

21.	. General architectural desc	ription: This is a simple wood frame house with a low pitched
		side gable roof. The ridge	runs east/west and the principal façade faces north. The main
		entry is located on the far	eft side of the façade with a picture window, flanked by
		casements, on the wall to t	he right. A horizontally proportioned window with two vertical
		muntins sits on the far righ	t end. A brick wainscoting runs across the façade at the line of
		the picture window sill. Th	e wall above the brick is vertical siding. A concrete landing
		runs from the right of the d	oor to the left edge of the house and three steps run forward to
		the ground. A side gabled	carport is applied to the east side. The ridge sits below the
		main ridge and the eave li	ne is set slightly back form the main eave. The roof is
		supported by three wood p	osts on the east end and closed at the rear. The side walls

have horizontal siding thro	ughout.
	22.	. Architectural style/building	type: Ranch Type
	23.	Landscaping or special set	ting features: A couple of trees are located at the corner of the
		house and several planting	beds are arranged in the yard. The driveway runs up to the
		carport on the east and the	yard is predominantly small rocks and mulch.

Looking south
