COLORADO CULTURAL RESOURCE SURVEY

**Architectural Inventory
Form**

1. Resource number: 5ME.14908
2. Temporary resource number: 1639.WSER
3. County: Mesa
4. City: Grand Junction
5. Historic building name: n/a
6. Current building name: n/a
7. Building address: 1639 W. Sherwood Ave.
8. Owner name and address: Merrill Kennedy
Po Box 977 Silverthorne, CO 80498-0977

47. Photograph numbers: Roll # 14 Frame # 21
Negatives filed at: City of Grand Junction Planning Dept.
48. Report title: Grand Junction Phase 3 Survey 49. Date(s): March 2005
50. Recorder(s): Suzannah Reid, Patrick Duffield and Lydia Herron
51. Organization: Reid Architects, Inc.
52. Address: PO Box 1303 Aspen, Colorado 81612
53. Phone number(s): 970 920 9225

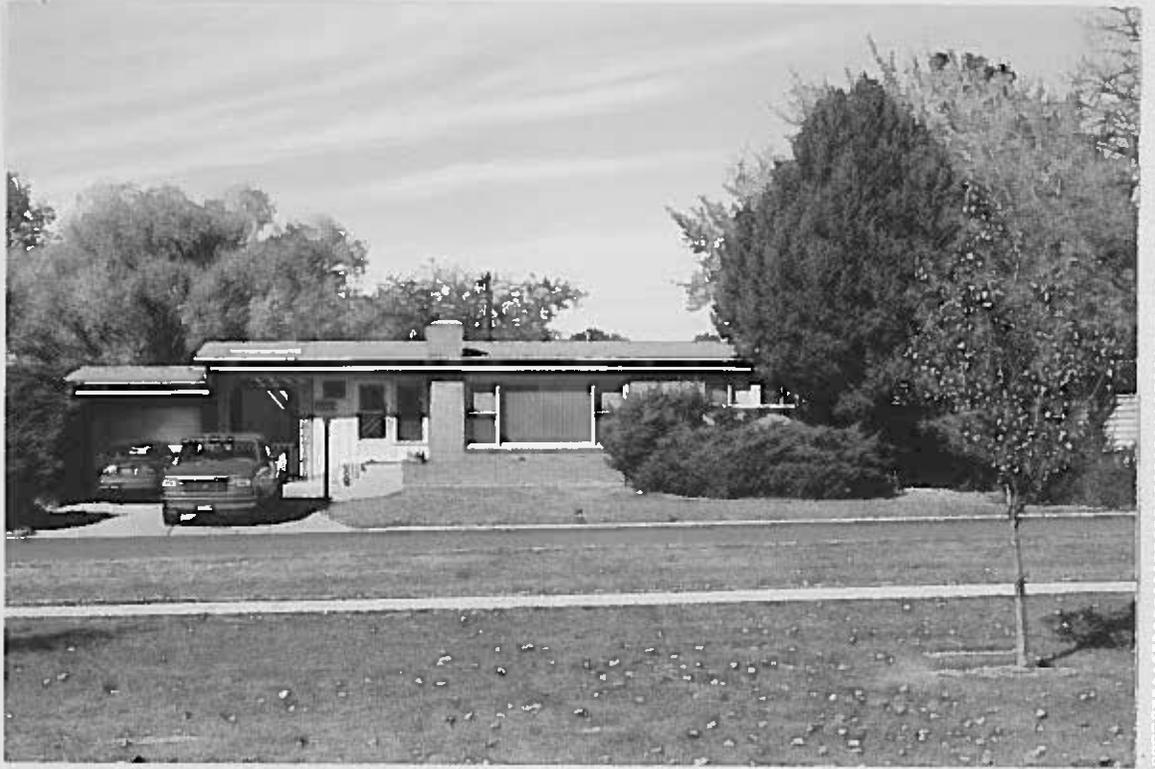
Roll # 14 Frame # 21

21. General architectural description: This is a long wood frame house with a low pitched gable roof. The main ridge runs northeast/southwest and the principal façade faces southeast. A large picture window, flanked by double hungs, is generally centered on the main wall. A rectangular roman brick chimney sits along the left jamb and the brick continues under the window sill and on the wall plane beyond. A horizontal strip of windows runs across the top of the wall to the right end of the wall. A similar pattern of windows run at the eave line on the northwest façade. To the left of the chimney on the principal façade is a full height fixed window; the door is directly adjacent to the left side of the window. A small square window is located at the top of the wall left of the door. These three elements sit in a field of board and batten siding, which is set in from the face of the adjacent brick. A concrete landing infills the area in front of the door; steps run to the grade on the front and side of the landing. An additional recessed section of brick wall completes the length of the main side gable form. A large picture window is located on this face and the recess is framed by decorative metal work. The roof in this section is cut away, with a trellis inset over the exterior area. The recessed brick wall plane continues to the southeast and has a single car garage door in the face of the remaining wall. The garage has a lower side gable roof, which mimics the main roof form and profile. A low stack bond brick planter wall begins at the entry steps and runs in front of the large picture window toward the northern end of the house.

5ME.14908

1639 W. Sherwood

Looking northwest
