COLORADO CULTURAL RESOURCE SURVEY

Architectural Inventory Form

1. Resource number: 5ME.2792
2. Temporary resource number: 3117.DHR
3. County: Mesa
4. City: Grand Junction
5. Historic building name: n/a
6. Current building name: n/a
7. Building address: 3117 D.5 Road
8. Owner name and address: Richard S Dunn
3115 D 1/2 Rd Grand Junction, CO 81504-6128

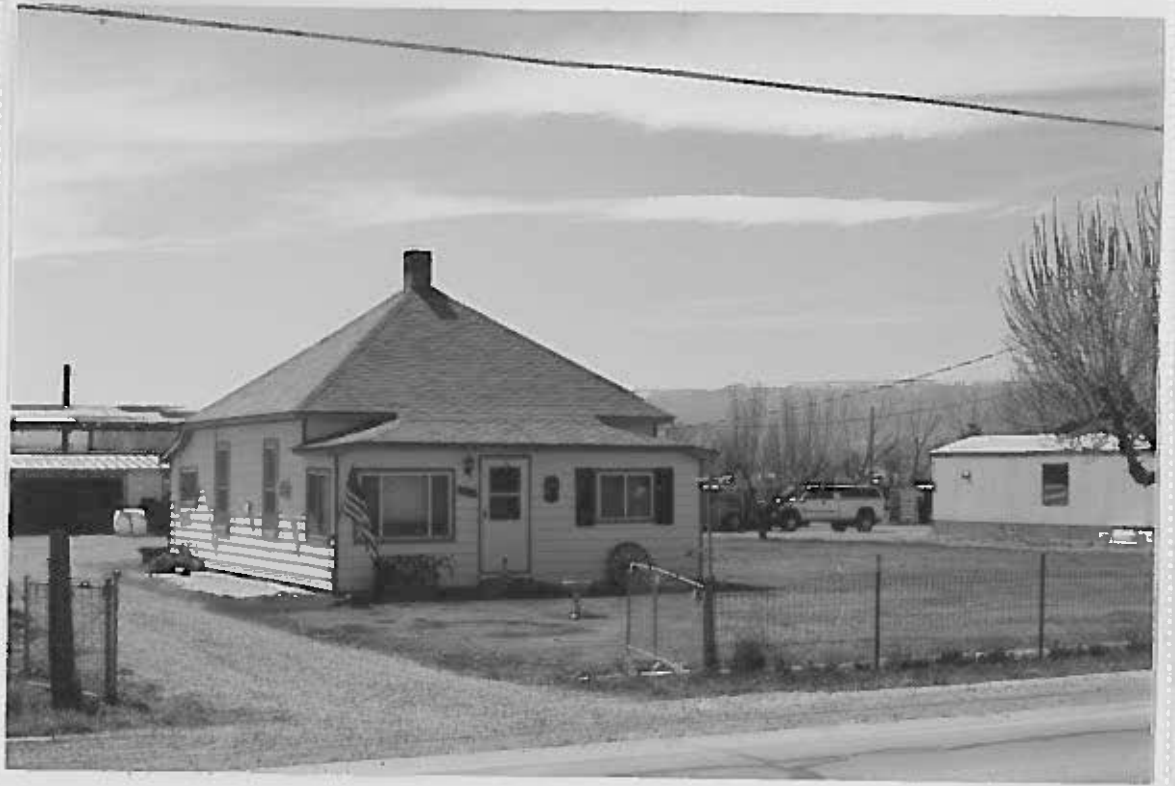
Roll # 15 Frame # 8

21. General architectural description: This is a modest one story wood frame house with a rectangular plan; the principal façade faces north. The main part of the house has a pyramidal roof that ends in a central brick chimney. A low hipped roof form is applied to the front of the house; the central part of the roof is continuous with the main roof plane. The hipped roof section has a single entry door off center to the left. A large picture window flanked by double hungs sits on the wall to the left of the door and a pair of casement style windows sit on the wall to the right. The east side of the house has another pair of casements close to the front corner. Two vertically proportioned double hung windows are located on the side walls of the pyramidal roof form. A shed roofed addition extends off the rear of the building with a single horizontally proportioned window opening.

Looking south
