# Architectural Inventory Form

<b>I.</b>	lden	tification				
	1.	Resource number:	5ME.2838			
	2.	Temporary resource number:	3095.DHR			
	3.	County:	Mesa			
	4.	City:	Grand Junction			
	5.	Historic building name:	n/a

6.	Current building name:	n/a			
	7.	Building address:	3095 D.5 Road			
	8.	Owner name and address:	Steven W Miller			
	-		3095 D 1/2 Rd Grand Junction, CO 81504-2590			
II.		ographic Information

48. Report title: Grand Junction Phase 3 Survey 49. Date(s):	October 2005		
50. Recorder(s): Suzannah Reid, Patrick Duffield and Lydia F	lerron		
51. Organization: Reid Architects, Inc.

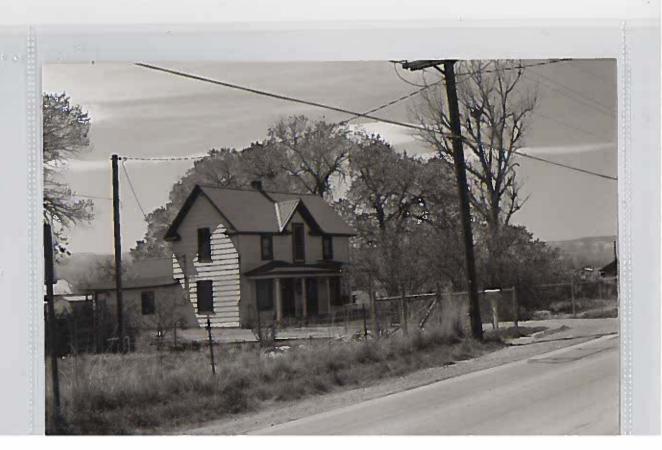
SME.2838
Roll # 15 Frame # 9
Looking southwest
Grand Junction, Mesa County, CO

21.	General architectural description: This is a narrow one and one half story wood frame
		side gable house. The main ridge runs east/west and the principal façade faces north. A
		small gable dormer sits in the center of the principal façade on the main roof. The main
		wall continues into the dormer and a single vertically proportioned door is centered on
		the dormer gable on the upper level. A smaller vertically proportioned double hung
		window is located on either side of the dormer and equally spaced along the wall. A
		hipped roof porch is applied to the main wall on the lower level. The porch roof stops
		short of the corners of the building and is depressed under the dormer door. The porch
		roof is supported by four equally spaced Tuscan columns. The columns have simple
		bases and capitals which support a shallow entablature. There are four equally spaced
		openings along the length of the wall under the porch roof. The center left opening is the

entry door, which is balanced on the right by a single similarly sized double hung window
		on the right. A single wider double hung window sits on the wall to the right and left of
		these openings. The double hung windows all have unequal sashes with a narrow panel
		on the top. Each side of the main form has two vertically proportioned double hung
		windows, one on each level, centered on the gable end. The main roof has a moderate
		overhand with small eave returns on the gable ends. A brick chimney sits just off the
		main ridge on the south side of the roof. A one story, lower pitched gable form is
		attached to the rear of the house. The east side has an additional shed roof addition
		which extends beyond the east wall of the house. The addition has fixed glass windows
		on the southeast corner.

29. Construction history (include	de description	and dates of major additions, alterations, or
	demolitions):	Siding repla	acement, addition at rear; dates unknown

43. Assessment of historic physical integrity related to significance	e: Alterations have had a		
moderate impact on the integrity of the house.			
VII. National Register Eligibility Assessment
