COLORADO CULTURAL RESOURCE SURVEY

Architectural Inventory Form 1 of 4

1014		Noncontributing to eligible NR District
1. 1	den	tification		
	1.	Resource number:	5ME.14677	- 333
	2.	Temporary resource number:_	1502.ORC	AAATT NOT TO THE

3.	County:	Mesa	
	4.	City:	Grand Junct	ion
	5.	Historic building name:	n/a	
	6.	Current building name:	n/a	
	7.	Building address:	1502 Orchar	d Ave.
	8.	Owner name and address:	Sean P Dola	n
			893 S Coron	ado Dr Sedalia, CO 80135-8304
II.		ographic Information

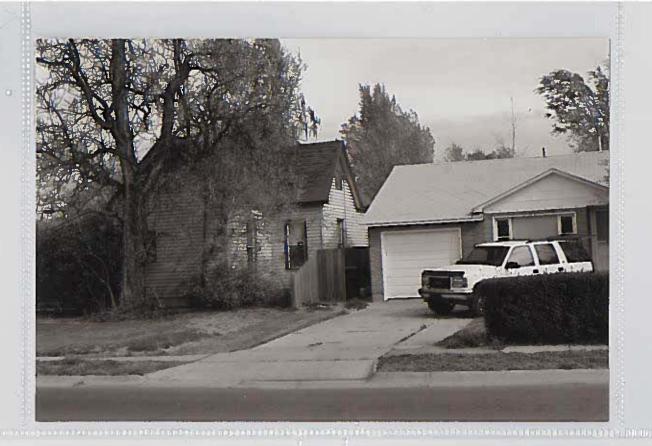
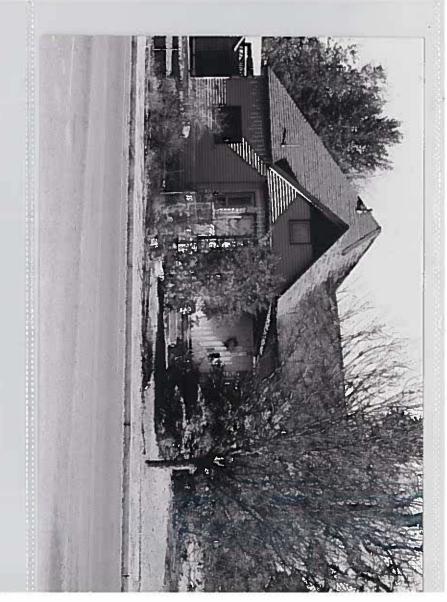
5ME.14677 1502 Orchard Ave. Roll # 16 Frame # 18 Z Looking north Grand Junction, Mesa County, CO 8ANX8N8 NNN+ 1 2218 862998 Ø 5651 ØØ2914 WHF BAG18A1XBN NNN 1502 Orchard Ave. Grand Junction, Mesa County, CO Roll #6 Frame #22 **8**23 Looking east 5ME.14678

2	1. General architectural desc	ription: This is a large wood frame house with a series of
	additive volumes. The ma	ain section is a steeply pitched pyramidal roof. A lower cross
	gable extends to the west	and meets the main volume wall plane. The gable shares the
	same south roof plane as t	the pyramid section. Another gable extends off the south roof
	plane, creating a long fron	t gable, facing the main street. The long front gable faces
	south and the entry is in th	ne ell created by the two gables. A shed roof extends to the
	south over the entry door.	The roof is supported by a group of thin metal supports and
	several concrete steps run	off the west side to the entry walk. The west facing gable has
	a bay in the center with ve	ertically proportioned double hung windows on each face. A
	single square window sits	in the upper level near the peak. A horizontally proportioned
	window sits to the north of	the west gable on the main volume wall. A pair of window

units sit on the west side o	f the south front gable at the corner and are mirrored on the
	south wall corner. A single	e double hung sits in the peak of the south gable. The house is
	predominantly horizontal v	wood siding with corner boards a band of contrasting material
	infills the gable ends above	e the window heads. Vertical board and batten siding fills the
	inside corner of the entry a	area
2	Architectural style/building	type:type:
2	Landscaping or special set	tting features: Dense vegetation surrounds the house and a
	patch of lawn sits between	the bushes and the sidewalk.
2	4. Associated buildings, featu	res, or objects: A gable garage sits at the rear, connected to
	the house by a trellis, with	a carport on the side.
	Architectural History	
2		nate: 1898 Actual:
		Mesa County Assessors Office
20	6. Architect:	
		Transport Western
27	7. Builder/Contractor:
