Historic Building Inventory Record

Architectural Inventory Form

1. Resource number: 5ME.11702
2. Temporary resource number: 1218.FIFT
3. County: Mesa
4. City: Grand Junction
5. Historic building name: n/a
6. Current building name: n/a
7. Building address: 1218 N. 15th Street
8. Owner name and address: Genard G Martinez
1218 N 15th St Grand Junction, CO 81501-4302

48. Report title: Grand Junction Phase 3 Survey 49. Date(s): March 2005

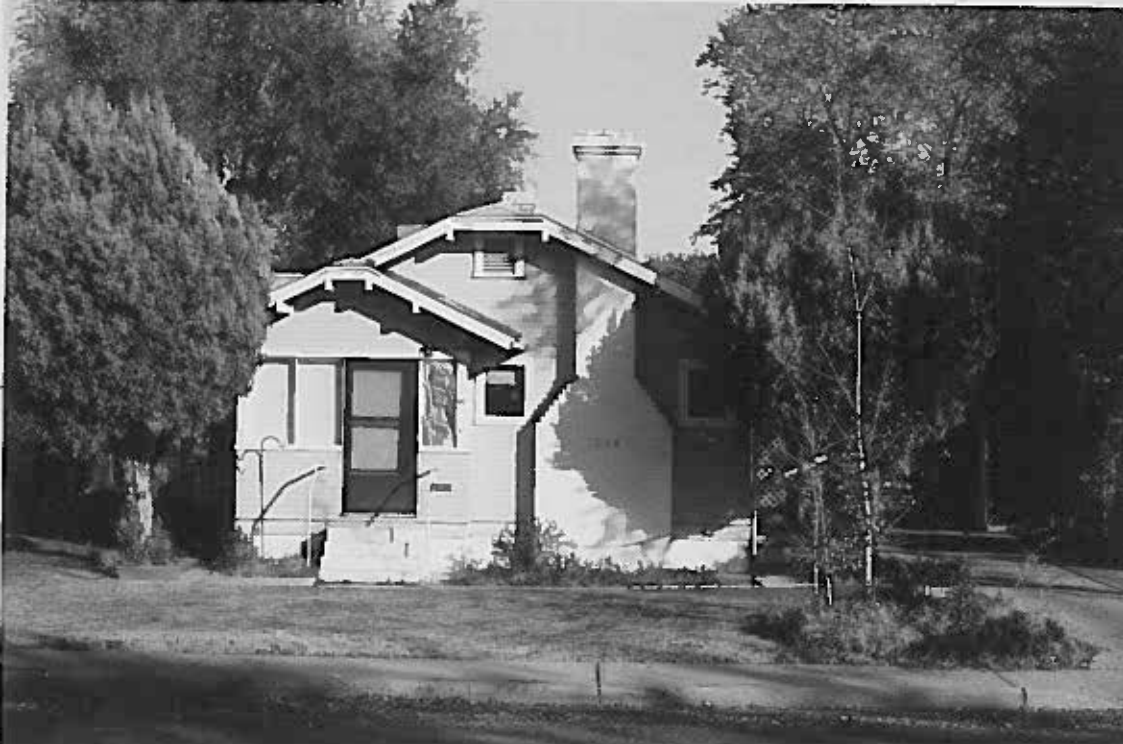
Roll # 4 Frame # 17

21. General architectural description: This is a wood frame building with a series of rectangular volumes. The main central volume has a clipped gable roof with the ridge running east/west, and the principal façade facing west. A smaller volume is added to the front and shares the same roof form and the north roof plane. A third volume is a bay on the north side and the last volume is added to the south side at the rear of the building and has a low pitched roof. The main entry door is located off center of the small front volume and has a series of vertically proportioned window openings wrapping on the three sides, with a low wall below. A set of four concrete steps access the door. The main volume has a large brick chimney applied to the outside which runs up through the roof plane, leaving the bargeboard intact. A small square window is centered on the main wall between the chimney and the enclosed porch; a similar window is located to the other side of the chimney. A rectangular vent is located in the peak. The roof has a generous overhang which is supported by projecting purlins. Another brick chimney is located along the ridge toward the rear. The bay on the north side is approximately the same size as the front porch volume and has the same roof form. A pair of vertically proportioned windows sit off center to the east. The remainder of the north side has a couple of windows of varying sizes. The carport is on the south side and is a flat roofed structure with a series of wood columns supporting the roof.

Looking east
