COLORADO CULTURAL RESOURCE SURVEY

Architectural Inventory Form

1. Resource number: 5ME.11701
2. Temporary resource number: 1212.FIFT
3. County: Mesa
4. City: Grand Junction
5. Historic building name: n/a
6. Current building name: n/a
7. Building address: 1212 N. 15th Street
8. Owner name and address: Marlene Hardesty
1212 N 15th St Grand Junction, CO 81501-4302

GRAND JUNCTION, COLORADO

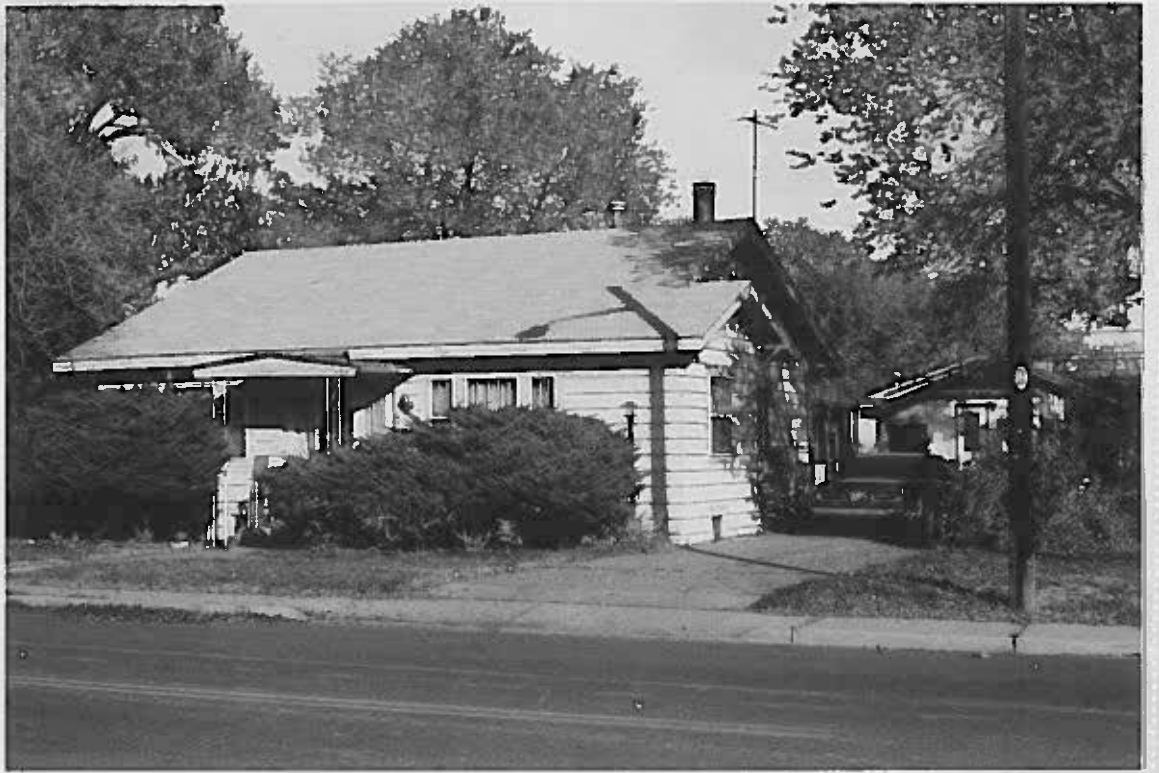
Roll # 4 Frame # 18

21. General architectural description: This is a wood frame rectangular plan building with a couple of additive forms. The ridge of the side gable roof runs north/south and has a moderate pitch with a large overhang on the eave ends. The overhang is supported by triangular brackets. The principal façade faces west and has a very low pitched gable roof over the entry door. This roof is supported by pairs of thin metal supports, one pair on each corner. The entry door is generally centered on the main façade and has window groupings to either side. The window groups are identical and consist of a group of three vertically proportioned double hung windows, the center of which is wider than the flanking ones. The windows have vertical muntins in the upper sash. The south side of the main volume has a small projecting volume that shares the front roof plane but has a lower ridgeline. This projection has a single vertically proportioned double hung window on the south side. A shed addition extends off the rear of the house for almost the full width. A metal slue is located just off the ridge on the south and another one is off the rear area of the main volume. The main wall of the building flares out at the base.

Looking northeast

43. Assessment of historic physical integrity related to significance: The integrity has been somewhat compromised by material alterations and the new entry porch roof.
