COLORADO CULTURAL RESOURCE SURVEY

Architectural Inventory Form

1. 1	den	tification	
	1.	Resource number:	5ME.14681
	2.	Temporary resource number:_	1745.ORC
	3.	County:	Mesa
	4.	City:	Grand Junction
	5.	Historic building name:	n/a

6.	Current building name:	n/a
	7.	Building address:	1745 Orchard Ave.
	8.	Owner name and address:	Virginia G Blount
			4620 Careyback Ave Elk Grove, CA 95758-5107
II.	Ged	ographic Information

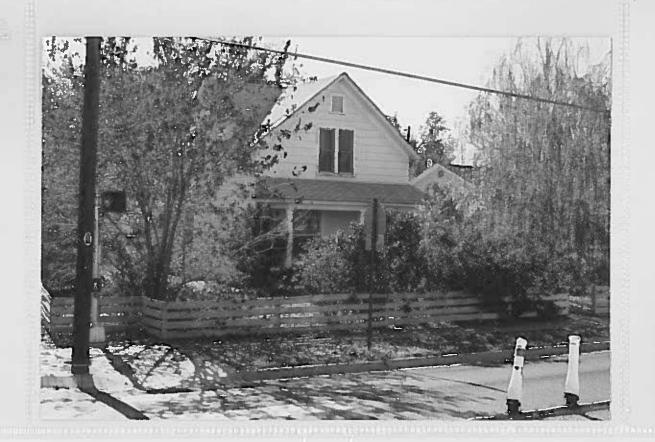
5ME.14681 1745 Orchard Ave. Roll #6 Frame #17 Looking south Grand Junction, Mesa County, CO WHF BA010A1X0N NNN+ 1 5651 002914 018 54694 WHF BAB18A1X8N NNN+ 1 5651 882914 Grand Junction, Mesa County, CO

21.	. General architectural desc	ription: This is a relatively large, generally rectangular, wood
		frame front gable house.	The ridge runs north/south and the principal façade faces north.
		A shed roof porch is applied	ed to the front façade; the porch roof is supported by three
		equally spaced square wo	od posts. The entry door sits off center to the west and a large
		double hung sits off center	to the east. A pair of vertically proportioned double hung
		windows sits in the upper l	evel on the gable end. The east side has a large gable dorme
		in the center of the roof pla	ane, with two vertically proportioned double hungs. Two
		double hungs are located	on the rear of the main form. At the rear, the wall and eave
		line step back and the mai	n roof ends in a hipped form. This step occurs on both sides. A
		single story shed roof addi	tion sits on the west side in the space created by the main

building stepping in. Anot	her small shed is added to the main wall on the west. A few
		windows are located on th	e west side of the main volume. Several windows with
		aluminum awnings are loc	ated on the west side of the addition.
