COLORADO CULTURAL RESOURCE SURVEY

**Architectural Inventory
Form**

1. Resource number: 5ME.14697
2. Temporary resource number: 1317.TEX
3. County: Mesa
4. City: Grand Junction
5. Historic building name: n/a
6. Current building name: n/a
7. Building address: 1317 Texas Ave.
8. Owner name and address: Merredith H Vonburg
1317 Texas Ave Grand Junction, CO 81501-7639

48. Report title: Grand Junction Phase 3 Survey 49. Date(s): March 2005

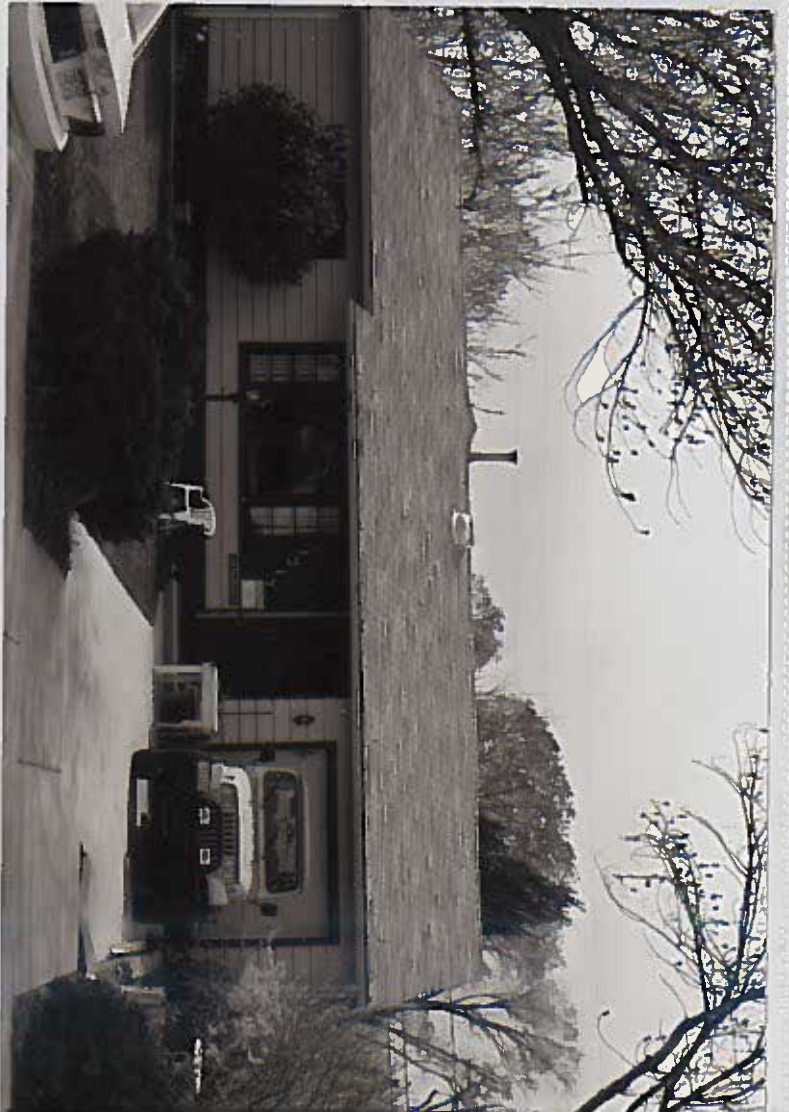
Roll # 16 Frame # 17

Looking south
