COLORADO CULTURAL RESOURCE SURVEY

Architectural Inventory Form

1. Resource number: 5ME.14698
2. Temporary resource number: 1330.TEX
3. County: Mesa
4. City: Grand Junction
5. Historic building name: n/a
6. Current building name: n/a
7. Building address: 1330 Texas Ave.
8. Owner name and address: Daniel D Tucker
1330 Texas Ave Grand Junction, CO 81501-7640

48. Report title: Grand Junction Phase 3 Survey 49. Date(s): March 2005

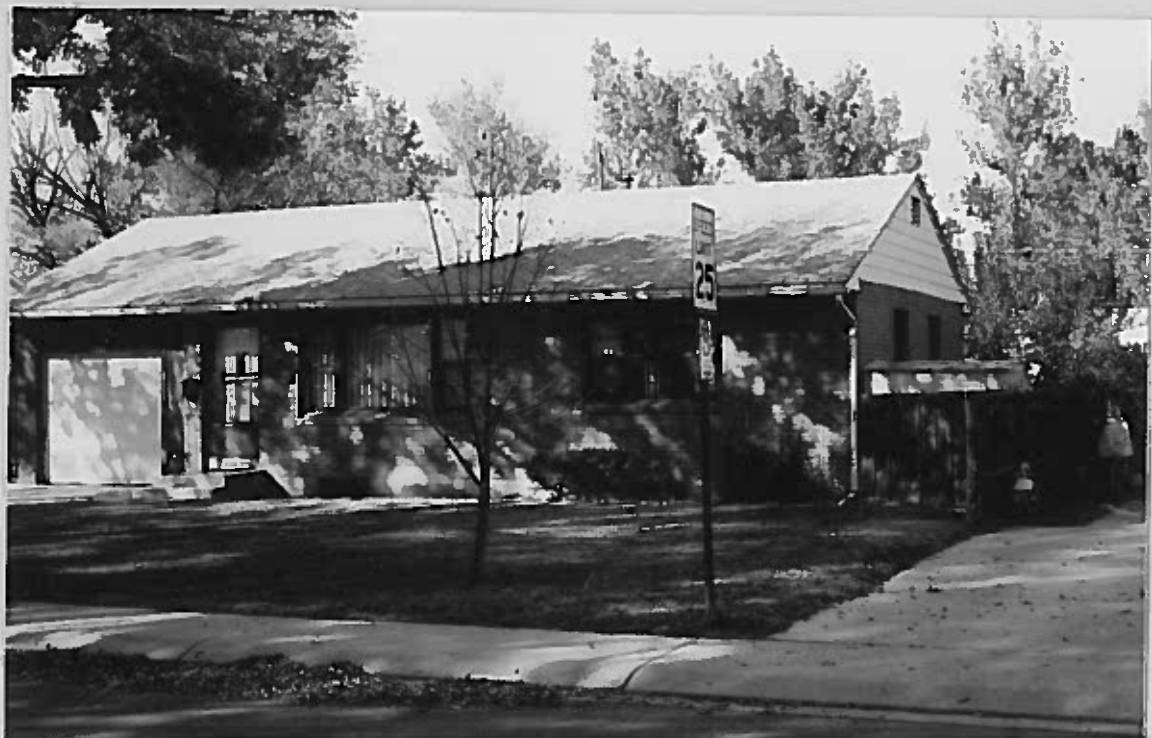
Roll #3 Frame #24

21. General architectural description: This is a rectangular masonry house with a side gable roof. The main ridge runs east/west and the principal façade faces south. The roof has minimal overhangs on the eave ends and a deeper overhang on the principal façade. At the west side a single car garage door is centered on an area of wood siding. The main entry door is located adjacent to the garage door and has a large picture window to the right. The picture window has a narrow double hung to each side and a pair of double hungs are centered on the remainder of the wall. The double hung windows have a single horizontal muntin in each sash. Two double hung windows are located on the east side, and the gable ends are infilled with horizontal siding.

43. Assessment of historic physical integrity related to significance: Infill at original carport alters the original character and scale. Integrity is seriously compromised.

Looking northwest
