COLORADO CULTURAL RESOURCE SURVEY

**Architectural Inventory  
Form**

1. Resource number: 5ME.14631
2. Temporary resource number: 1313.BUN
3. County: Mesa
4. City: Grand Junction
5. Historic building name: n/a
6. Current building name: n/a
7. Building address: 1313 Bunting Ave.
8. Owner name and address: Maria A Serafino- Noble  
236 Gunnison Ave Unit A Grand Junction, CO 81501-2312

48. Report title: Grand Junction Phase 3 Survey 49. Date(s): March 2005

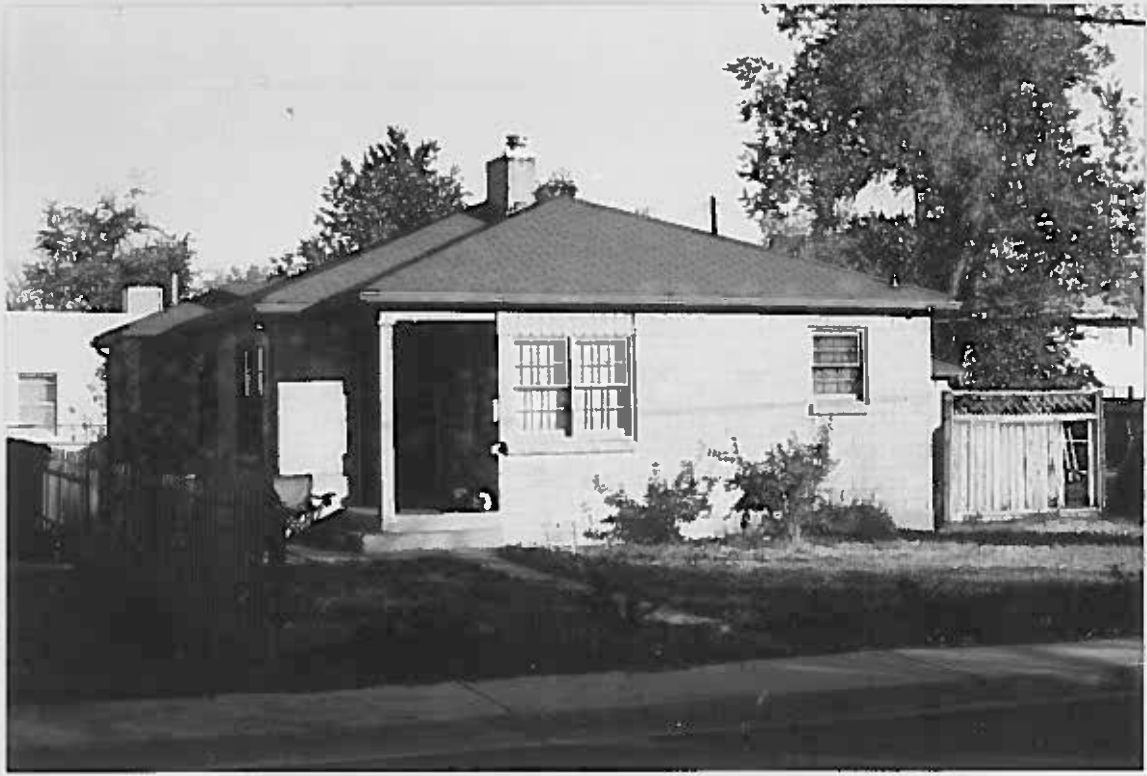
Roll # 4 Frame # 21

21. General architectural description: This is a one story terra cotta masonry structure comprised of a series of stepped volumes with low pitched hipped roofs. The main ridge runs east/west and the principal façade faces north. The entry is located on the north west corner of the house and the entry porch is cut out of the volume with a single square post with a simple capital supports the corner of the main roof. The east entry wall extends beyond the plane of the entry wall, creating the first step along the façade. The second step forward occurs near the east end and has a lower ridge. The recessed entry has a double hung window on the west side and the door sits in the corner to the left. A pair of double hungs with the same sill and head are located on the west side just around the corner. A band of decorative siding infills the area above the window heads to the underside of the eave. A smaller double hung is located near the south west corner of the building. All windows have three over two divided lights in both the upper and lower sash. On the north facing wall at the center of the façade elevation are two sets of vertically proportioned double hungs with the same muntin pattern. Off the far east side, a small gable addition extends further east and off the rear another hipped roof section extends to the south. The masonry has radiused units on the corners and into the window openings. The brick chimney sits on the valley of the first step adjacent to the entry opening. The overhang is small and an ogee trim runs around the perimeter of the building.

Looking south

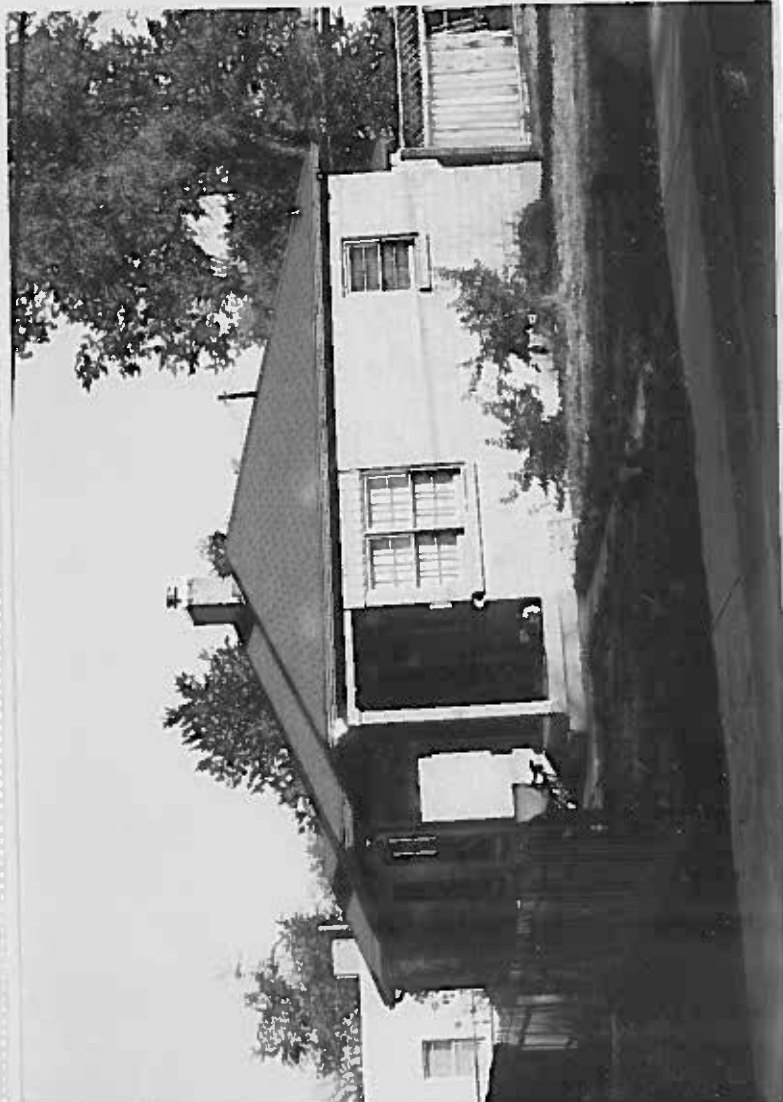
Roll # 4 Frame # 22

Looking south
