COLORADO CULTURAL RESOURCE SURVEY

**Architectural Inventory
Form**

1. Resource number: 5ME.14709
2. Temporary resource number: 1930.FOR
3. County: Mesa
4. City: Grand Junction
5. Historic building name: n/a
6. Current building name: n/a
7. Building address: 1930 N. 4th Street
8. Owner name and address: George R Cook
1930 N 4th St Grand Junction, CO 81501-7402

47. Photograph numbers: Roll # 6 Frame # 32
Negatives filed at: City of Grand Junction Planning Dept.
48. Report title: Grand Junction Phase 3 Survey 49. Date(s): March 2005

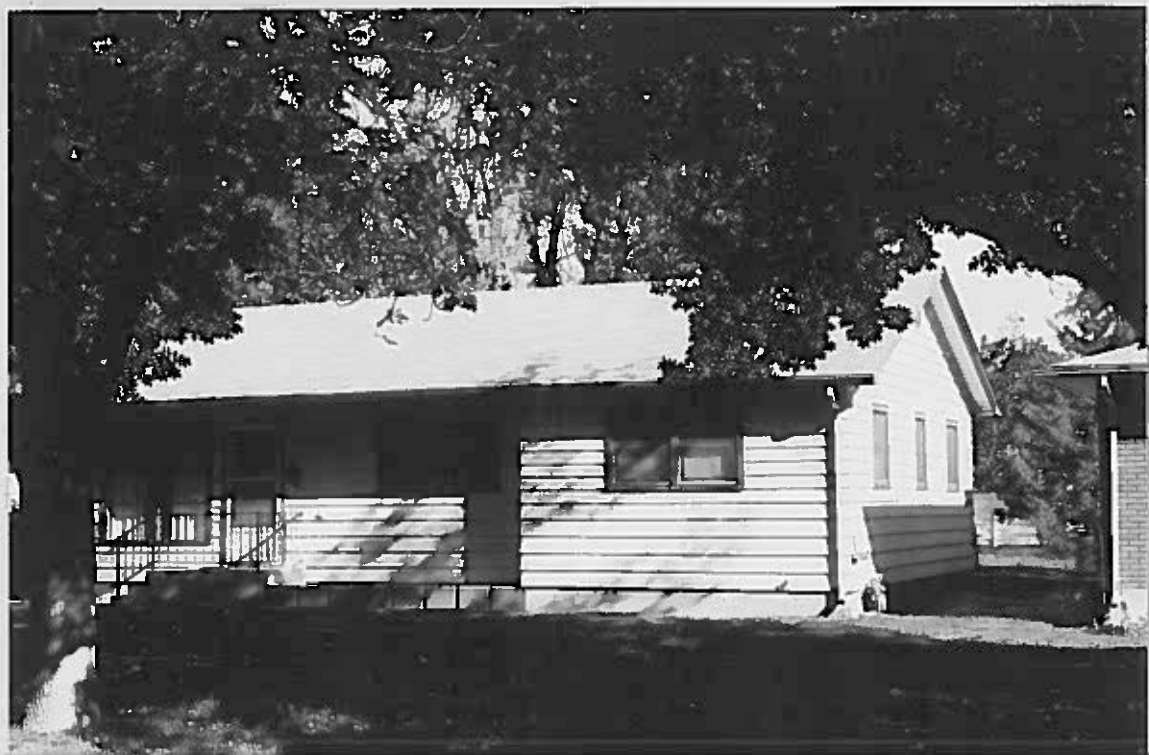
Roll # 6 Frame # 32

21. General architectural description: This is a simple wood frame house with a side gabled roof over the main volume. The ridge runs north/south and the principal façade faces west. The roof has a moderate overhang on the gable ends and a variable overhang on the principal façade. The principal façade can be divided into three sections of generally equal width. The first section on the north end has the main entry door to the right and a large multi-paned window to the left. A concrete landing sits in front of the door with several concrete steps to grade. The center section has a pair of double hung windows centered on the section. The third section projects out from the main façade, but remains under the large roof overhang. A pair of double hungs are located on the center of the wall plane. Three single vertical windows are evenly distributed along the south side. A flat roofed carport is located on the north side. Another shed roof extends off the rear.

Looking northeast
