Architectural Inventory Form

1. Resource number: 5ME.14710
2. Temporary resource number: 1940.FOR
3. County: Mesa
4. City: Grand Junction
5. Historic building name: n/a
6. Current building name: n/a
7. Building address: 1940 N. 4th Street
8. Owner name and address: Troy T Mitchell
1940 N 4th St Grand Junction, CO 81501-7402

48. Report title: Grand Junction Phase 3 Survey 49. Date(s): March 2005

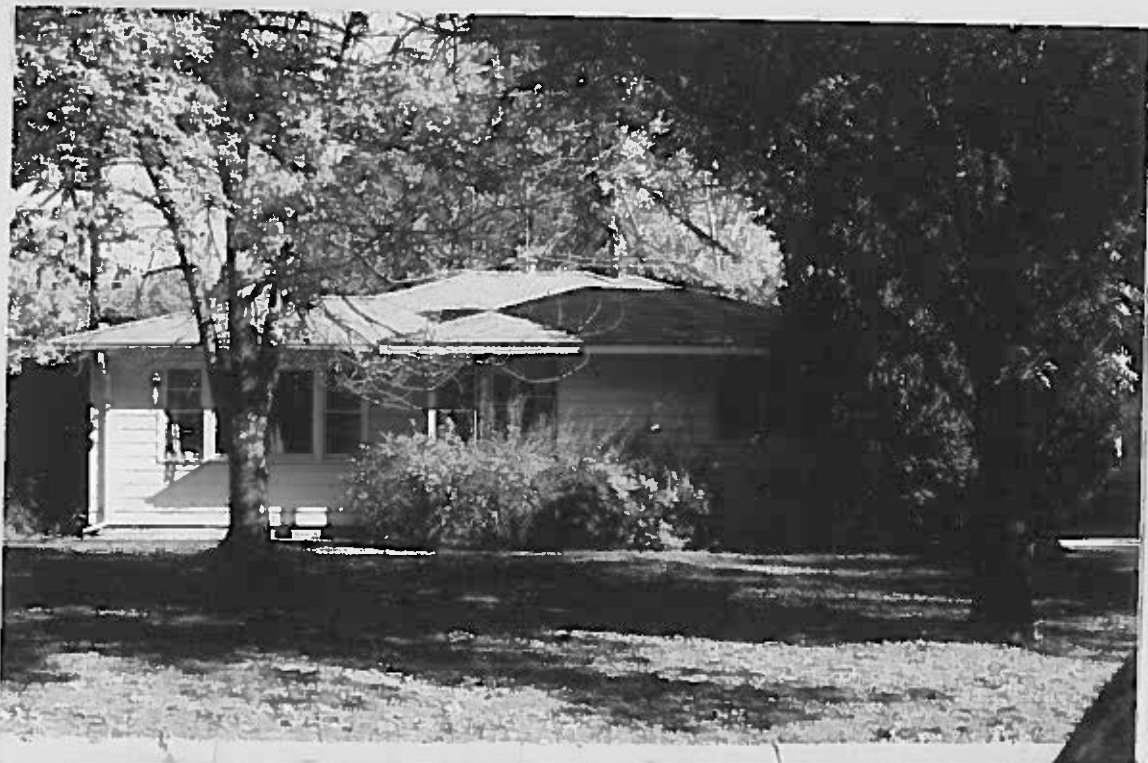
Roll # 6 Frame # 33

21. General architectural description: This is a generally rectangular wood frame house with a series of additive volumes. The main hipped roof ridge runs north/south and the principal façade faces west. Two lower hipped roofs sit in front of the main roof plane and a flat roof extends off the north side. The lower hipped roof sections align with the north and south sides, respectively. They overlap in the center with the right section sitting in front of the left. The main wall of the left section has a large picture window, flanked by double hungs in its center and this wall extends into a recess in the second section. The second hipped roof section has a void at the left corner, creating an entry area. The roof is supported by a decorative screen and a single post at the corner. The screen sits in the main wall plane. A horizontally proportioned window is located at the south end of the façade; the window is comprised of a fixed unit with a double hung on the left side. The same unit is mirrored on the south wall, just around the corner. The carport on the north is open at the rear and has a storage shed against the house.

Looking east
