COLORADO CULTURAL RESOURCE SURVEY

Architectural Inventory Form

1. Resource number: 5ME.14717
2. Temporary resource number: 1935.FIF
3. County: Mesa
4. City: Grand Junction
5. Historic building name: n/a
6. Current building name: n/a
7. Building address: 1935 N. 5th Street
8. Owner name and address: David P Bailey
1935 N 5th St Grand Junction, CO 81501-7405

48. Report title: Grand Junction Phase 3 Survey 49. Date(s): March 2005

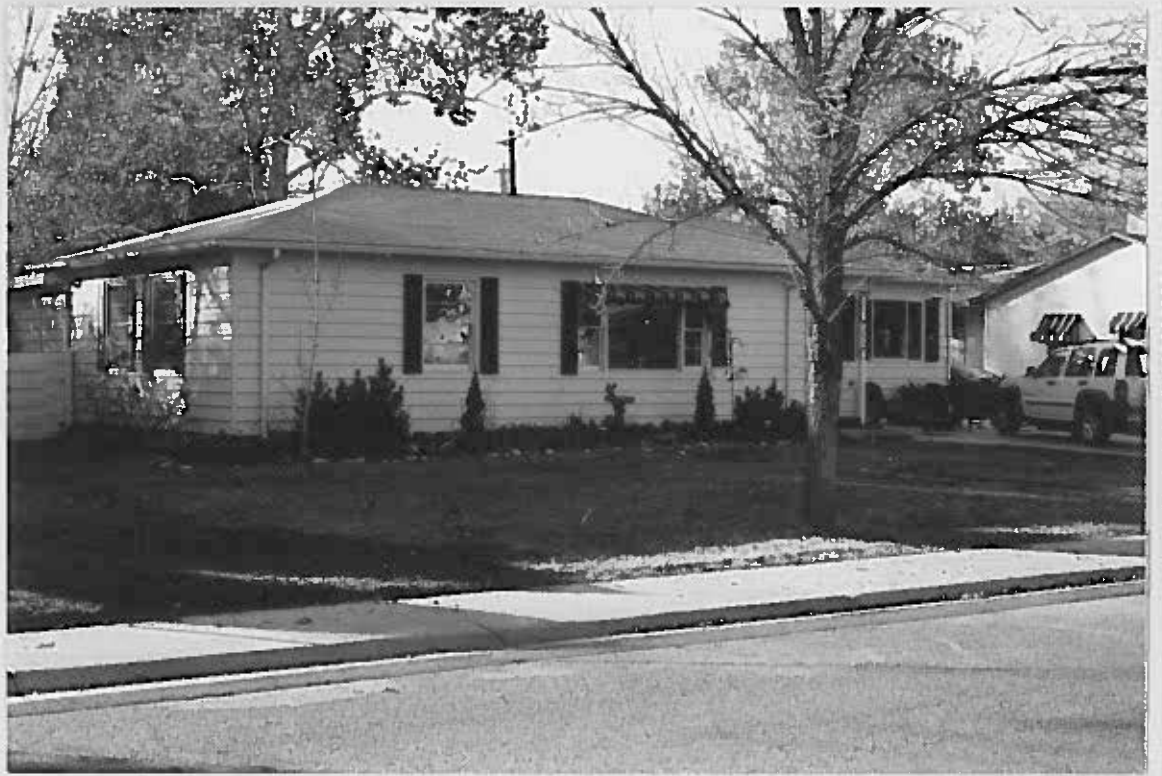
Roll # 8 Frame # 26

21. General architectural description: This is a simple wood frame house comprised of two volumes. The main ridge runs north/south and the principal façade faces east. The main section has a small recessed area at the northeast corner; the corner of the roof is supported by a single square wood post. The main entry door is located on the back of the recess. A large picture window, with double hungs to each side, is located on the main wall on the right and a single double hung sits on the left. The second volume extends off the north side of the house with a lower hipped roof. The east facing wall has another picture window with flanking casements. The double hungs have a single horizontal muntin in each sash. The eave line is continuous around the perimeter of the building. The south wall has a two double hungs near the center of the wall and a shed roof addition extends off the rear of the house.

Looking northeast

43. Assessment of historic physical integrity related to significance: The loss of the original carport element and the change in siding materials have seriously impacted the integrity. While the building retains its original scale to the street, the loss of the carport element eliminates an important original feature in the character of the neighborhood.
