COLORADO CULTURAL RESOURCE SURVEY

# Architectural Inventory Form

1. Resource number: 5ME.14721
2. Temporary resource number: 1940.SXT
3. County: Mesa
4. City: Grand Junction
5. Historic building name: n/a
6. Current building name: n/a
7. Building address: 1940 N. 6th Street
8. Owner name and address: Shirley E Arney  
1940 N 6th St Grand Junction, CO 81501-7410

48. Report title: Grand Junction Phase 3 Survey 49. Date(s): March 2005

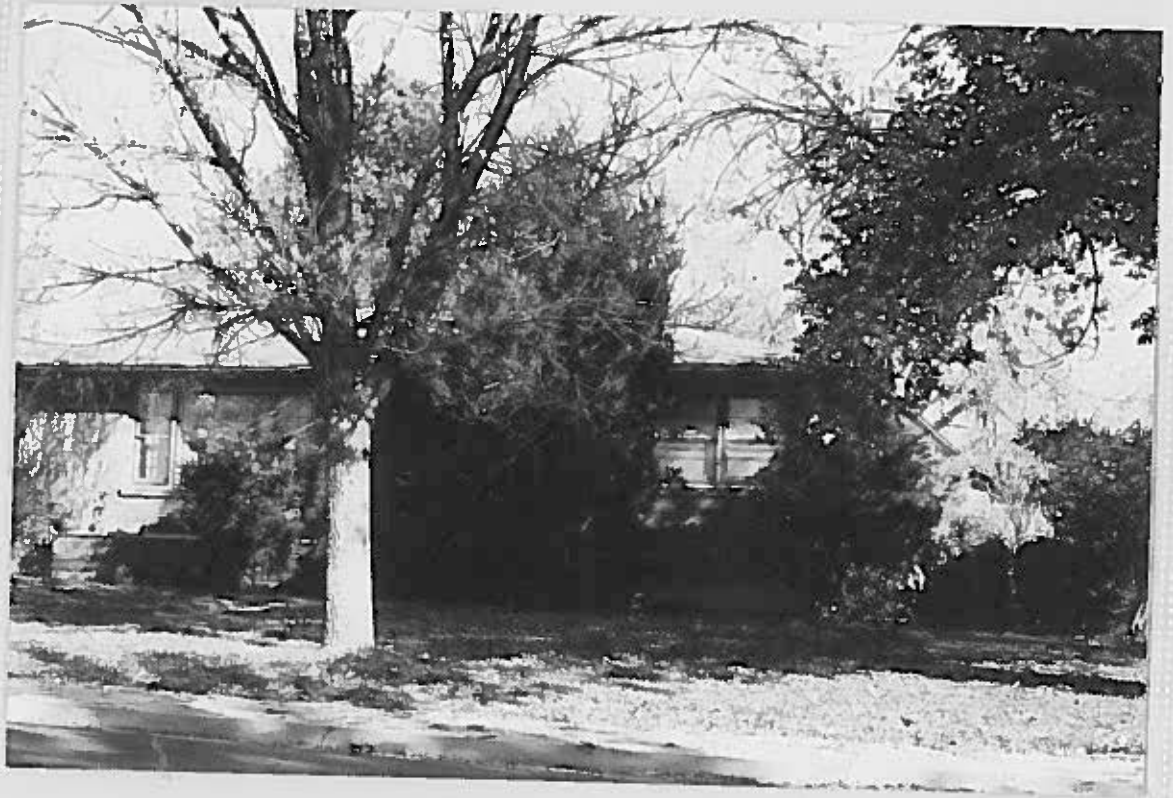
Roll # 7 Frame # 24

21. General architectural description: This is a simple masonry house with additions. The ridge of the hipped roof runs north/south and the principal façade faces west. The entry door is generally centered on the main wall and sits in a shallow recess. The roof overhang is supported by a sloping post, with a vertical pilaster, to the left of the door. Beyond that, a picture window, flanked by double hungs, sits off center toward the entry door. To the south a pair of double hungs sits on the corner. A single double hung is located around the corner on the south wall. A rectangular brick chimney is applied to the wall on the north side, as is a metal carport that extends off the wall to the north. The double hung windows have a single horizontal muntin in each sash. All the windows share the same sill height, and the heads run up to the soffit. The house sits on a concrete foundation and several concrete steps run up to the landing at the entry.

Looking east
