# Architectural Inventory Form

1. Resource number: 5ME.14731
2. Temporary resource number: 1901.SEV
3. County: Mesa
4. City: Grand Junction
5. Historic building name: n/a
6. Current building name: n/a
7. Building address: 1901 N. 7th Street
8. Owner name and address: Scott Field  
1901 N 7th St Grand Junction, CO 81501-7417

47. Photograph numbers: Roll # 10 Frame # 7  
Negatives filed at: City of Grand Junction Planning Dept.  
48. Report title: Grand Junction Phase 3 Survey 49. Date(s): March 2005  
50. Recorder(s): Suzannah Reid, Patrick Duffield and Lydia Herron  
51. Organization: Reid Architects, Inc.  
52. Address: PO Box 1303 Aspen, Colorado 81612  
53. Phone number(s): 970 920 9225

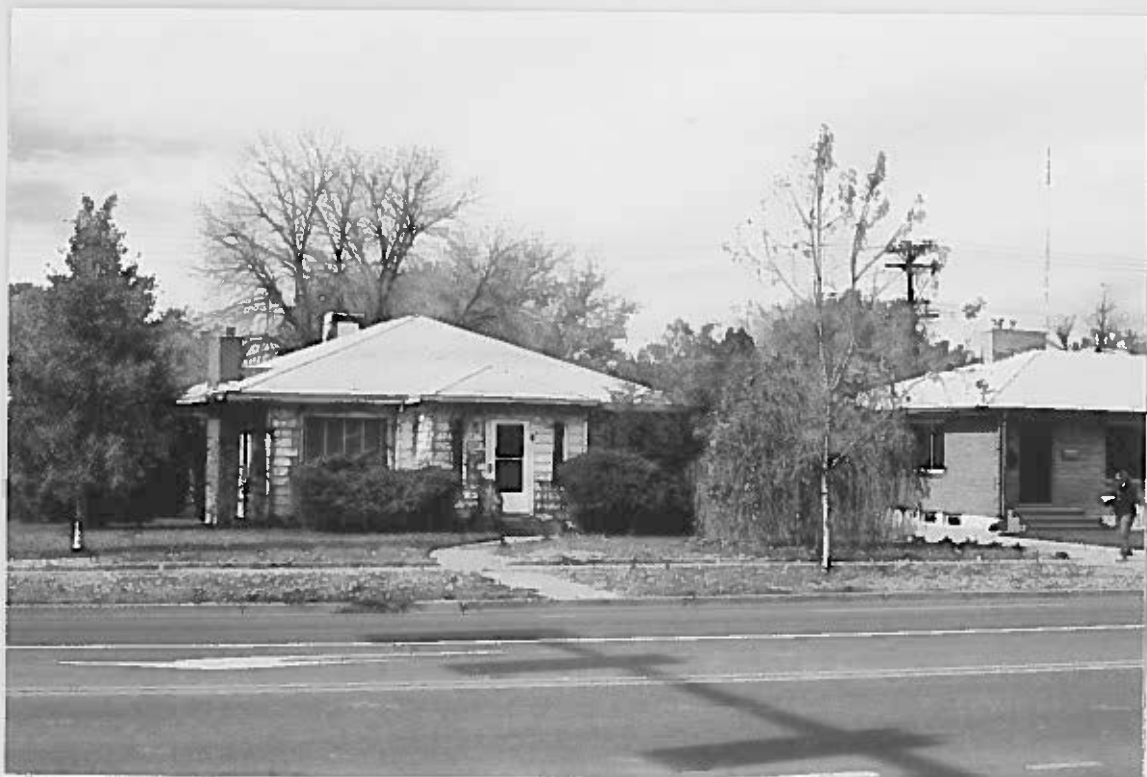
Roll # 10 Frame # 7

21. General architectural description: This is a small wood frame house with a moderately pitched hipped roof. The roof has a short ridge that runs east/west and the principal façade faces east. A hipped roof vestibule is centered on the principal wall with the main entry door in the center and narrow vertical strip windows centered on the remaining wall to either side. A large picture window sits on the main wall to the left of the vestibule and a pair of casements sit on the right. A picture window, with flanking double hungs, is located on the south wall adjacent to a rectangular brick chimney that is applied to the wall plane. At the rear of the house a hipped roof garage is attached to the southwest corner. The north wall has two pairs of double hung windows at each end and a single double hung in the center.

Looking west
