**Architectural Inventory
Form**
1 of 5

1. Resource number: 5ME.14791
2. Temporary resource number: 561.WAL
3. County: Mesa
4. City: Grand Junction
5. Historic building name: n/a
6. Current building name: n/a
7. Building address: 561 Walnut Ave.
8. Owner name and address: John Turner
561 Walnut Ave Grand Junction, CO 81501-7437

48. Report title: Grand Junction Phase 3 Survey 49. Date(s): March 2005

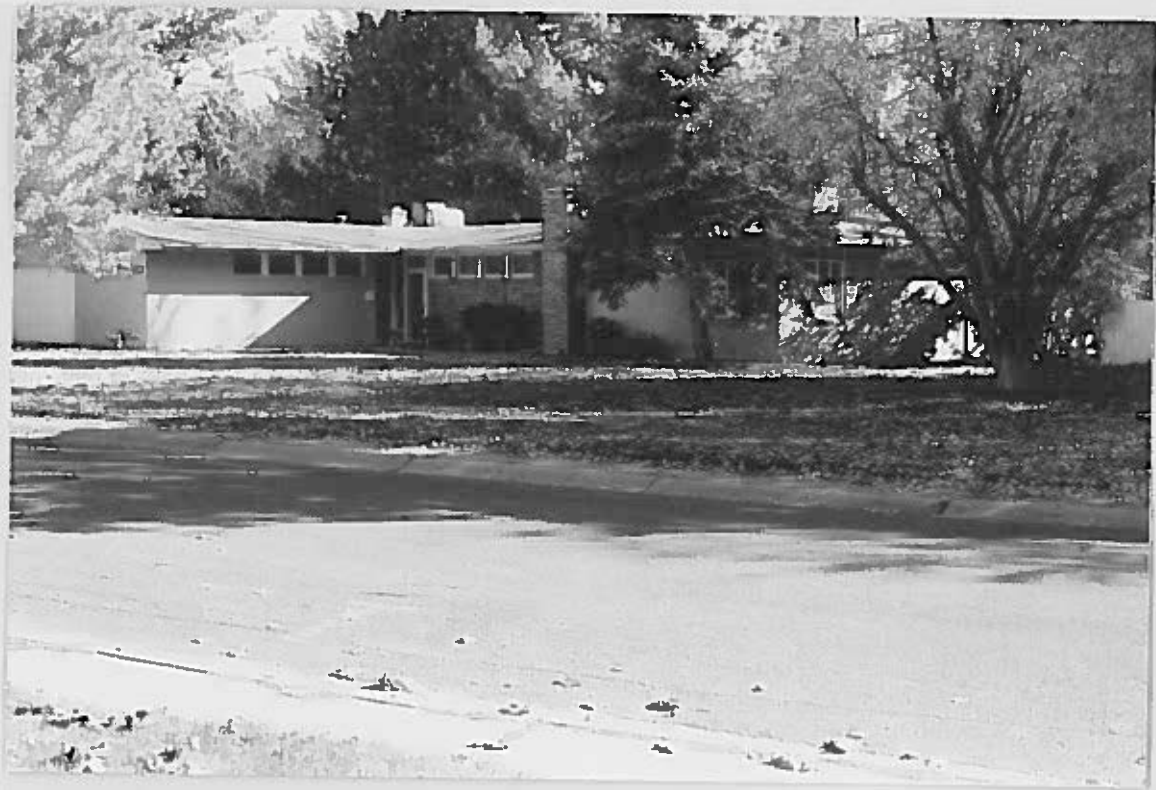
Roll #7 Frame #15

21. General architectural description: This is a large horizontally proportioned house with a series of large additive volumes. The principal façade faces north. The volume closest to the street has an asymmetrical low pitched front gable. The roof eaves are at the same height and the ridge is off set to the right. A single garage door is located on the longer side of the gable and a pair of horizontally proportioned windows with a high sill is located on the right. A long wall runs back to the second volume, which runs perpendicular to the first volume. A row of horizontally proportioned windows sits just under the eave on the west facing wall of the first volume. Two vertical windows run the full height on each side of the inside corner. The main entry door, with a transom, is just to the right of the vertical window on the north facing wall. A series of four horizontally proportioned windows runs across the top of the wall. A rectangular chimney engages the wall about halfway along the length, interrupting the eave line. The chimney and wall plane to the left are red slump brick. The remainder of the north wall is stucco with a row of horizontally proportioned windows along the top of the wall and a picture window, with casements on either side, on the corner. The west façade runs to the rear of the site as another wing. A window similar to the front picture unit sits on the north corner of the west side.

43. Assessment of historic physical integrity related to significance: Enclosure of the original carport and stucco finish has seriously compromised the integrity of the house. Both material and pattern changes have eliminated the original character of the building and it no longer contributes to the overall character of the neighborhood.

Looking southeast
