# Architectural Inventory Form

1. Resource number: 5ME.8914
2. Temporary resource number: 649.SIXT
3. County: Mesa
4. City: Grand Junction
5. Historic building name: n/a
6. Current building name: n/a
7. Building address: 649 N. 16th Street
8. Owner name and address: Elizabeth Cannedy  
649 N 16th St Grand Junction, CO 81501

48. Report title: Grand Junction Phase 3 Survey 49. Date(s): March 2005

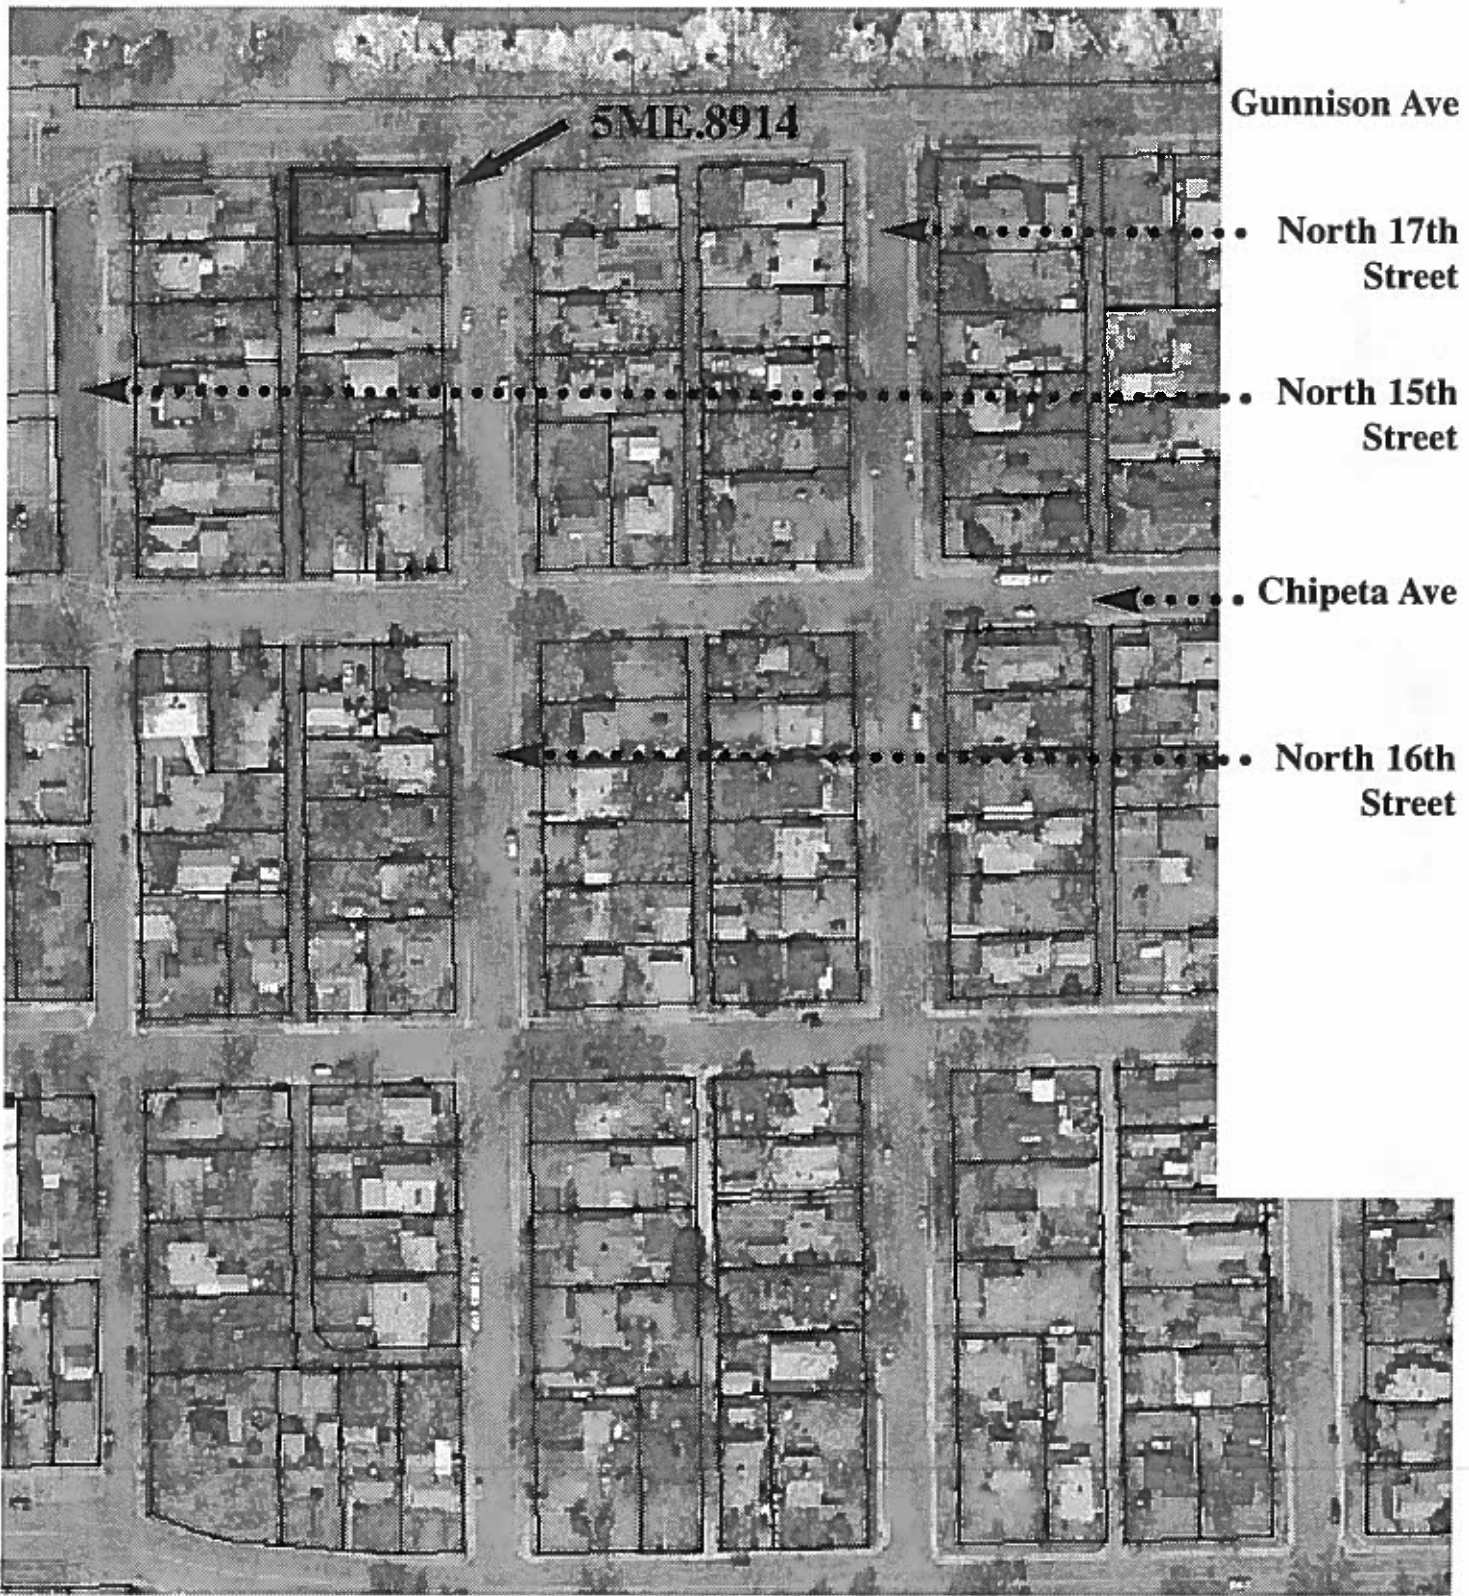
# 649 N.16th Street

Grand Junction, Colorado  
*image from 2002 aerial map*

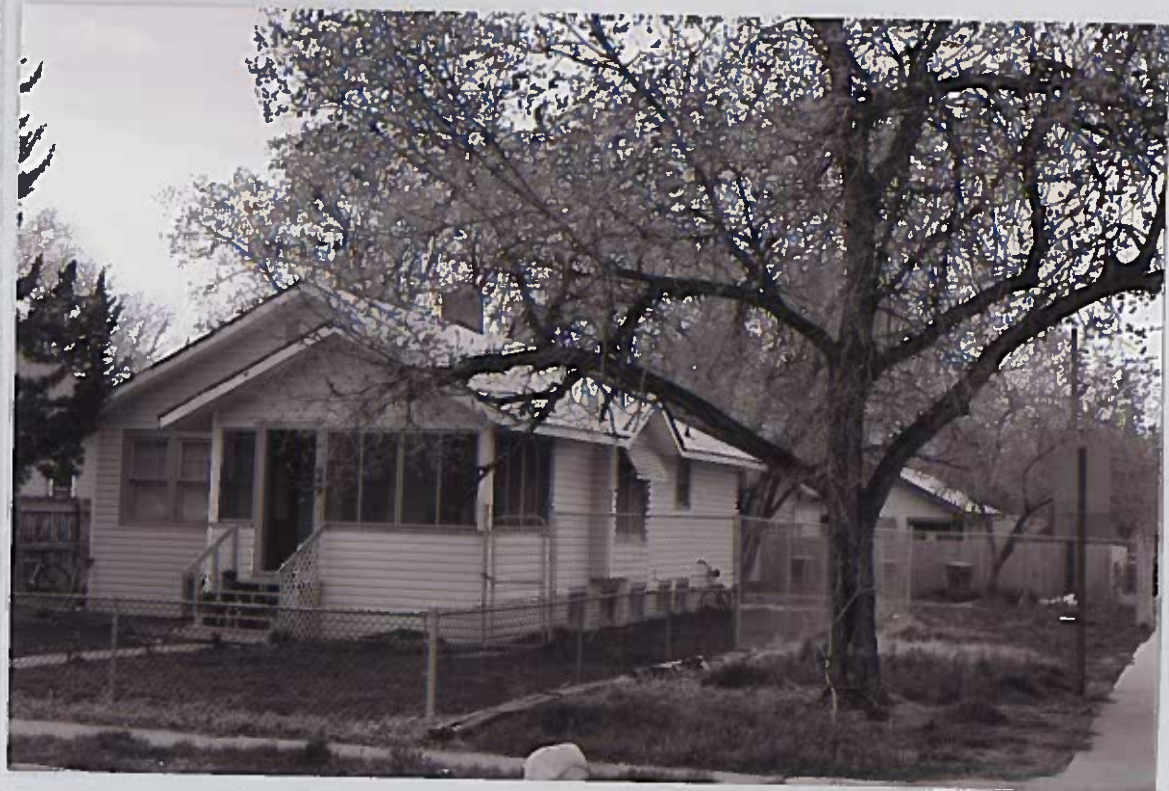
Roll # 16 Frame # 13

21. General architectural description: This is a simple rectangular wood frame house, with a front gabled roof. The main ridge runs east/west and the front of the house faces east. A lower gabled volume projects forward from the main façade, creating a screened porch. The porch roof is supported by two square posts in the corners, which sit on a low wall encircling the porch. Several wood steps lead up to the door which is off center on the main wall of the porch gable. Screen window panels infill the perimeter of the porch, above the low wall and to the head of the door. Adjacent to the porch volume on the south side of the main wall is a group of three double hung windows which appear to have three over three muntins in the upper sash.

Looking southwest

43. Assessment of historic physical integrity related to significance: Alterations have  
seriously impacted the integrity.
