COLORADO CULTURAL RESOURCE SURVEY

Architectural Inventory Form

1. Resource number: 5ME.8965
2. Temporary resource number: 440.FIFT
3. County: Mesa
4. City: Grand Junction
5. Historic building name: n/a
6. Current building name: n/a
7. Building address: 440 N. 15th Street
8. Owner name and address: Dean Palmerlee
440 N 15th St Grand Junction, CO 81501-4418

47. Photograph numbers: Roll # 16 Frame # 14
Negatives filed at: City of Grand Junction Planning Dept.
48. Report title: Grand Junction Phase 3 Survey 49. Date(s): March 2005
50. Recorder(s): Suzannah Reid, Patrick Duffield and Lydia Herron
51. Organization: Reid Architects, Inc.
52. Address: PO Box 1303 Aspen, Colorado 81612
53. Phone number(s): 970 920 9225

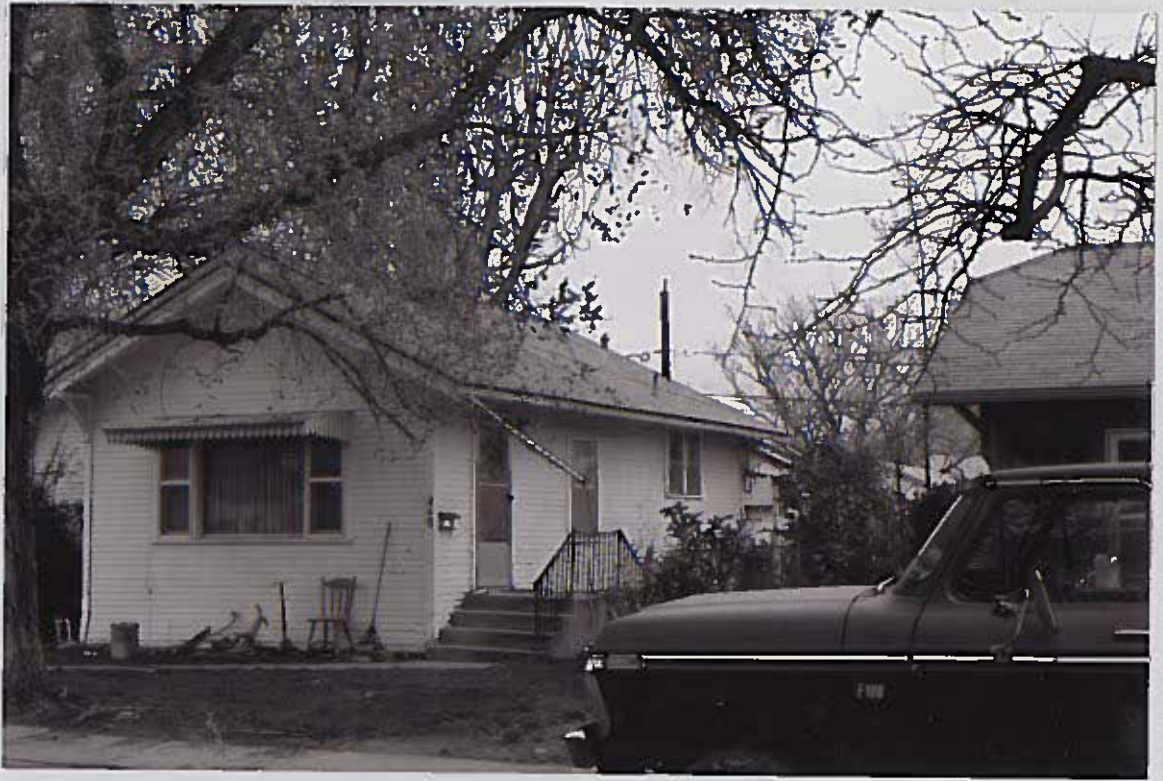
Roll # 16 Frame # 14

21. General architectural description: This is a single story wood frame house with a medium pitched gabled roof, running east/west. The house is made of two volumes, the primary volume and a smaller additive volume on the main façade. The smaller volume has a gable roof which has a lower ridge and shares the same south plane as the main volume. A picture window is centered on the smaller gable and is flanked by two narrow double hungs. The entry is on the south side of the smaller volume and is accessed by a set of concrete steps. The main volume has one vertically proportioned double hung in the remaining wall space that faces west. The north side of the main volume has two vertically proportioned double hungs set near either end. A brick chimney sits off the ridge to the south. The siding is a narrow clapboard with corner boards. The roof has moderate overhangs with brackets along the rake of the roof.

Looking northeast
