Historic Building Inventory Record

Architectural Inventory Form

1. Resource number: 5ME.11710
2. Temporary resource number: 1215.FIFT
3. County: Mesa
4. City: Grand Junction
5. Historic building name: n/a
6. Current building name: n/a
7. Building address: 1215 N. 15th Street
8. Owner name and address: Helen G Wagner
1215 N 15th St Grand Junction, CO 81501-4301

47. Photograph numbers: Roll # 5 Frame # 36
Negatives filed at: City of Grand Junction Planning Dept.
48. Report title: Grand Junction Phase 3 Survey 49. Date(s): March 2005
50. Recorder(s): Suzannah Reid, Patrick Duffield and Lydia Herron
51. Organization: Reid Architects, Inc.
52. Address: PO Box 1303 Aspen, Colorado 81612
53. Phone number(s): 970 920 9225

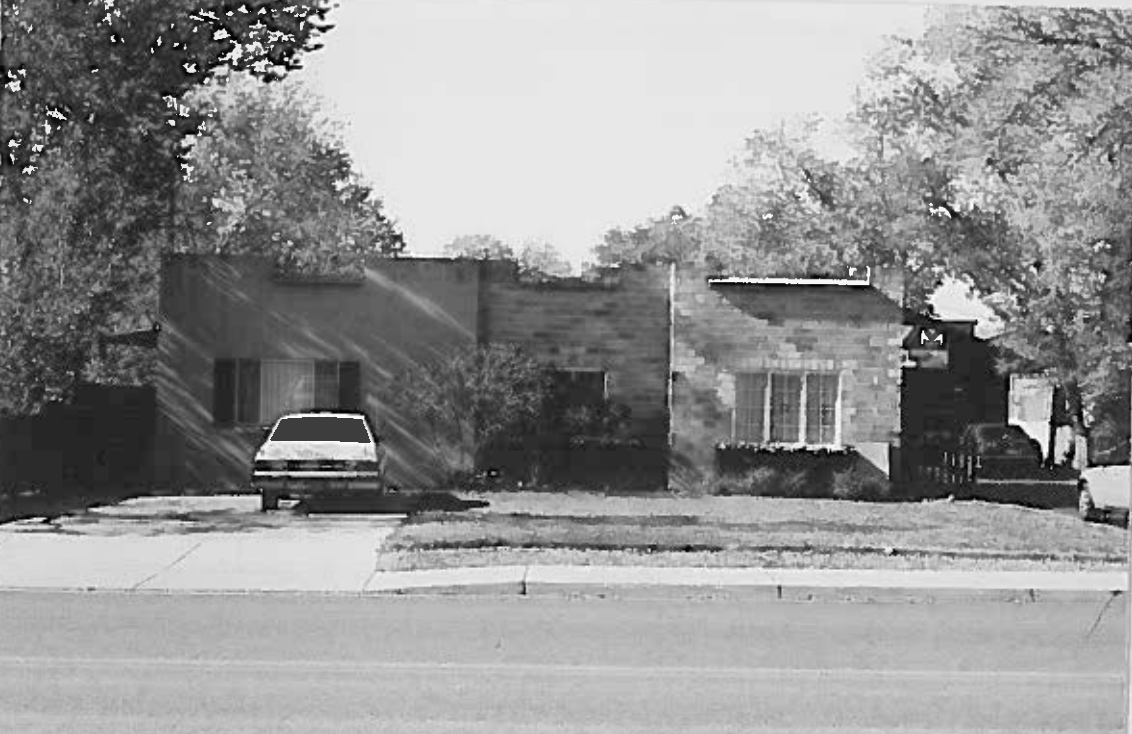
Roll # 5 Frame # 36

21. General architectural description: This is a generally rectangular plan masonry building with several stepping volumes. The principal façade faces east and is comprised of three similar sections. The south part is the largest wall plane; it is stuccoed and has a picture window with smaller flanking windows to each side. The window is off center to the south side. The parapet wall has a step down in the center with a row of sloped block running across it. The center section is recessed from the south section. It has a larger area of step down in the center with a window centered below. In this case the window and the stepped down area are the same width. The north section projects out beyond the other two sections and has the longest stepped down parapet of the three (all step downs are filled with the row of sloped block). A set of three vertically proportioned casement style windows, are centered below, but are narrower in width than the parapet step above. The center and north sections are large textured terra cotta masonry blocks in a running bond pattern with a varied coloration. The corners and the window openings have contrasting quoins of smooth lightly colored block. The north side of the building also has a three part composition. On this side the three parts are generally equal and have a similar pattern of stepped down parapet wall with a window (one door) centered below. This pattern repeats around the building. The south side has a shed roof porch area, which may be the building entrance.

Looking west
