COLORADO CULTURAL RESOURCE SURVEY

Architectural Inventory Form

. 1	den	tification	
	1.	Resource number:	5ME.14840
	2.	Temporary resource number:_	2426.TEX
	3.	County:	Mesa
	4.	City:	Grand Junction
	5.	Historic building name:	n/a

48. Report title: Grand Junction Phase 3 Survey 49. Date(s): March 2005			
50. Recorder(s): Suzannah Reid, Patrick Duffield and Lydia H	lerron		
51. Organization: Reid Architects, Inc.

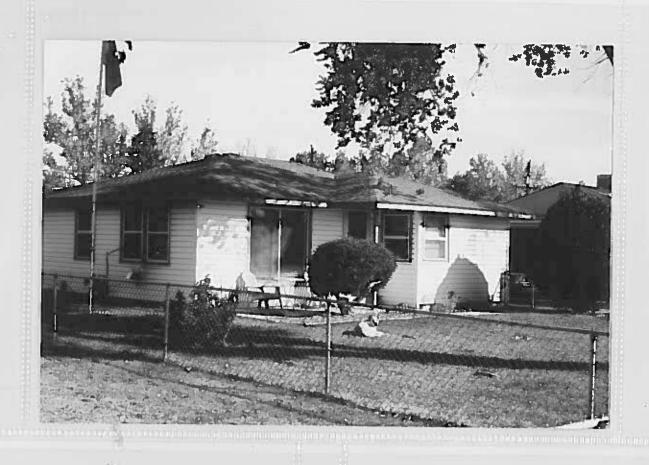
Roll #1 Frame #33

21.	1. General architectural description: This is a simple wood frame house with an L-Shaped		
		plan. The main volume has a short ridge which runs east/west and a small volume		
		projects to the south, with a	lower ridge. The roof has a continuous eave line with a	
moderate overhang. The principal façade (facing south) has a large picture window wit				
a single vertical muntin, on the left side and the entry door under the projecting roof the center of the main wall. The projecting volume has a small double hung on each			the left side and the entry door under the projecting roof near	
	of the corner near the door. The roof overhang is supported by a single wood post. A			
			are located on the west side with a single similar double hung	
			puble hungs have a single horizontal muntin in each sash.

Looking northeast
