# Architectural Inventory Form

- 4. City: Grand Junction
- 5. Historic building name: \_\_\_\_\_\_n/a\_\_\_\_
- 6. Current building name: \_\_\_\_\_n/a\_\_\_
- 7. Building address: <u>1940 Kennedy Ave.</u>
- 8. Owner name and address: Jason Holm

- 47. Photograph numbers: Roll # 1 Frame # 35 Negatives filed at: City of Grand Junction Planning Dept.
- 48. Report title: Grand Junction Phase 3 Survey 49. Date(s): March 2005
- 50. Recorder(s): Suzannah Reid, Patrick Duffield and Lydia Herron
- 51. Organization: Reid Architects, Inc.
- 52. Address: PO Box 1303 Aspen, Colorado 81612
- 53. Phone number(s): 970 920 9225

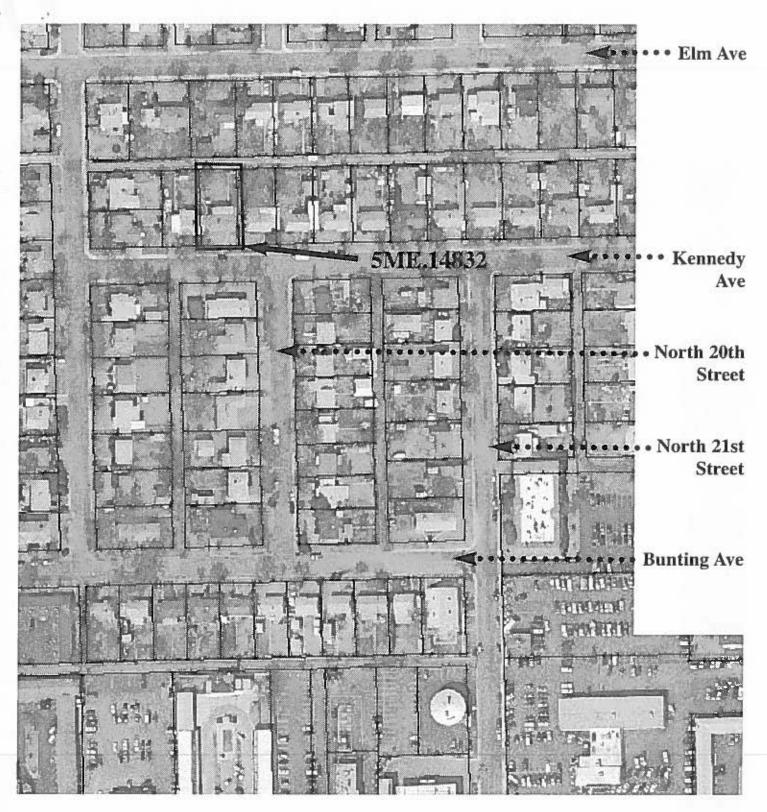
# 1940 Kennedy Ave.

- 21. General architectural description: <u>This is a modest wood frame rectangular house with</u> the long side facing the street (south). The main façade has a veneer of brick on the wall below the main window sill which is applied to the front only. The entry door sits on the far eastern side of the main façade with an adjacent picture window flanked by a double hung on each side. Two horizontally proportioned slider windows are located on the remainder of the façade. Their sills are higher than the picture window and they are closer to the window and the far corner than to each other. The overhang on the sides is minimal with a simple ogee trim, and the overhang on the eaves is slightly larger to provide protection for the entry door. The house sits on a concrete foundation and has composition shingles on the surfaces without brick. There are no windows on the east side, and a long shed roof porch is attached to the rear.
