HISTORIC BUILDING INVENTORY RECORD

project name: Grand Junction Downtown Survey			
county:	Mesa	city:	Grand Junction
state ID no. 5ME	\$140 temp	orary n	0.
current building name: The Winery; Culture Expressions; various			
address:	642/644/650 Main, Grand Junction, CO 81501		
owner:	Frank Bering, 642 Main Street, Grand Junction, CO 81501 (642) Robert Armantrout, 2291 Shiprock, Grand Junction, CO 81503- 1189 (644)		
township: 1S	range: 1W section	on: 14,	NE 1/4, SW 1/4
historic name: Lilja Building			
USGS quad name: Grand Jct., CO 1962 N3900-W10830 <u>X</u> 7.5' 15'			
district name:			
block: 105 lot(s) addition: City			
yr. of addition			
film roll by: Marty Alexandroff no.			
negative nos.5856-14; 6837-6			
location of negatives: City of Grand Junction			
date of construction:estimateactual			
source: 1982 Historic Structures Survey			
use: <u>commer</u>	rcialpresent		commercialhistoric
condition: <u>X</u> excellent good <u>fair</u> deteriorating

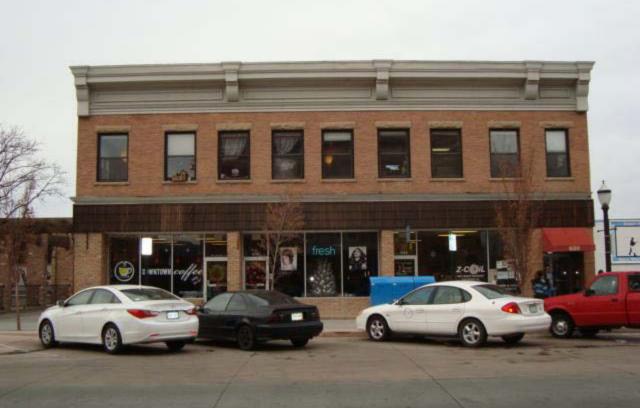
describe: display windows, signage, recessed entry, east side rear entrance to separate business

architectural description: Two story commercial brick building with wood bracketed cornice at roofline. One-over-one double hung windows on second level with voussoirs. Clerestory is covered with wood paneling and signage. Front is recessed with columns of new brick and display windows and brick kickplates. Two recessed entries have glass doors with glass transoms. There is a recessed doorway on the right side of the front which leads to the upstairs. It has a glass transom and red awning above. The west side of the building faces an alley. Much of the building is covered with shrubbery and ivy. The entrance to a restaurant is near the rear on the side. It has a small door with an awning and florescent lighting underneath. The recessed entrance is paneled with a double glass door and glass transom leading up an enclosed stairway. Painted wood seals a large doorway or opening on the east side. Lamps are placed along the side and provide lighting. Wood beams provide connection across alley to building on west side. There is also a cement stairway to a basement with an iron railing. The east side of the building has small windows near the rear of an addition. Second level windows appear to be bricked in. A metal shed roof appears at the rear, second level.
