COLORADO HISTORICAL SOCIETY		SITE NO.: 5ME8311
Office of Archaeology and Historic Preservation 1300 Broadway Denver, CO 80203 HISTORIC BUILDING INVENTORY		Eligible for National Register
County: Mesa	Crry: Grand Junction	Eligible for State Register
HISTORIC BUILDING NAME: Litton, James H., House		Period of significance
CURRENT BUILDING NAME:	1	LOCAL LANDMARK DESIGNATION: [] yes [X] no
ADDRESS: 2503 N. 1st St., Grand Junction, CO 81501-2013		Date of designation: N/A Designating authority: N/A
		P.M.: UTE township: 1S range:1W NE ¼ of NE ¼ of NE¼ of section 10
OWNER NAME & ADDRESS: Patrick A. Gormley, 2433 N. 1st St., Grand Junction, CO 81501-2011		UTM REFERENCE-12 Easting: 710110 Northing: 4329440
		USGS QUAD NAME: Grand Junction
		Year: 1962; photorevised 1973 [X] 7.5' [] 15'
STYLE: Vernacular Wood Frame		Block: Lot(s): Beg SE cor N2NE4NE4 W 439ft N42.6ft E to a pt 20+ Addition: Year of addition:
BUILDING TYPE:		[X] original location [] moved

INVENTORY COMPLETED BY: Museum Group Staff	DATE: 5/31/96
AFFILIATION: Museum of Western Colorado	PHONE: (970) 241-9117
ADDRESS: PO Box 20000-5020, Grand Junction, Colorado 81502-5020	PROJECT NAME: Grand Junction Historic Resources Survey, Phas

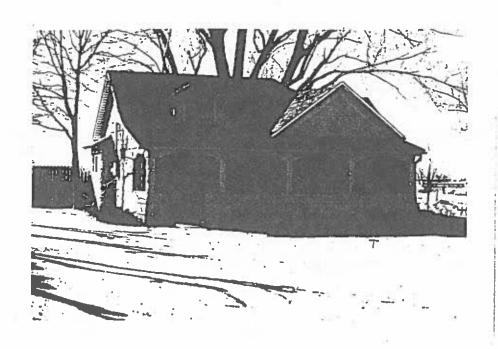
2503 N 1st St., Grand Junction, Mesa Co, CO 2945-101-00-102 03/08/1996 Roll 35 Frame 24 VIew E Dir NW 5me \$311

ARCHITECTURAL DESCRIPTION: One story with cross gables. Foundation skirted with wood shingle siding. Low concrete ramp leads to a screened porch with an extended shed roof across the facade. Battered porch base and half-wall have wood shingle siding. Five piers and two responds around porch also have shingle siding. Segmental arch heads are on the porch screen openings. Screen door. Front door is paneled with a large light. Windows around house are mainly double hung wood sash, one-over-one. Inside the porch, a south facade window has a five light transom. On the south elevation is a high, horizontal window with leaded glass in a lozenge pattern. Also on the south elevation is a bay with hip roof and paired windows on the face. On the north wing is a smaller, shed roof wing with pairs of small, single light sliding windows. Light gray wood shingle siding and trim. Dark gray composition shingle roof. The eaves have fascia boards. A short, gabled wing is on the facade. A hip roof domer on the facade has a three light window, and wood shingle siding. Domer and bay have exposed rafter ends. A gabled wing on the north elevation has a flared east slope.
