COLORADO CULTURAL RESOURCE SURVEY

Architectural Inventory Form

1. Resource number: 5ME.14659
2. Temporary resource number: 1337.KEN
3. County: Mesa
4. City: Grand Junction
5. Historic building name: n/a
6. Current building name: n/a
7. Building address: 1337 Kennedy Ave.
8. Owner name and address: Sarah Kathleen Rieves
747 Centauri Dr Grand Junction, CO 81506-1805

48. Report title: Grand Junction Phase 3 Survey 49. Date(s): March 2005

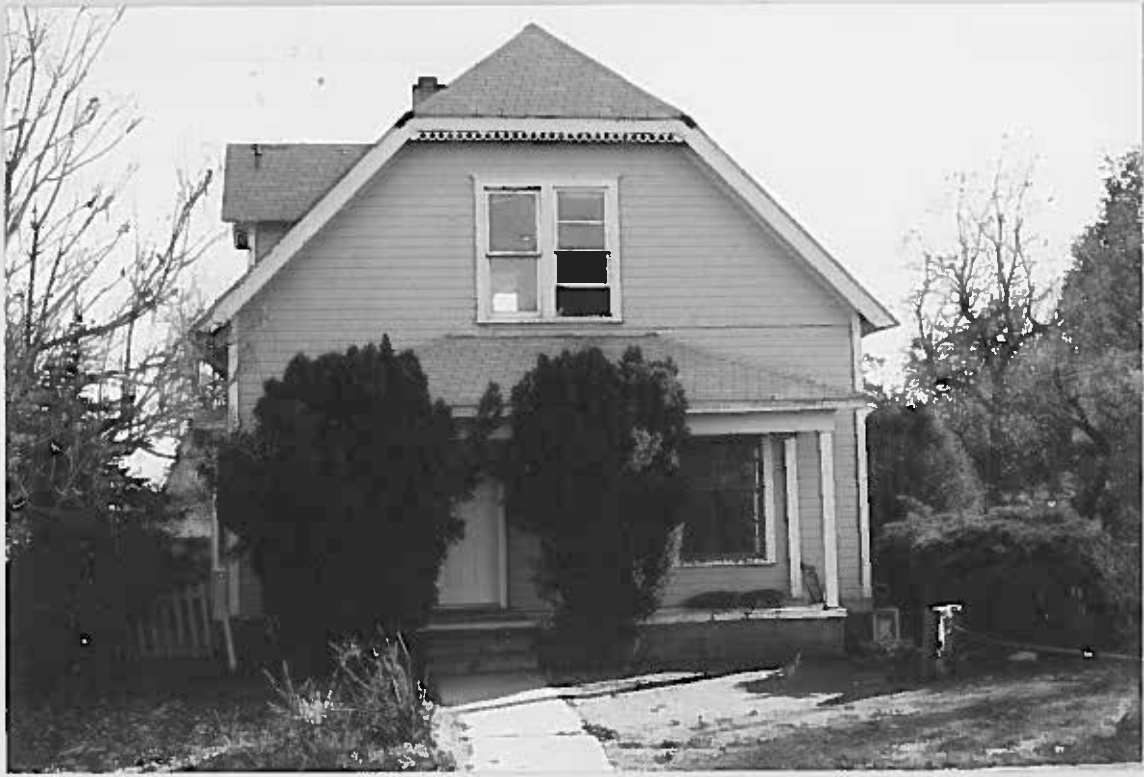
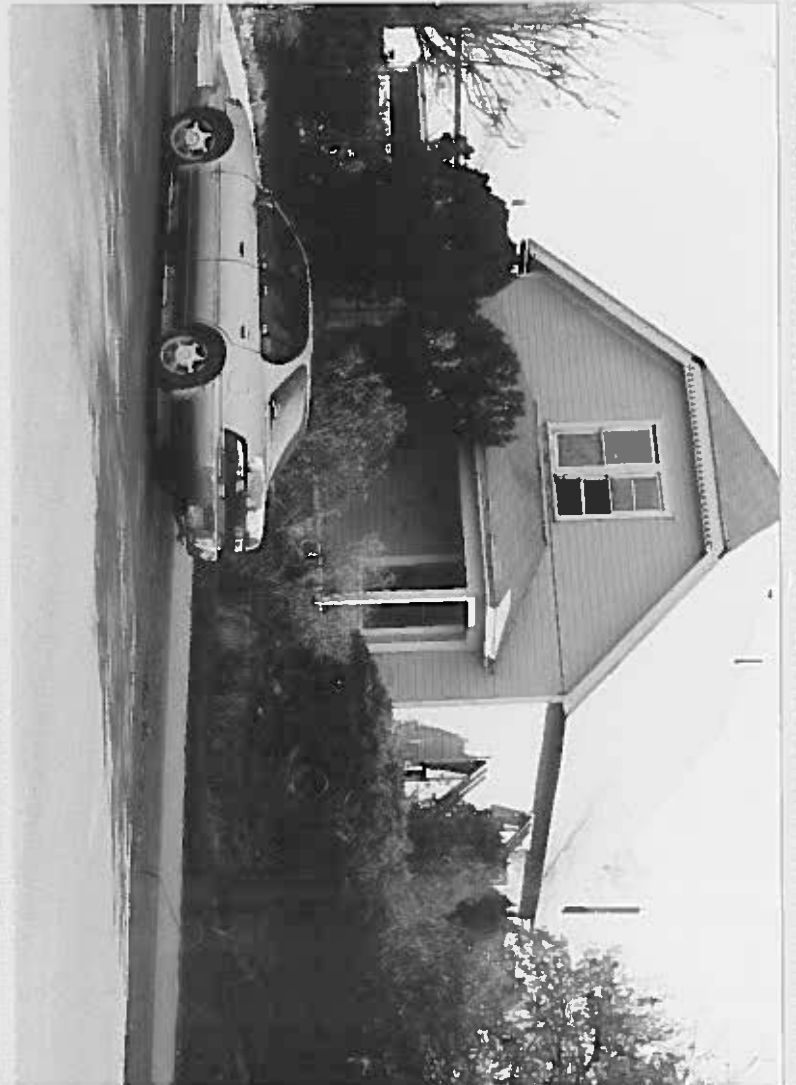
Roll # 4 Frame # 9

21. General architectural description: This is a large, rectangular, wood frame house with a primarily front gable roof. The ridge runs north/south and the principal façade faces north. The principal façade is symmetrical with a pair of vertically proportioned double hungs centered on the upper level and a hipped roof porch applied to the wall on the lower level. The entry door is located off center to the left with a large double hung on the right. Another small window is located to the left of the door. The porch roof has a moderate pitch and is supported by three equally spaced square columns on the outside and two pilasters on the inside. The porch floor is wood with a stone base. The main front gable has a clipped end on the façade, but is a straight gable on the rear. The bargeboards have decorative applied shapes and a decorative cut on the eave ends. A circle frieze runs along the bargeboard at the eave of the small hipped section. The west side has two double hungs and a central horizontal window on the upper level. The east side has a shallow bay near the center of the wall, with a gabled dormer above. The bay has vertically proportioned double hung windows on all faces. A brick chimney is located toward the rear on the east roof plane. An enclosed porch sits on the rear with another open porch beyond. The house has horizontal siding throughout with corner boards.

Looking south
