HISTORIC BUILDING INVENTORY

SITE NO.: 5ME8256

HISTORIC BUILDING NAME: Welch, Frank E., House

PROJECT NAME: Grand Junction Historic Resources Survey, Phase 2

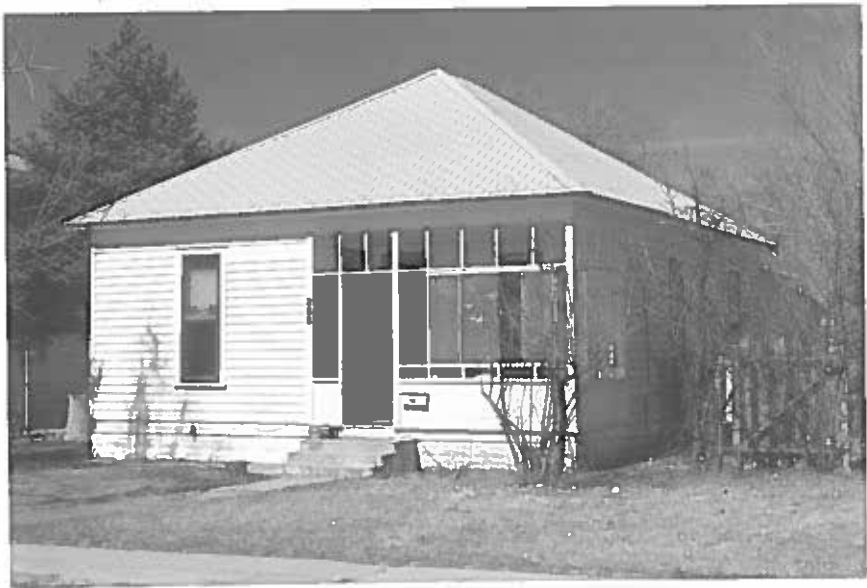
Roll 38 Frame 4 View S Dir N/NW

ARCHITECTURAL DESCRIPTION: One story with pyramidal hip roof. Concrete block foundation. Concrete steps lead up to integral porch in east half of facade. Vertical narrow beaded siding on half-wall. Two full height squared 4x4 posts on porch facade. Wood framing for screening is in place, but screens have been removed. Two front doors, each paneled with a large light which is rimmed by rows of small stained glass squares, open onto porch. Transoms and screen door. Windows are double hung wood sash, one-over-one, with black frame window screens. Yellow simple drop siding and foundation. Door and window surrounds are white. Gray composition shingle roof. Boxed eaves with fascia boards. Landscaped with lawn, locust and fir trees on west lawn. Sapling in parking area. Wood fence around backyard. Small metal storage shed in backyard.
