COLORADO HISTORICAL SOCIETY Office of Archaeology and Historic Preservation 1300 Broadway Denver, CO 80203 HISTORIC BUILDING INVENTORY		SITE NO.: 5ME8296
		Eligible for National Register
County: Mesa	CITY: Grand Junction	Eligible for State Register
HISTORIC BUILDING NAME: The house at 254 Belford Avenue		Period of significance
CURRENT BUILDING NAME:		LOCAL LANDMARK DESIGNATION: [] yes [X] no Date of designation: N/A Designating authority: N/A
ADDRESS: 254 Belford Ave., Grand Junction, CO 81502-0984		
		P.M.: UTE township: 1S range:1W NW ¼ of NE ¼ of NW% of NW% of section 14
OWNER NAME & ADDRESS: Paul R. Bainter, PO Box 984, Grand Junction, CO 81501-0984		UTM REFERENCE-12 Easting: 710415 Northing: 4327930
		USGS QUAD NAME: Grand Junction
STYLE: Bungalow		Year: 1962; photorevised 1973 [X] 7.5' [] 15' Block: 10 Lot(s): 19 and 20 Addition: Year of addition:
BUILDING TYPE:		[X] original location [] moved Date of moves(s):

INVENTORY COMPLETED BY: Museum Group Staff DATE: 3/29/96 AFFILIATION: Museum of Western Colorado PHONE: (970) 241-9117 ADDRESS: PO Box 20000-5020, Grand Junction, Colorado 81502-5020 PROJECT NAME: Grand Junction Historic Resources Survey, Phase 2

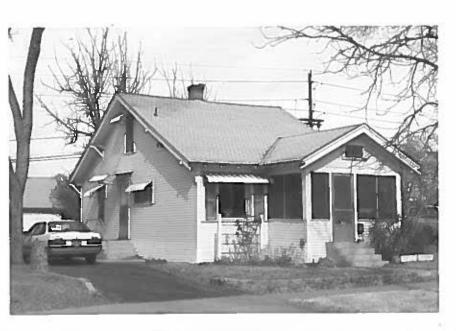
254 Belford Ave., Grand Junction, Mesa Co, CO 2945-142-02-004 02/07/1996 Roll 29 Frame 11 View S Dir NE

ARCHITECTURAL DESCRIPTION: One story with side gables. Battered foundation. Concrete steps lead up to gabled, screened porch on east half of facade, Four full height posts across porch. Siding on half-wall. Storm door. Front door is flush, with two small lights. Another entry on west elevation has concrete steps with pipe railing, storm door and flush door. Chicago window on west facade. Windows around house are double hung wood sash, one-over-one, with storm windows. Shallow, projecting bay on east elevation has hip roof. A small single light window is on east and west elevations. White metal awnings over many windows. White narrow lapped siding. Gray steps, storm door and window frames. Gray composition shingle roof. Bargeboards have notched talls. Exposed rafter ends. Knee braces under side gables, Brick chimney on ridge,
