COLORADO HISTORICAL SOCIETY Office of Archaeology and Historic Preservation		Site No.: 5ME8308
1300 Broadway Denver, CO 80203  HISTORIC BUILDING INVENTORY		Eligible for National Register
COUNTY: Mesa	Спу: Grand Junction	Eligible for State Register
HISTORIC BUILDING NAME: The house at 541 Belford Avenue		Period of significance Initials
CURRENT BUILDING NAME: Murphy Residence		LOCAL LANDMARK DESIGNATION: [ ] yes [X] no
ADDRESS: 541 Belford Ave., Grand Junction, CO 81501-2617		Date of designation: N/A Designating authority: N/A
		P.M.: UTE township: 1S range:1W SW ¼ of NE ¼ of NE¼ of NW¼ of section 14
OWNER NAME & ADDRESS: Beatrice B. Murphy, 541 Belford Ave., Grand Junction, CO 81501-2617		UTM REFERENCE-12 Easting: 710775 Northing: 4327870
		USGS QUAD NAME: Grand Junction
		Year: 1962; photorevised 1973 [X] 7.5' [ ] 15'
STYLE: Classic Cottage		Block: 16 Lot(s): 8 and 9 Addition: Year of addition:
BUILDING TYPE:		[X] original location [] moved

PROJECT NAME: Grand Junction Historic Resources Survey, Phase 2

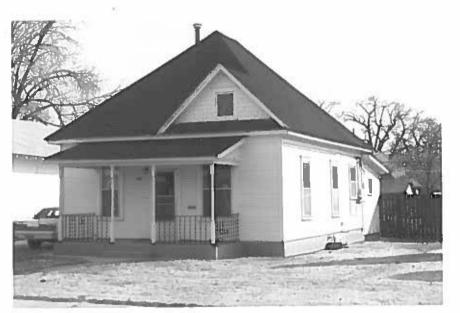
541 Belford Ave., Grand Junction, Mesa Co, CO 2945-142-08-005 02/07/1996 Roll 30 Frame 2 View N Dir S/SE

ARCHITECTURAL DESCRIPTION: One story with hip roof with cross gable. Concrete coated foundation. Concrete steps lead up to porch with shed roof across center of facade. Porch floor is a thick concrete stab. Four full height, stender turned posts across porch. Black wrought iron balustrades. Storm door over paneled door with large light. Windows around house are double hung wood sash, one-over-one, with metal frame storm windows. Shed roof wing across rear has sliding single light windows. White narrow drop siding and trim. Roof is dark red composition shingles, green on south slope. Boxed eaves and fascia boards. Cross gable on west third of facade is pedimented, with a kick. A single light window is on the gable face. Gable is sided with white wood shingles.
