COLORADO	HISTORICAL SOCIETY	
Office of Archaeology and Historic Preservation 1300 Broadway Denver, CO 80203 HISTORIC BUILDING INVENTORY		SITE NO.: 5ME7436 Eligible for National Registeryesno
		dateinitials CriteriaABCD Contributes to a potential National Register district yesno district name:
COUNTY: Mesa	CITY: Grand Junction	Eligible for State Registeryesno dateinitials Criteriaabcde Areas of significance:
HISTORIC BUILDING NAME: Miller, Florence, House		Period of significance Initials
CURRENT BUILDING NAME: Blackburn Residence ADDRESS: 624 N. 15th St., Grand Junction, CO 81501-4422		LOCAL LANDMARK DESIGNATION: [] YES [X] NO
		Date of designation: N/A Designating authority: N/A
		P.M.: UTE township: 1S range:1W NW ¼ of NW ¼ of SE¼ of NW¼ of section 13
OWNER NAME & ADDRESS: Olive L. Blackburn, 624 N. 15th St., Grand Junction, CO 81501-4422		UTM REFERENCE-12 Easting: 712180 Northing: 4327510
		USGS QUAD NAME: Grand Junction

624 N. 15th St. Grand Junction, Mesa Co, CO 2945-132-05-007 5ME7436

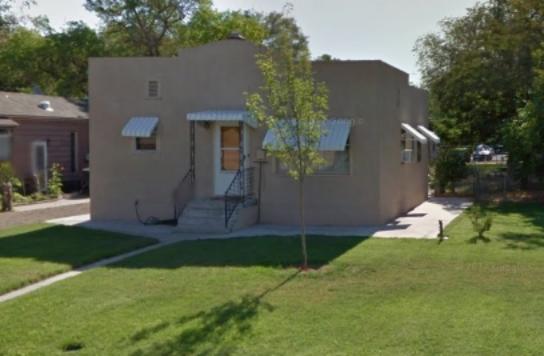
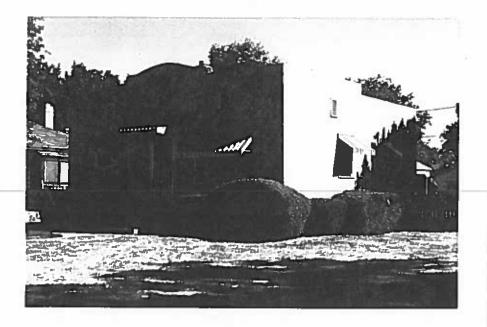
with plain window surrounds. Removable awning	picture window on south facade of house. Oth s over windows and front door. Stucco walls. s on facade and sides of house. Picket fence a	rought iron railings, and concrete front stoop lead to flush her windows are double hung wood sash, six-over-one around back yard containing Red Bud and Missouri
PHOTOGRAPHS (Include photographs showing each	n side of building and any associated buildings))
Film roll no.: 7 Negative no.: 21	Photographer: Carolyn Howard Location of negatives: City Of Grand Junction	
CONSTRUCTION HISTORY (include description and d modifications not noted in Assessor's Records.	ates of major additions, alterations, or demolitio	ins): Metal awnings. Additional construction or
Florence (Mrs. George) Miller. According to long-	time owner Mrs. Olive (Roy) Blackburn, ca. 194 y who owned cabins across the street. Mrs. Bl	Constructed ca. 1946, this residence was first owned by 46-present, the house was actually constructed in 1942 lackburn remembers purchasing the house in 1946 from Directories.
