<p>COLORADO HISTORICAL SOCIETY Office of Archaeology and Historic Preservation 1300 Broadway Denver, CO 80203</p> <p>HISTORIC BUILDING INVENTORY</p>		SITE NO.: 5ME7597 Eligible for National Register <input type="checkbox"/> yes <input type="checkbox"/> no date _____ Initials _____ Criteria <input type="checkbox"/> A <input type="checkbox"/> B <input type="checkbox"/> C <input type="checkbox"/> D Contributes to a potential National Register district <input type="checkbox"/> yes <input type="checkbox"/> no district name: _____
COUNTY: Mesa	CITY: Grand Junction	Eligible for State Register <input type="checkbox"/> yes <input type="checkbox"/> no date _____ Initials _____ Criteria <input type="checkbox"/> a <input type="checkbox"/> b <input type="checkbox"/> c <input type="checkbox"/> d <input type="checkbox"/> e Areas of significance: _____
HISTORIC BUILDING NAME: Coulson, Kenneth, House		Period of significance _____ Needs data _____ date _____ Initials _____

CURRENT BUILDING NAME: _____		LOCAL LANDMARK DESIGNATION: <input type="checkbox"/> yes <input checked="" type="checkbox"/> no Date of designation: N/A Designating authority: N/A
ADDRESS: 1630 Dolores St., Grand Junction, CO 81503

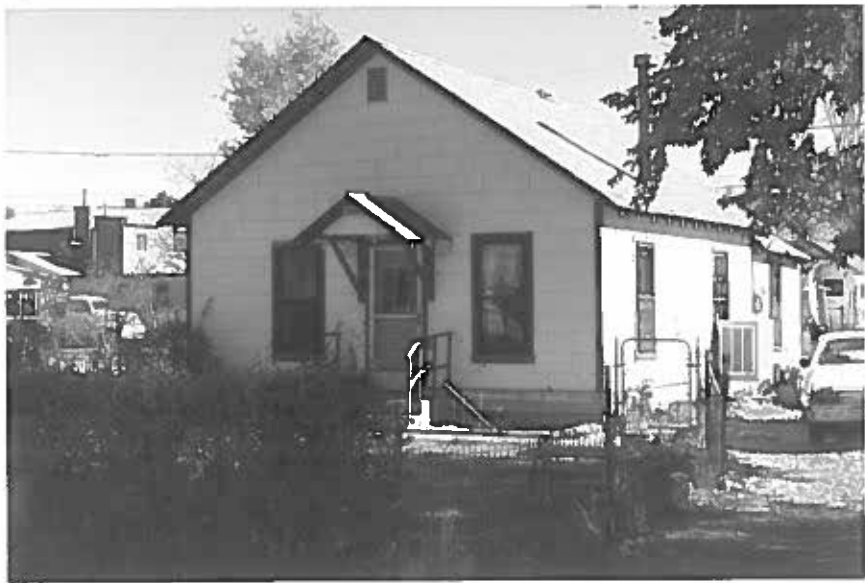
11/01/1995
Roll 8 Frame 16
View W Dir NE
SME7597

ARCHITECTURAL DESCRIPTION: One story with front gable. Concrete front steps and stoop with wood railings lead to entry with small gabled portico supported by knee braces. Paneled front door with large light. Windows are tall and narrow, double hung wood sash. Two tall vertical lights in upper and lower sashes. Siding is white asbestos/concrete shakes. Window and door surrounds, corner boards, knee braces are brown. Composition shingle roof with tall metal vent for chimney. Exposed rafter ends.
