HISTORIC BUILDING INVENTORY

SITE NO.: 5ME7751

HISTORIC BUILDING NAME: Miles, W.F., House

PROJECT NAME: Grand Junction Historic Resources Survey, Phase 2

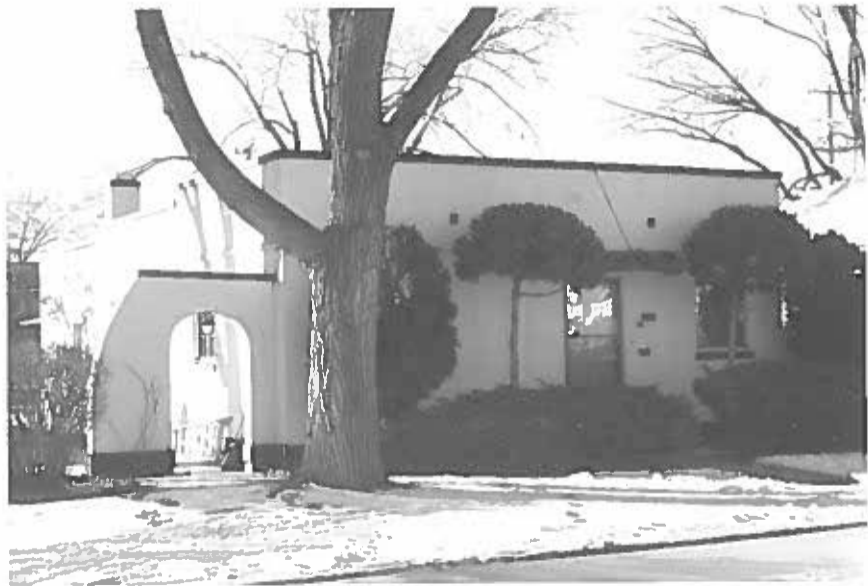
1109 Belford Ave.
Grand Junction, Mesa Co, CO
2945-141-07-002
5ME7751

ARCHITECTURAL DESCRIPTION: One story with flat roof with parapet. Two semicircular concrete steps under semicircular cantilevered portico with flat roof. Front door is flush. Storm door. On the east elevation is a wing wall with an arched doorway through it. The symmetrical facade has a pair of six light, steel casement windows on both sides with no casing or surrounds, and black rowlock brick sills. Pairs of steel casement windows around house, with black rowlock brick sills. White stucco siding. Above low foundation a course of black soldier bricks encircle house at foundation level. Narrow black coping along roof parapet. Black foundation and steps, black window frames and muntins. Flat roof has an even parapet across facade. On east and west elevations the parapets step to follow slope of roof. White brick chimney on east elevation.

01/12/1996
Roll 17 Frame 17
View N Dir S/SW
5ME7751
