Resources Survey, Phase 2

PROJECT NAME: Grand Junction Historic

1105 Grand Ave.

5ME7770

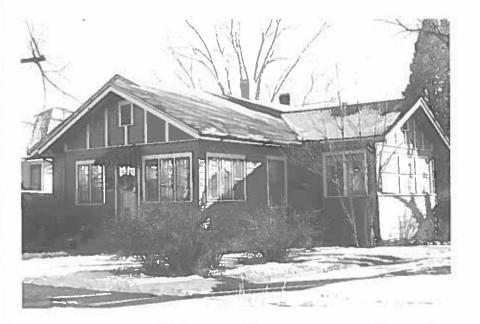
01/12/1996 Roll 17 Frame 02

ARCHITECTURAL DESCRIPTION: One story with cross gables. Painted concrete block foundation. Concrete steps lead up to sunporch/entry with gable roof extending across west three-quarters of the facade. Ribbons of casement windows on three sides of sunporch have twelve lights each. Front door is paneled and has a four light window. Small, canvas awning overdoor. Windows around house are double hung wood sash, twelve and six over one; on he east elevation, they are one-over-one. All have storm windows. A gabled wing on the west elevation has another sun room with ribbons of six over one windows. A bay window with shed roof is on east elevation. Clapboard siding and foundation is barn red. Gables have the same siding with lecorative vertical half timbering. Door and window surrounds, doors, bargeboards and half timbering are peach. Windows frames and muntins are dark treen. Red composition shingle roof with two brick chimneys on east slope.

View N Dir SE
