COLORADO HISTORICAL SOCIETY Office of Archaeology and Historic Preservation 1300 Broadway Denver, CO 80203		SITE NO.: 5ME7804
		Eligible for National Registeryesno date initials CriteriaABCD
HISTORIC BUILDING INVENTORY		Contributes to a potential National Register district
County: Mesa	CITY: Grand Junction	Eligible for State Register ves no date initials Criteriaabcde Areas of significance:
HISTORIC BUILDING NAME: Hill, John, House		Period of significance Initials
CURRENT BUILDING NAME: Hughes Residence		LOCAL LANDMARK DESIGNATION: [] yes [X] no
ADDRESS: 923 Rood Ave., Grand Junction, CO 81501-3435		Date of designation: N/A Designating authority: N/A
		P.M.: UTE township: 1S range:1W NW ¼ of SW ¼ of NE¼ of SE¼ of section 14
OWNER NAME & ADDRESS: Caroline M. Hughes, 923 Rood Ave., Grand Junction, CO 81501-3435		UTM REFERENCE-12 Easting: 711400 Northing: 4326970
		USGS QUAD NAME: Grand Junction
		Year: 1962; photorevised 1973 [X] 7.5' [] 15'

National Register eligibility: Individual [] yes [X] no Criteria: [] A [] B [] C [] D Area(s) of significance: Architecture	Contributes to a potential district: []yes [X]no District name:	
Period of significance: 1905		
STATEMENT OF SIGNIFICANCE

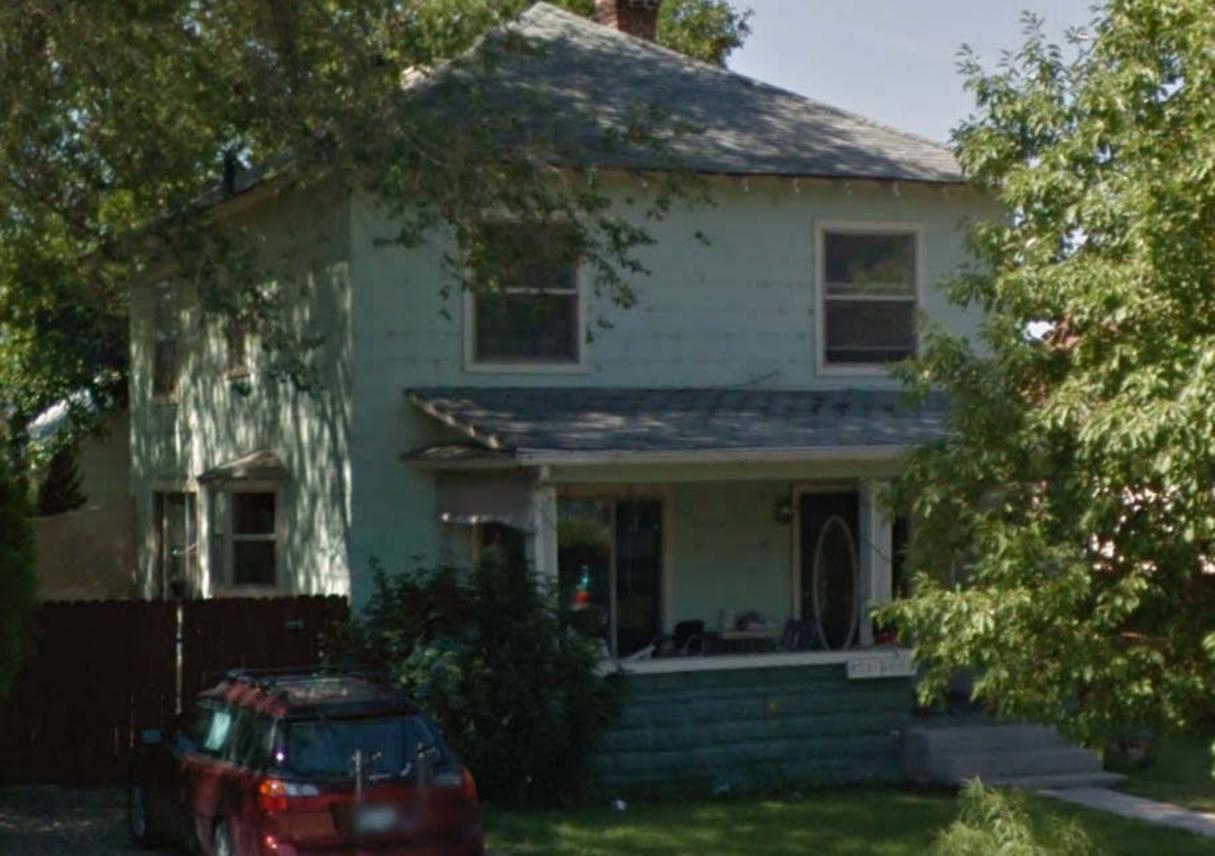
923 Rood Ave. Grand Junction, Mesa Co, CO 2945-144-15-004 5ME7804

seven-eights of facade. Porch half-wall is concr Front door is flush with diamond light. Windows columns, coping on porch half-wall and rafter en dark green. Light green composition shingle roo Landscaped with lawn. Large poplar by wet area. High, unpainted fence around backyard.	ete block. Three half columns and two responds are double hung wood sash, one-over-one. Pal- ids are pale yellow. Foundation, steps, porch hal of with slightly flared eaves and exposed rafter er it end of the porch leans away from the house at , light green rough sawn clapboard siding, light gi	s lead up to porch with shed roof extending across a, all of them fluted, are spaced along the half-wall. e green asbestos shingle siding. Window surrounds, if wall, front door surrounds and fluting in columns are ads with ornamental cuts. Brick chimney on west slope. a 40° angle. Gravel and another poplar tree in parking ray composition shingle roof, and contemporary metal
