PROJECT NAME: Grand Junction Historic Resources Survey, Phase 2

1123 Ouray Ave. , Grand Junction, Mesa Co, CO

5ME7842

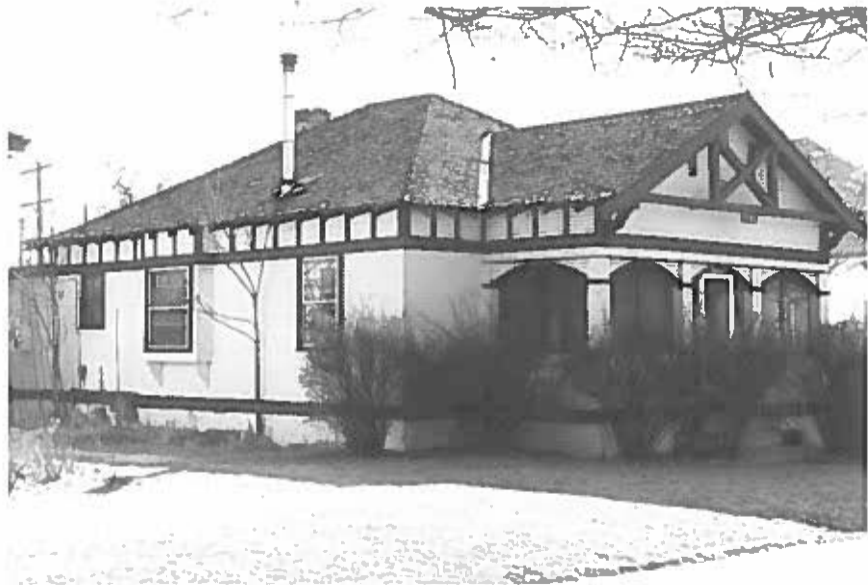
Roll 34 Frame 15 View N Dir SW

ARCHITECTURAL DESCRIPTION: One story with hip roof. Concrete steps with white wrought iron railing lead up to gabled screened porch extending across three-fifths of the facade. Porch gable faced with siding and bargeboards with shaped ends. A 6 x 6 tie beam, supported by wall beams, stretches between the ends of bargeboards. On the tie beam are two upright beams, with an "x" brace between. All these components are 6 x 6 timbers. Siding on the porch half-wall and base. Six, squared half-columns around porch also have narrow lapped siding. Segmental arches curve between the columns. Screen door. Front door inside porch is paneled and has a large oval light. Windows are double hung wood sash, one-over-one. Small projecting bay window on east elevation is under the eave of the principal roof. White narrow horizontal ribbed siding. Door and window surrounds, string courses, water table, bargeboards, knee braces, gable timbers, and decorative half-timbering are green. A string course surrounds the house at window top level. Above that, to eave line, are decorative vertical half-timbers every two feet. Cedar shingle roof with flared eaves. Knee braces have decorative cuts and exposed rafter ends are shaped. Brick chimney on south slope.
