COLORADO HISTORICAL SOCIETY			SITE NO.: 5ME7901	
Office of Archaeology and Historic Preservation 1300 Broadway Denver, CO 80203		Eligible for National Registeryesno date initials Criteria A B C D Contributes to a potential National Register districtyesnodistrict name:		
HISTORIC BUILDING INVENTORY				
				County: Mesa
COUNTY, Mesa	CITY. Gland Julicik	лі <u>=</u>	date initials Criteriaabcde Areas of significance:	
HISTORIC BUILDING NAME: Reed, C.S., House				
			Period of significance Needs data date Initials	
CURRENT BUILDING NAME:			LOCAL LANDMARK DESIGNATION: [] yes [X] no Date of designation: N/A Designating authority: N/A	
ADDRESS: 1103 Hill Avg. Crand Junetica, CO. 84504 3335				
ADDRESS: 1103 Hill Ave., Grand Junction, CO 81501-3226				.,
			P.M.: UTE township: 1S range;1W	
				SE¼ of NE¼ of section 14
OWNER NAME & ADDRESS: Paul L. Bonnell, 1143 Chipeta Ave., Grand Junction, CO 81501-3352			UTM REFERENCE-12 Easting: 711640 Northing: 4327720

INVENTORY COMPLETED BY: Museum Group Staff	DATE: 3/29/96	
AFFILIATION: Museum of Western Colorado	PHONE: (970) 241-9117	
ADDRESS: PO Box 20000-5020, Grand Junction, Colorado 81502-5020	PROJECT NAME: Grand Junction Historic Resources Surve

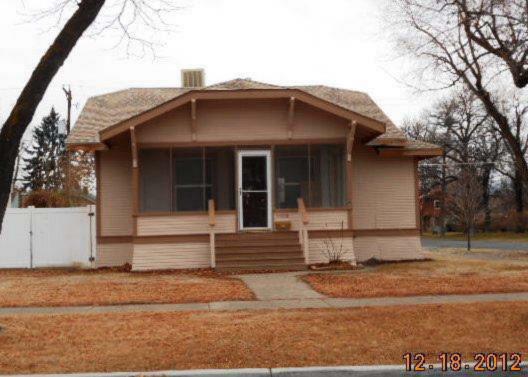
ARCHITECTURAL DESCRIPTION: One story with side hip on gable. Battered foundation. Wood steps, with battered piers, lead up to screened porch with hip on gable roof. Porch extends across center of facade. Siding on porch half-wall. Full length squared corner posts. Screen door. Front door is paneled and has a large single light. Windows are double hung wood sash, six and four and five over one, and have storm windows. Shallow wing and projecting bay on west elevation under shed roof. White simple drop siding. Door and window surrounds, columns, knee braces, comer boards, water table, screen door and porch screen framing are brown. Gray composition shingle roof with exposed rafter ends. Bargeboards with pointed ends. Knee braces under eaves. Brick chimney on south slope.

Landscaped with lawn, small evergreens on east facade, and locust trees and ash trees in parking. Wire fence around backyard. One car garage at rear with front gable, gray composition shingle roof, white simple drop siding, and metal contemporary door.
