HISTORIC BUILDING INVENTORY

SITE NO.: 5ME8186

HISTORIC BUILDING NAME: Magill, Robert and Stella, House

PROJECT NAME: Grand Junction Historic Resources Survey, Phase 2

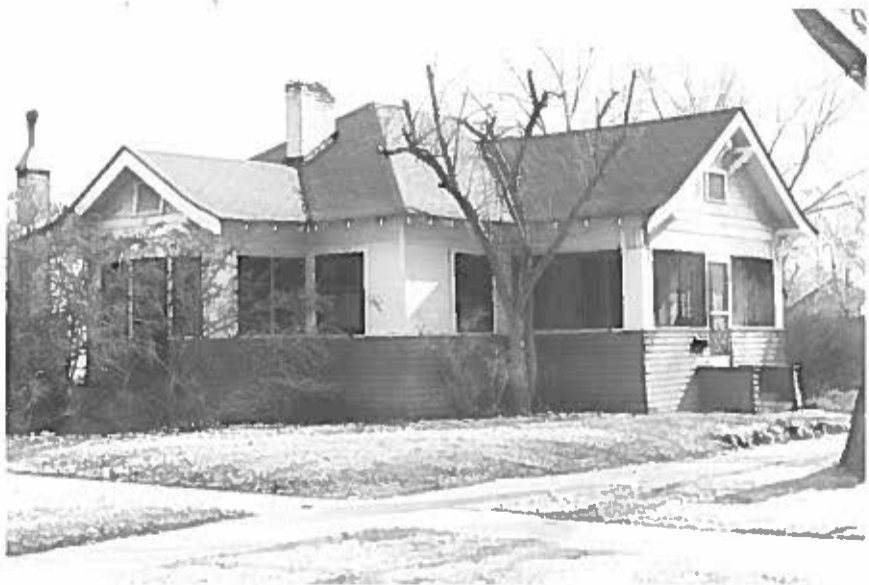
730 N. 6th St., Grand Junction, Mesa Co, CO
2945-142-19-001 02/06/1996
Roll 27 Frame 13 View W Dir SE

ARCHITECTURAL DESCRIPTION: One story with hip roof and cross gables. Battered foundation. Concrete steps, framed by wood shingled piers, lead to screened porch with gable roof in center of facade. Battered half-wall covered with wood shingles. Squared half posts are doubled in the corners. Metal screen door. Main door is paneled with three lights of beveled glass. Two sets of French windows flank the main door. Concrete steps lead to smaller enclosed sunporch with gable roof on north elevation. Wood shingled half-wall with squared half posts doubled at corners. Porch is glazed with double hung sash, twelve over one. Paneled porch door with light divided into twelve panes. Double hung wood sash windows, fifteen over one, around the house. Wood shingle siding up to the window sills painted brown. Upper wall has narrow lapped clapboards painted white. Wood shingles painted white appear in both gables. Windows frames painted black. Exposed rafter ends and knee braces and bargeboards in porches painted white. Fascia, corner boards and window surrounds are white. Brown composition shingle flared roof with overhanging eave. Brick chimney on north slope.
