HISTORIC BUILDING INVENTORY

SITE NO.: 5ME7670

HISTORIC BUILDING NAME: Erwin, J.H., House

PROJECT NAME: Grand Junction Historic Resources Survey, Phase 2

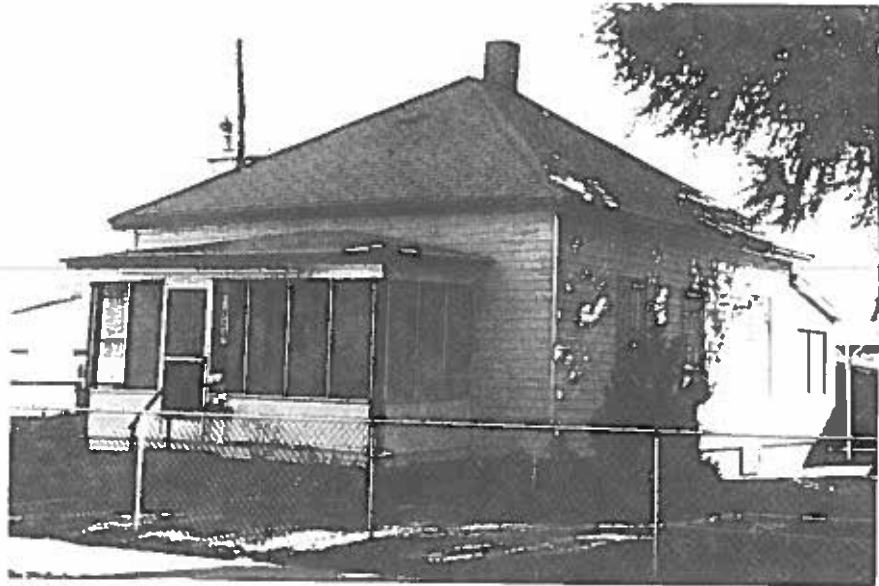
521 Fairview Ave.
Grand Junction, Mesa Co, CO
2945-154-26-014
5ME7670

ARCHITECTURAL DESCRIPTION: One story with hip roof. Concrete front steps and stoop with black pipe railing lead to screened porch with dropped hip roof extends across three-quarters of facade. Half-wall on porch has vertical siding. Three full length squared columns on porch corners and center have cushioned capitals. Front door is paneled with large light. Windows are double hung wood sash, one over one. Gray aluminum siding simulates lapped siding and is narrow enough to be harmonious with the period of the house. Window surrounds, two corner porch columns, foundation, steps, cornice and chimney are also gray. Light gray composition shingle roof with boxed eaves and a gray painted chimney on west slope.

CONSTRUCTION HISTORY (include description and dates of major additions, alterations, or demolitions): Aluminum siding, screen door and storm window frames. Additional construction or modifications not noted in Assessor's Records.

STATEMENT OF SIGNIFICANCE (briefly justify the significance checked above): A Classic Cottage with updating which is not intrusive. This house is quite original, including the screened porch. The new siding is of a scale which is appropriate for the house. Although not eligible for the National Register, his house may contribute to a local register.
