COLORADO HISTORICAL SOCIETY Office of Archaeology and Historic Preservation 1300 Broadway Denver, CO 80203		SITE NO.: 5ME8314
		Etigible for National Registeryesno dateinitials
HISTORIC BUILDING INVENTORY		CriteriaABCD  Contributes to a potential National Register districtyesno district name:
COUNTY: Mesa	CITY: Grand Junction	Eligible for State Register
HISTORIC BUILDING NAME: The house at 231 Belford Avenue		Period of significance
CURRENT BUILDING NAME:		LOCAL LANDMARK DESIGNATION: [ ] yes [X] no  Date of designation: N/A  Designating authority: N/A
ADDRESS: 231 Belford Ave., Grand Junction, CO 81501-2309		
		P.M.: UTE township: 1S range:1W SE ½ of NW ½ of NW½ of NW½ of section 14
OWNER NAME & ADDRESS: Daniel Trujillo, 231 Belford Ave., Grand Junction, CO 81501-2309		UTM REFERENCE-12 Easting: 710405 Northing: 4327880
		USGS QUAD NAME: Grand Junction
		Year: 1962; photorevised 1973 [X] 7.5' [ ] 15'

PROJECT NAME: Grand Junction Historic Resources Survey, Phase 2

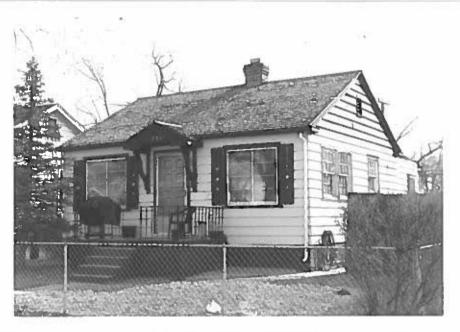
231 Belford Ave., Grand Junction, Mesa Co, CO 2945-142-11-005 02/07/1996 Roll 29 Frame 7 View N Dir S/SE 5 m = 83 4

ARCHITECTURAL DESCRIPTION: One story with side gable roof. Shallow gabled wing on east elevation. Concrete steps lead to large concrete stoop with wrought iron railing in center of facade. Small, pedimented gable roof with sawed knee braces over entry. Metal storm door. Front door is paneled. Majority of windows are double hung wood sash, eight over eight, with storm windows. Two windows in west elevation are eight over one. Two pairs of eight light windows in facade have wood plank shutters with diamond cut-outs. Foundation is skirted with blue bevel clapboard siding. White clapboard wood siding except in gables where it is painted blue. Window frames and downspout are white. Steps and stoop, porch pediment and sawed knee braces, raking cornice and returns, window surrounds and facade shutters and guitters are navy blue. Cedar shingle roof. Brick chimney in ridge.
